S-38 1302 Bridge Over I-26
Orangeburg County, South Carolina

Asbestos and Lead-Based Paint
Survey Report

Structure # 387130200100
ARM Project #16-318-22

October 14, 2022

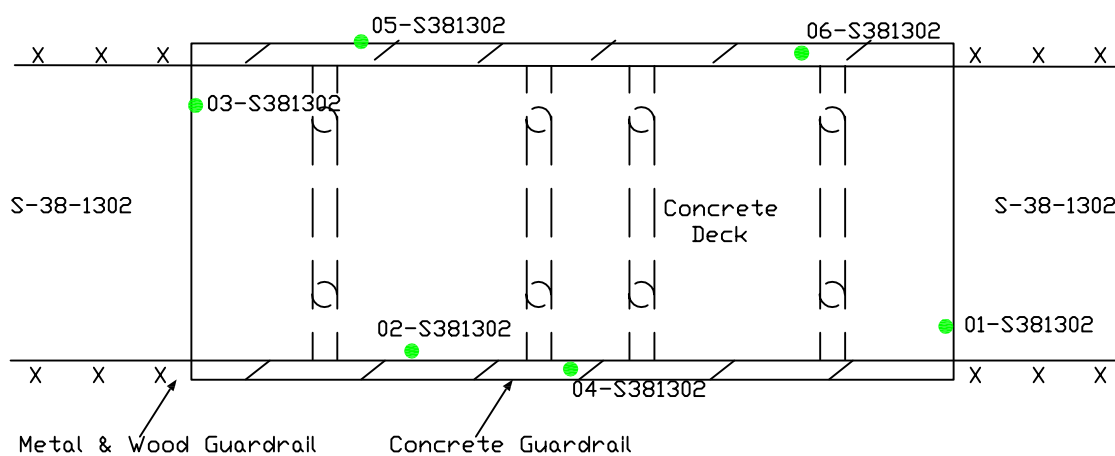
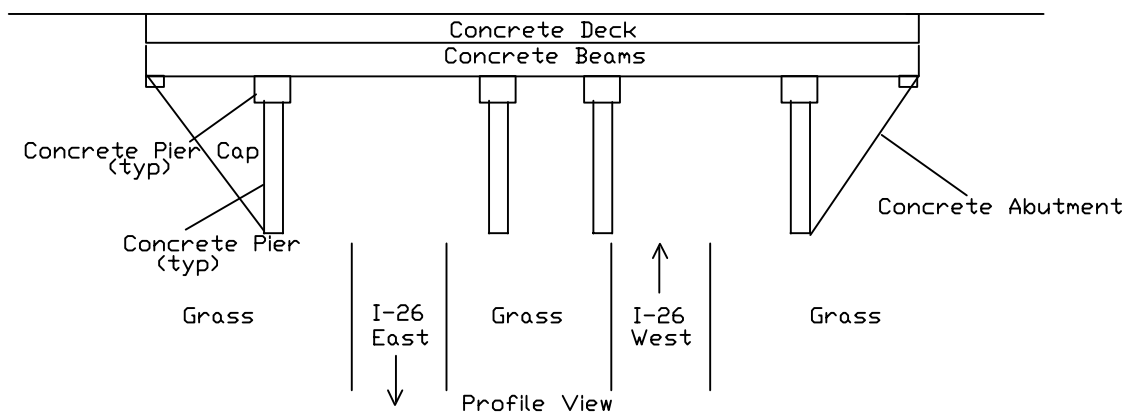
FIGURE 2

Site Plan Showing
Sample Locations

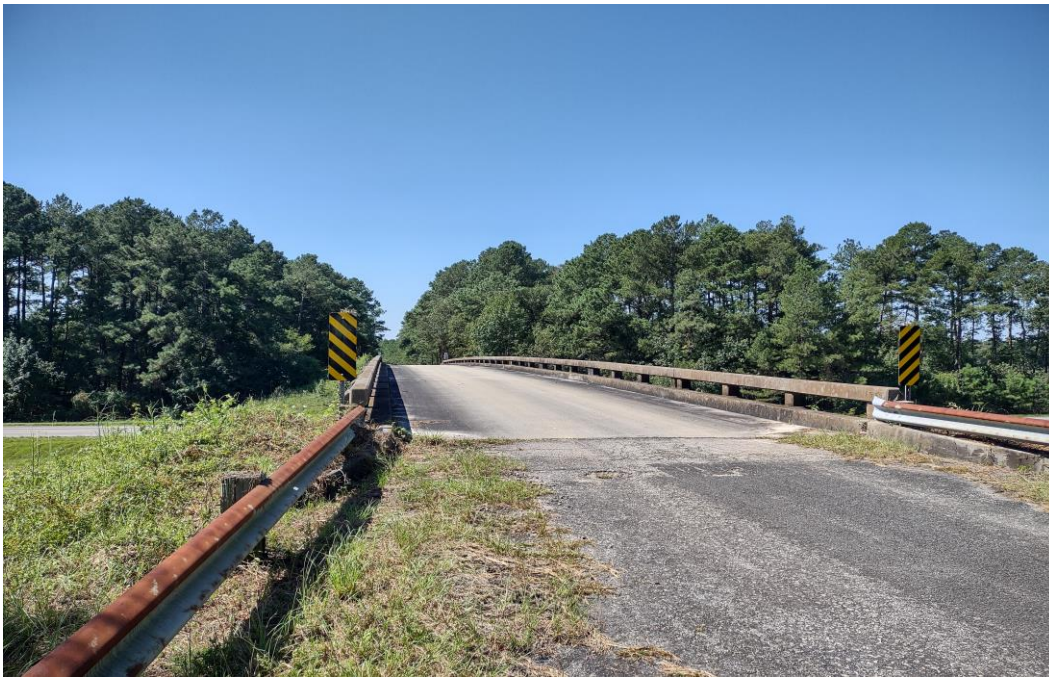
Photograph 1

A view of the S-38 1302 bridge over I-26 in Orangeburg County where an Asbestos and Lead-Based Paint Survey was performed by ARM Environmental.

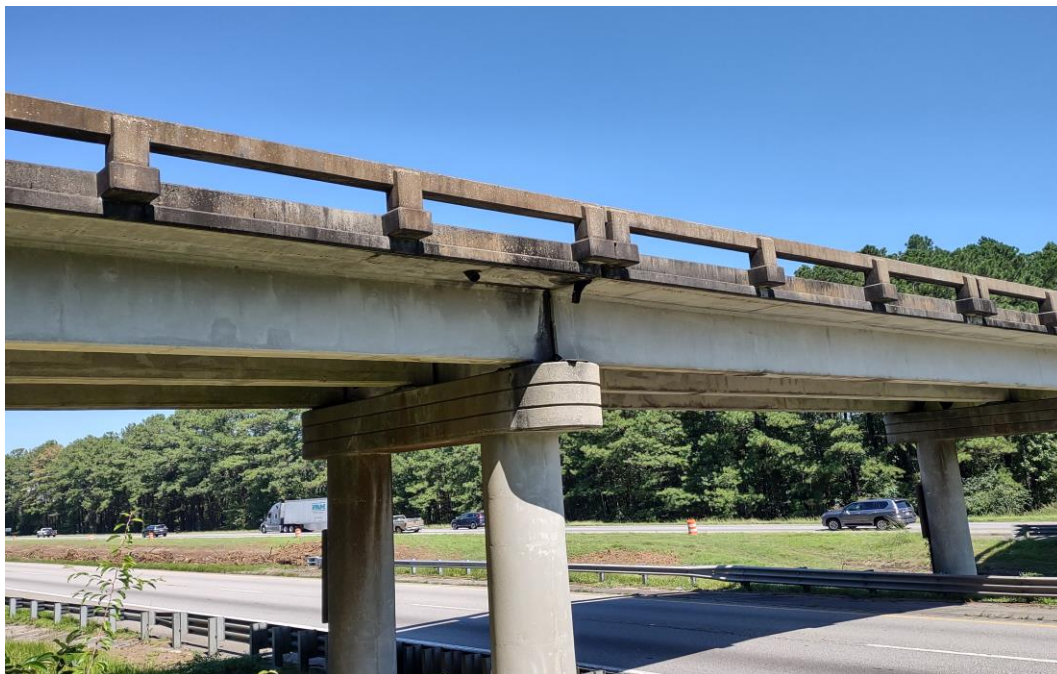
Photograph 2

Another view of the S-38 1302 bridge. There were no asbestos containing materials or lead-based paint detected on the bridge materials tested.
