I-26 & I-95 INTERCHANGE IMPROVEMENTS

June 29, 2023

PIPE INSPECTION REPORT

This report contains the results of the video pipe inspection and assessment of the existing storm water drainage pipes within the project area in Orangeburg and Dorchester Counties.

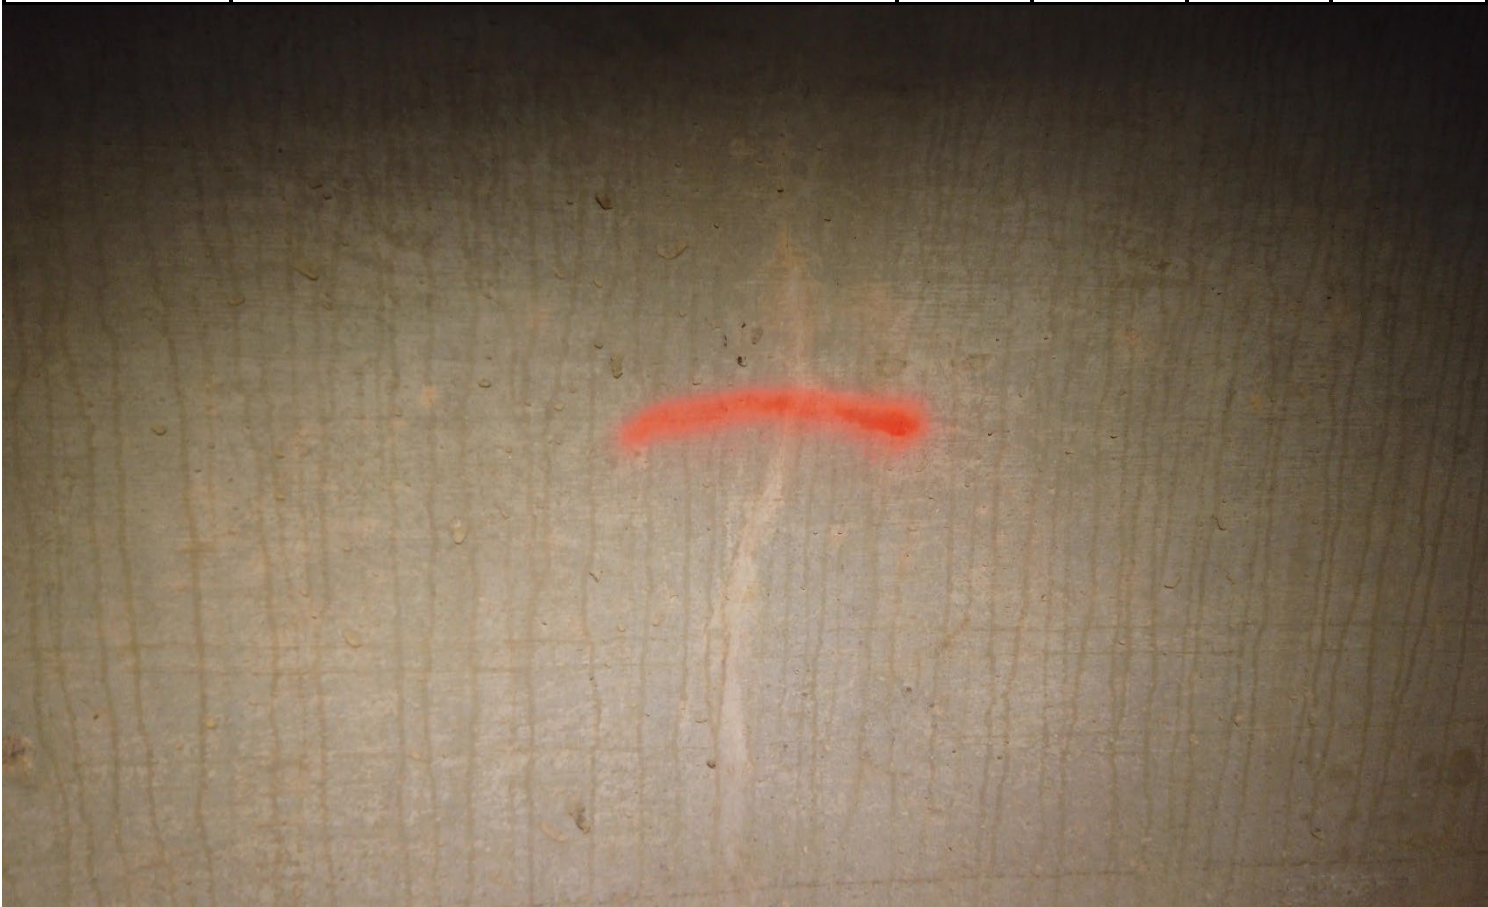
Footage	Defect Description	Top	Right	Left	Bottom
26 ft	Crack and Infiltration		Y

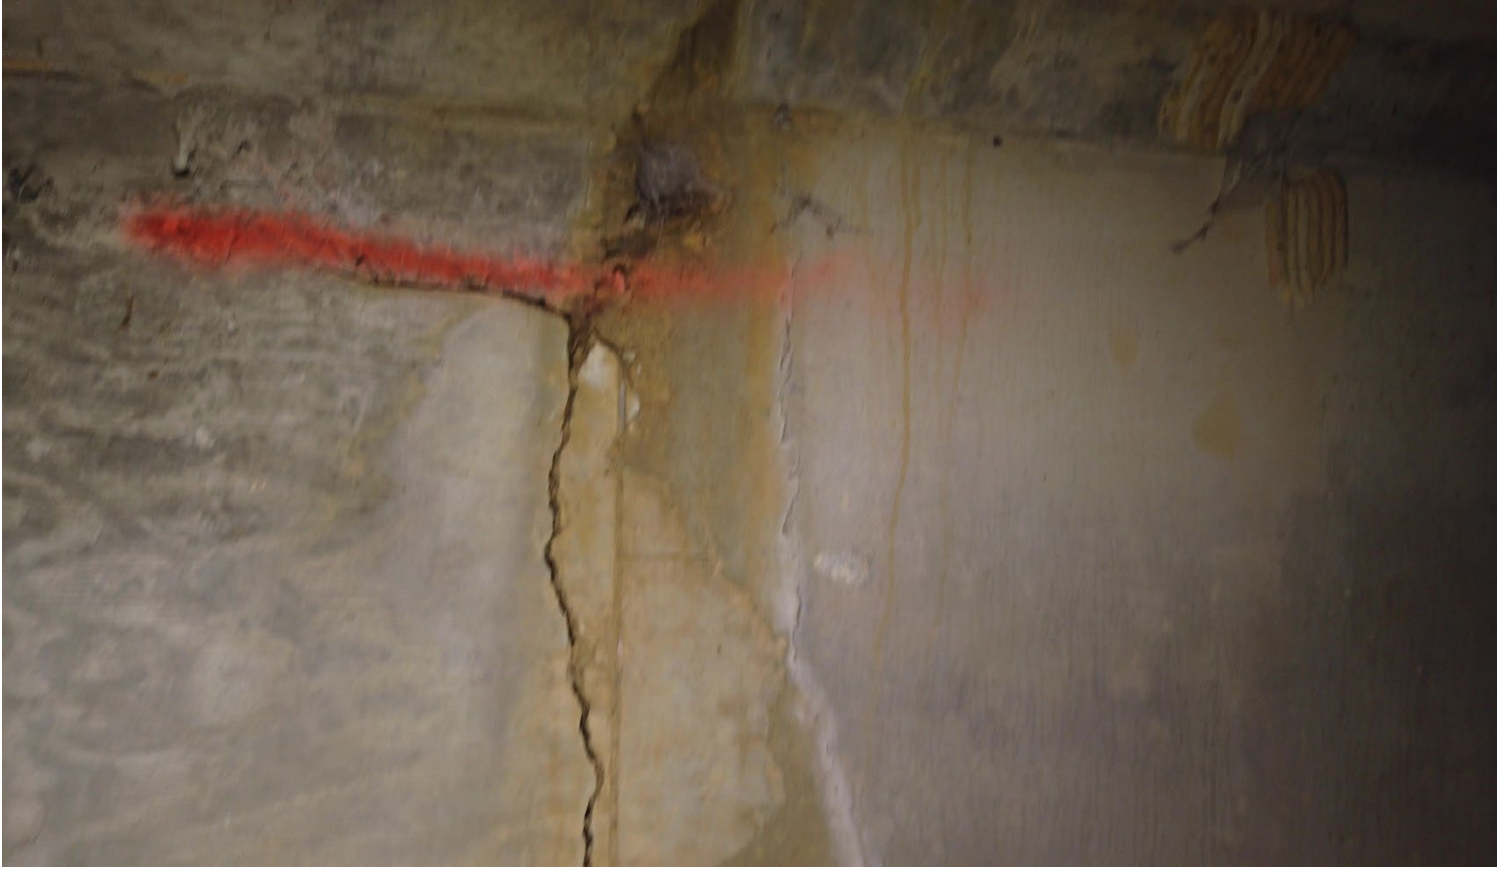
Footage	Defect Description	Top	Right	Left	Bottom
84 ft	Crack and Infiltration		Y

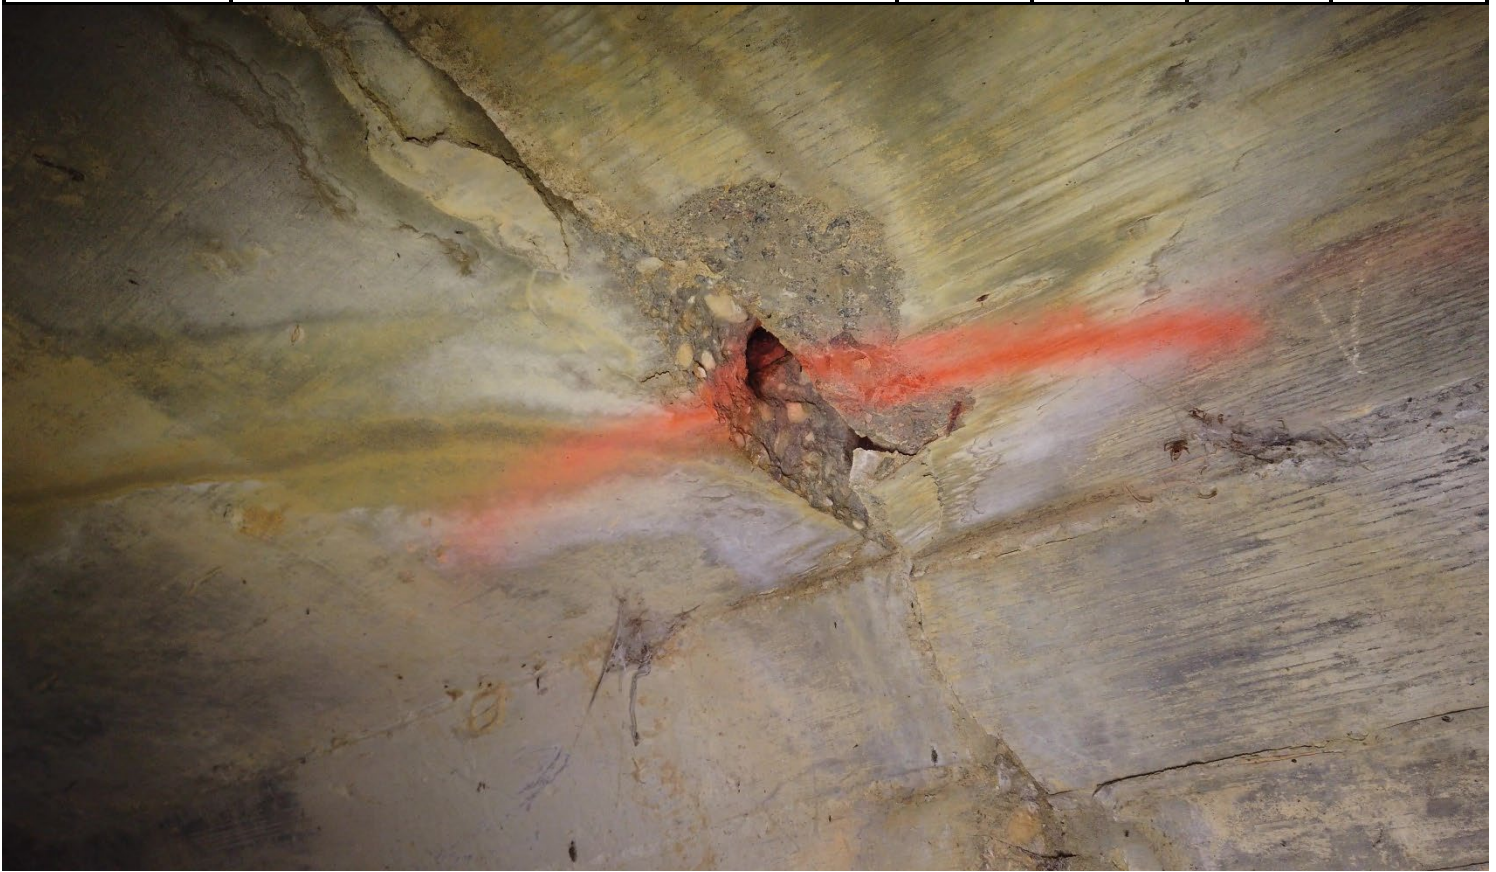
Footage	Defect Description	Top	Right	Left	Bottom
95 ft	Crack			Y

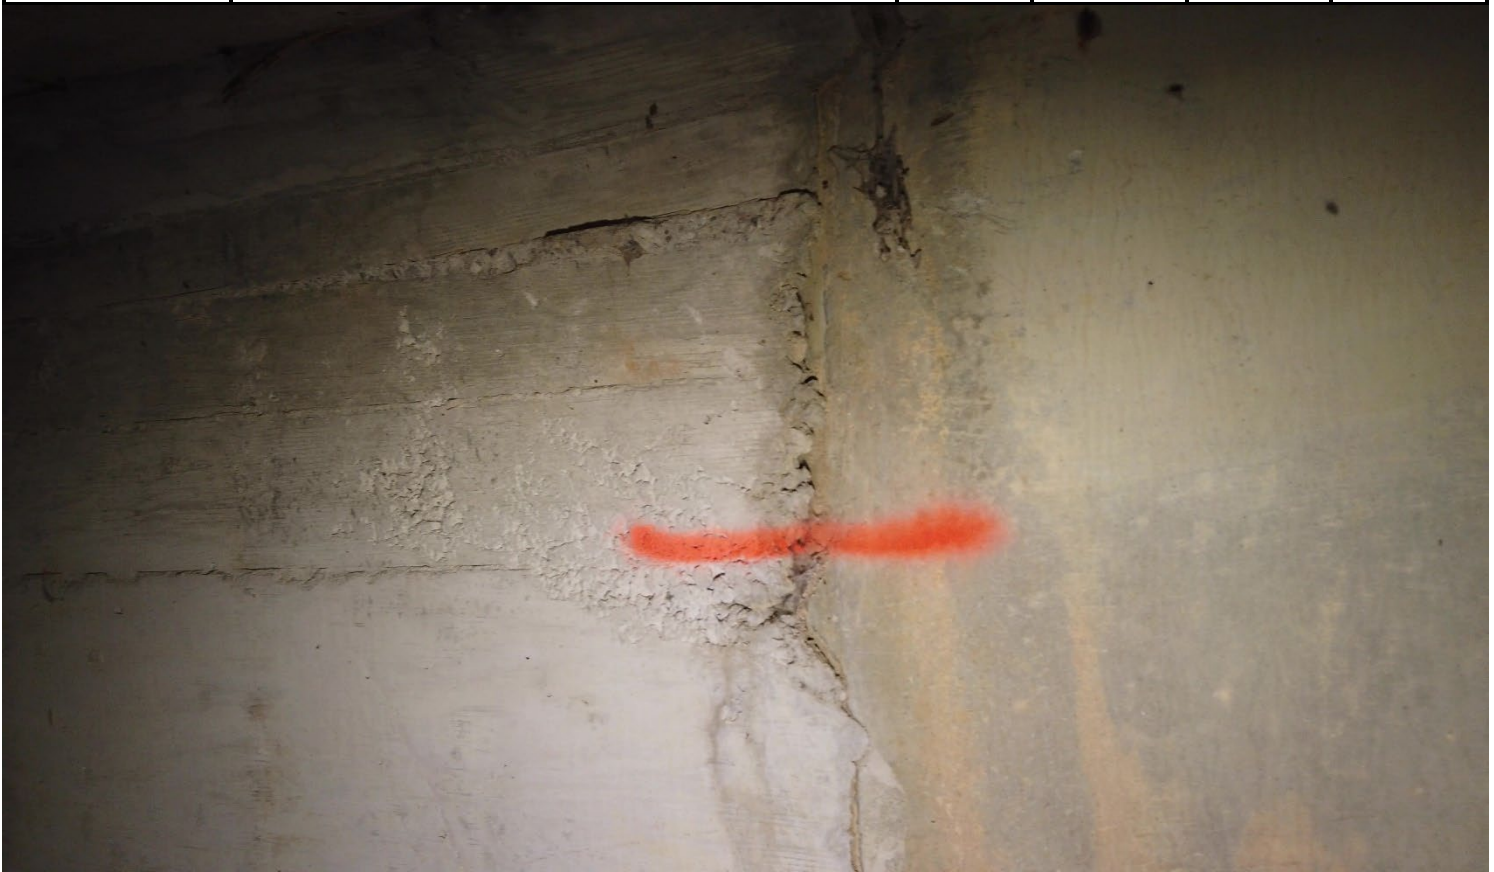
Footage	Defect Description	Top	Right	Left	Bottom
163 ft	Crack and Infiltration	Y

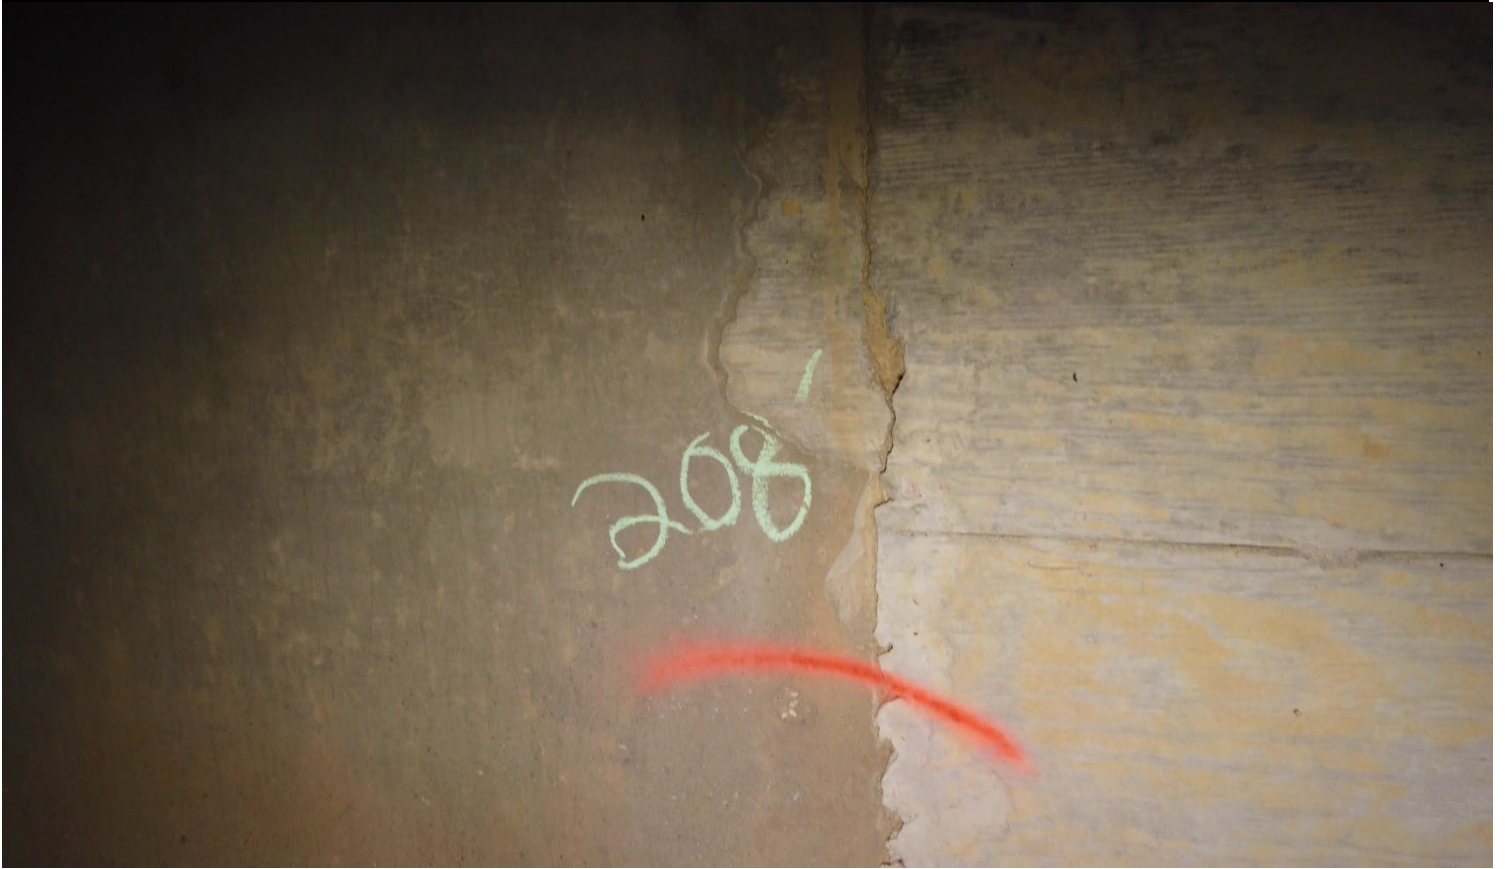
Footage	Defect Description	Top	Right	Left	Bottom
208 ft	Cracks	Y

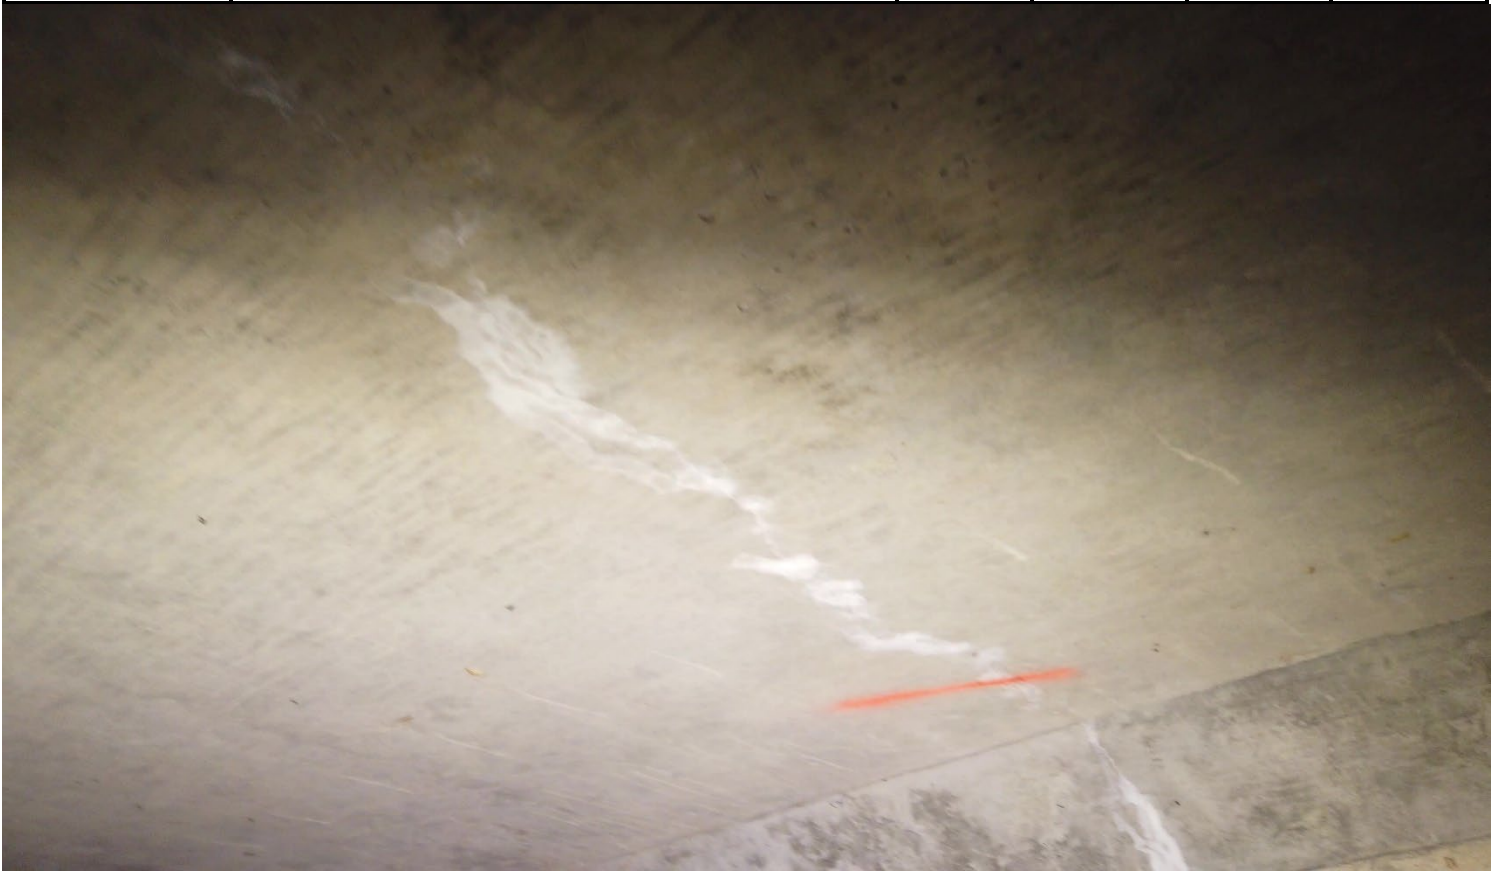
Footage	Defect Description	Top	Right	Left	Bottom
243 ft	Crack			Y

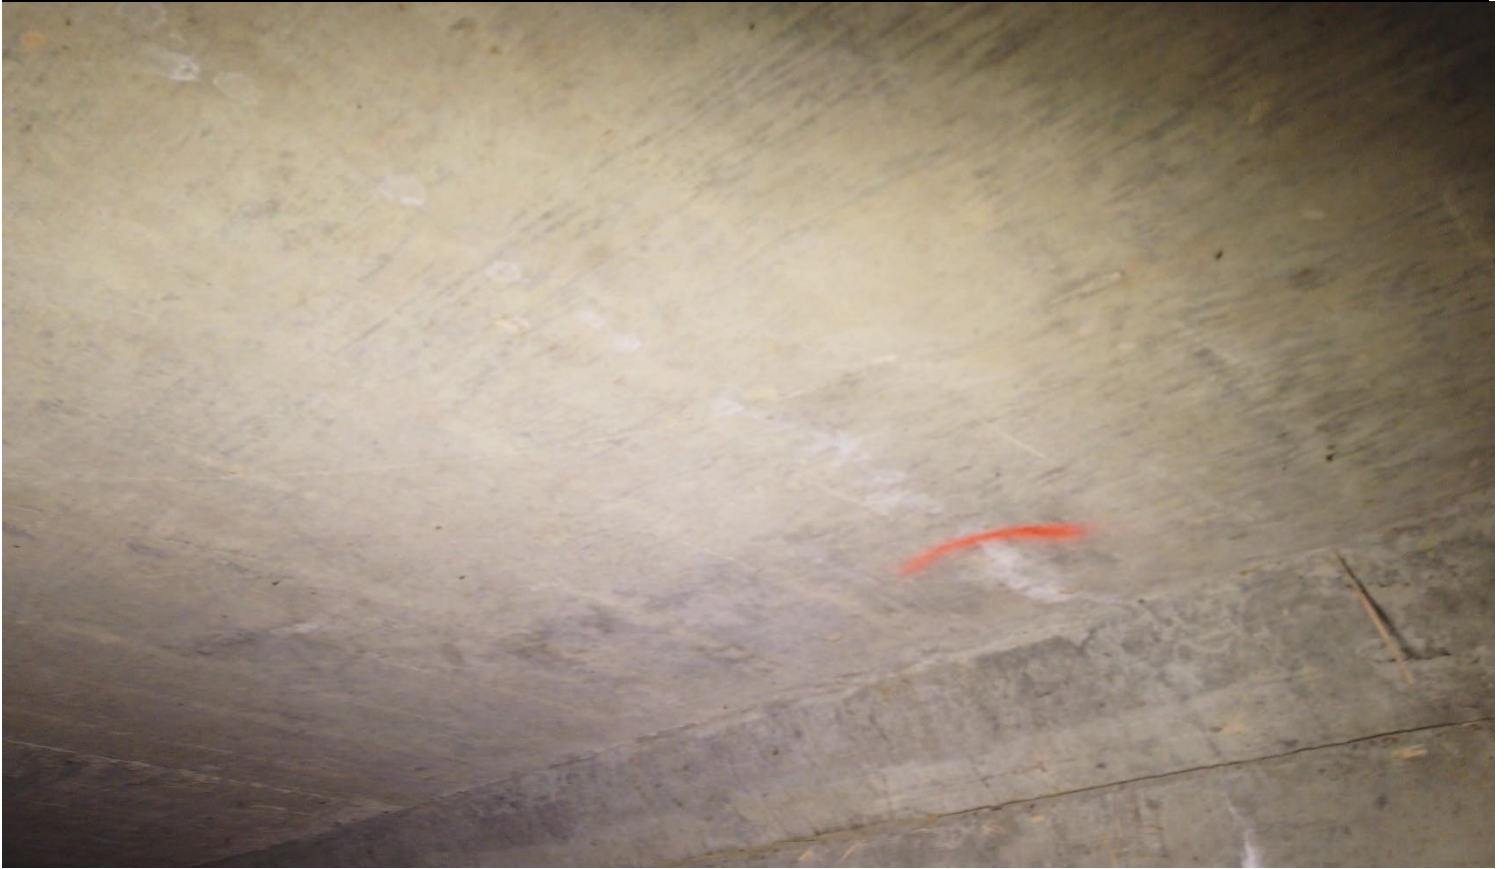
Footage	Defect Description	Top	Right	Left	Bottom
277 ft	Crack		Y	Y

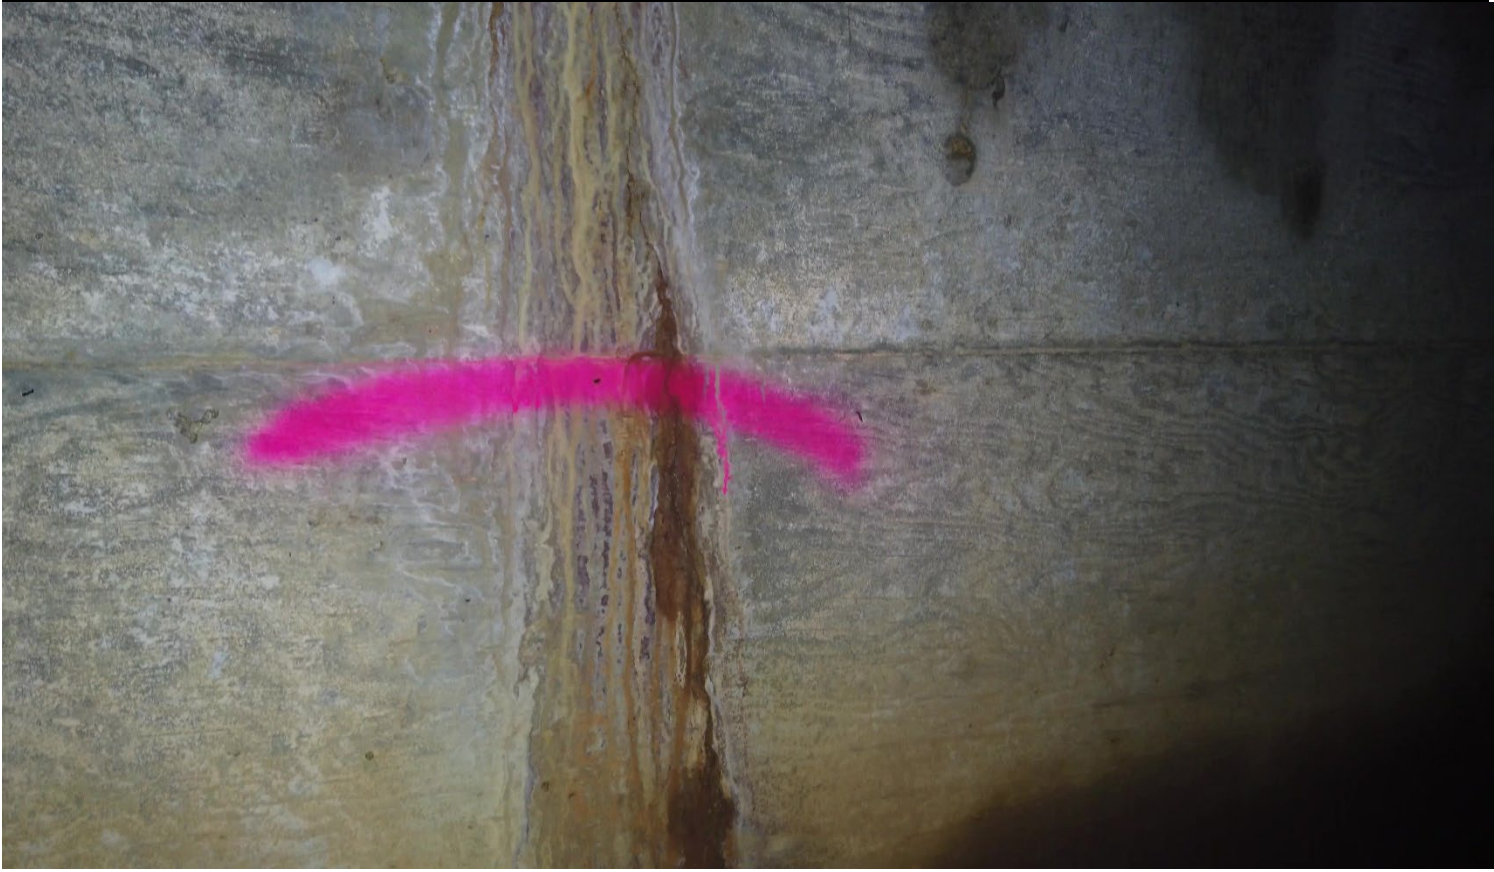
Footage	Defect Description	Top	Right	Left	Bottom
107 ft	Crack and Infiltration	Y	Y	Y

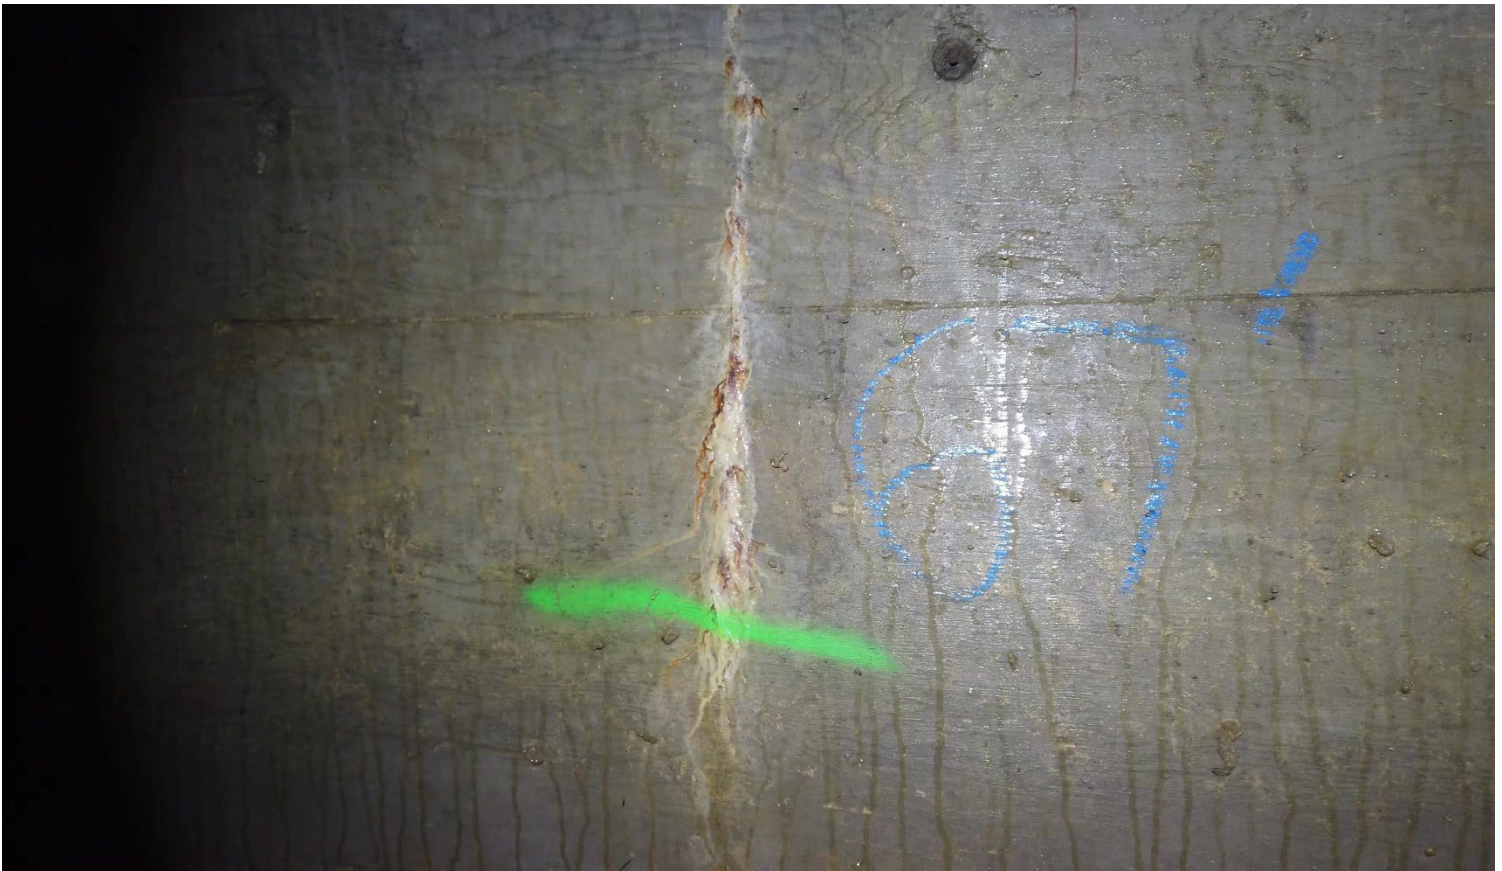
Footage	Defect Description	Top	Right	Left	Bottom
67 ft	Crack and Infiltration	Y

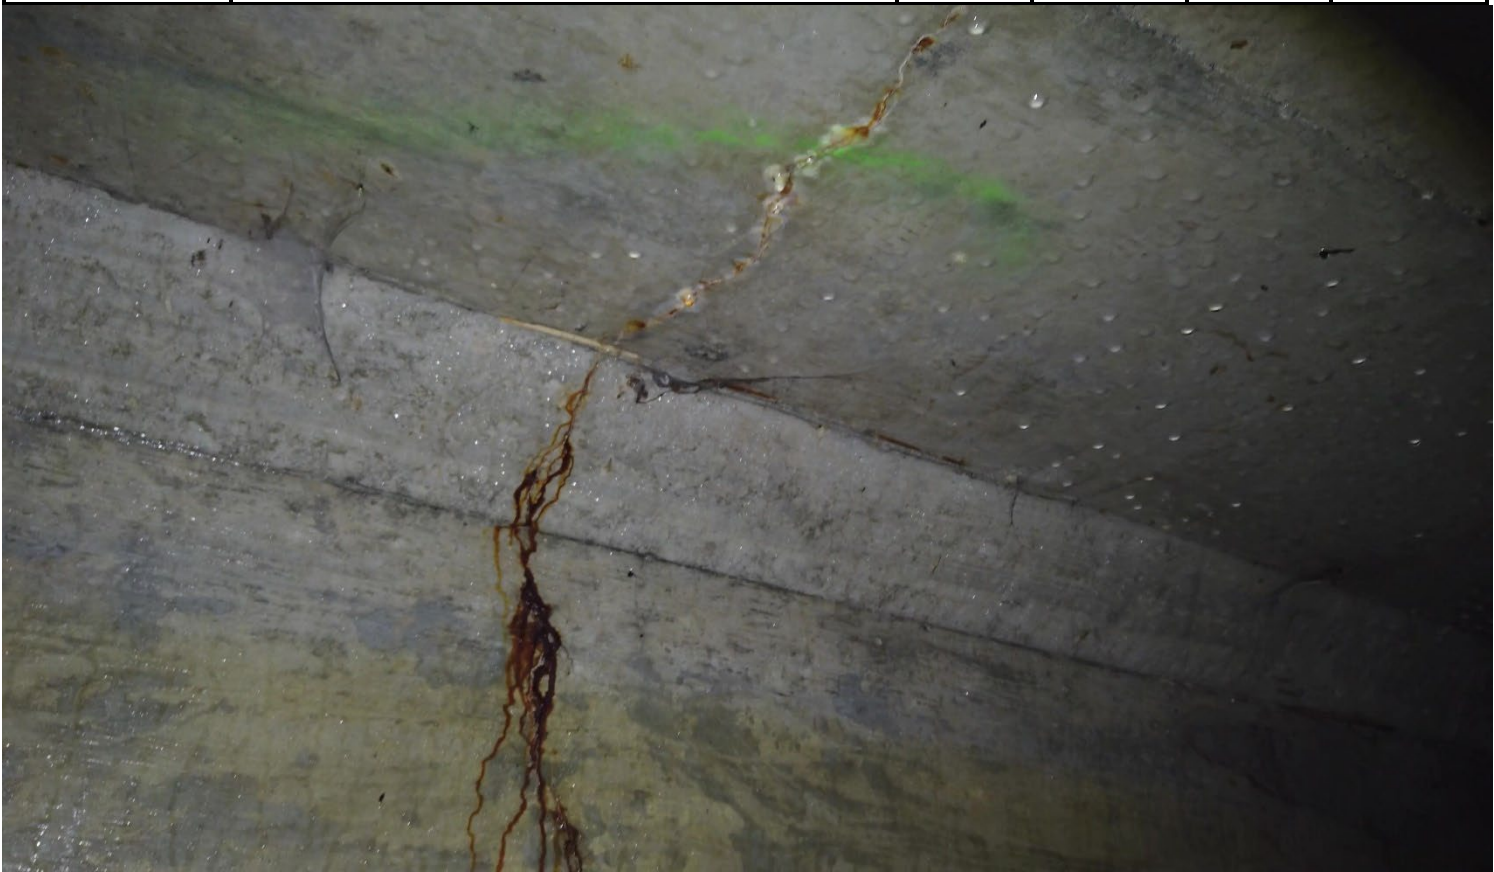
Footage	Defect Description	Top	Right	Left	Bottom
99 ft	Crack and Infiltration	Y		Y

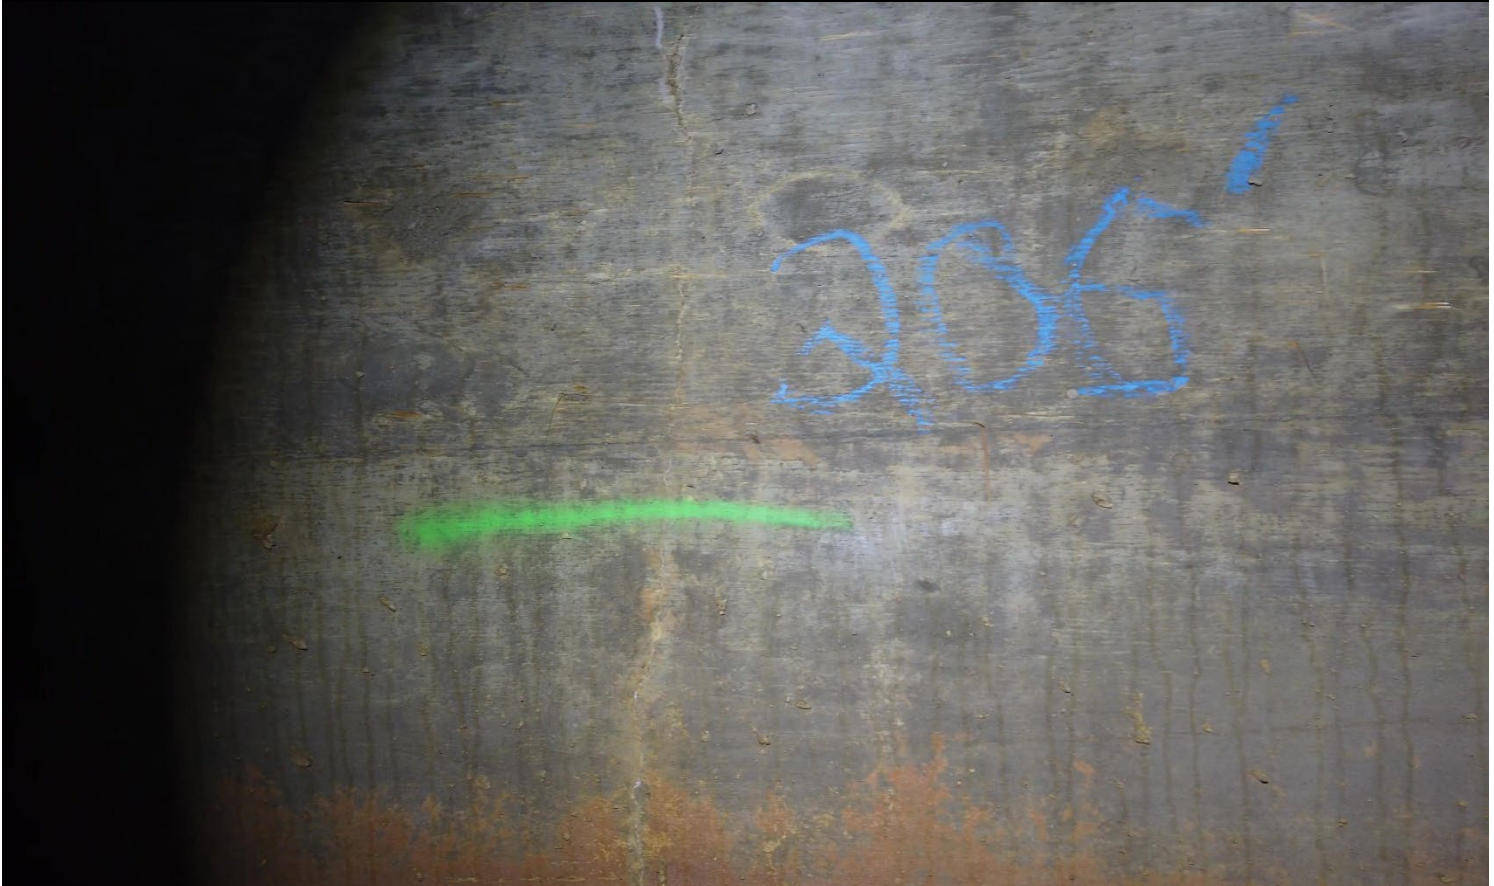
Footage	Defect Description	Top	Right	Left	Bottom
206 ft	Crack and Infiltration	Y

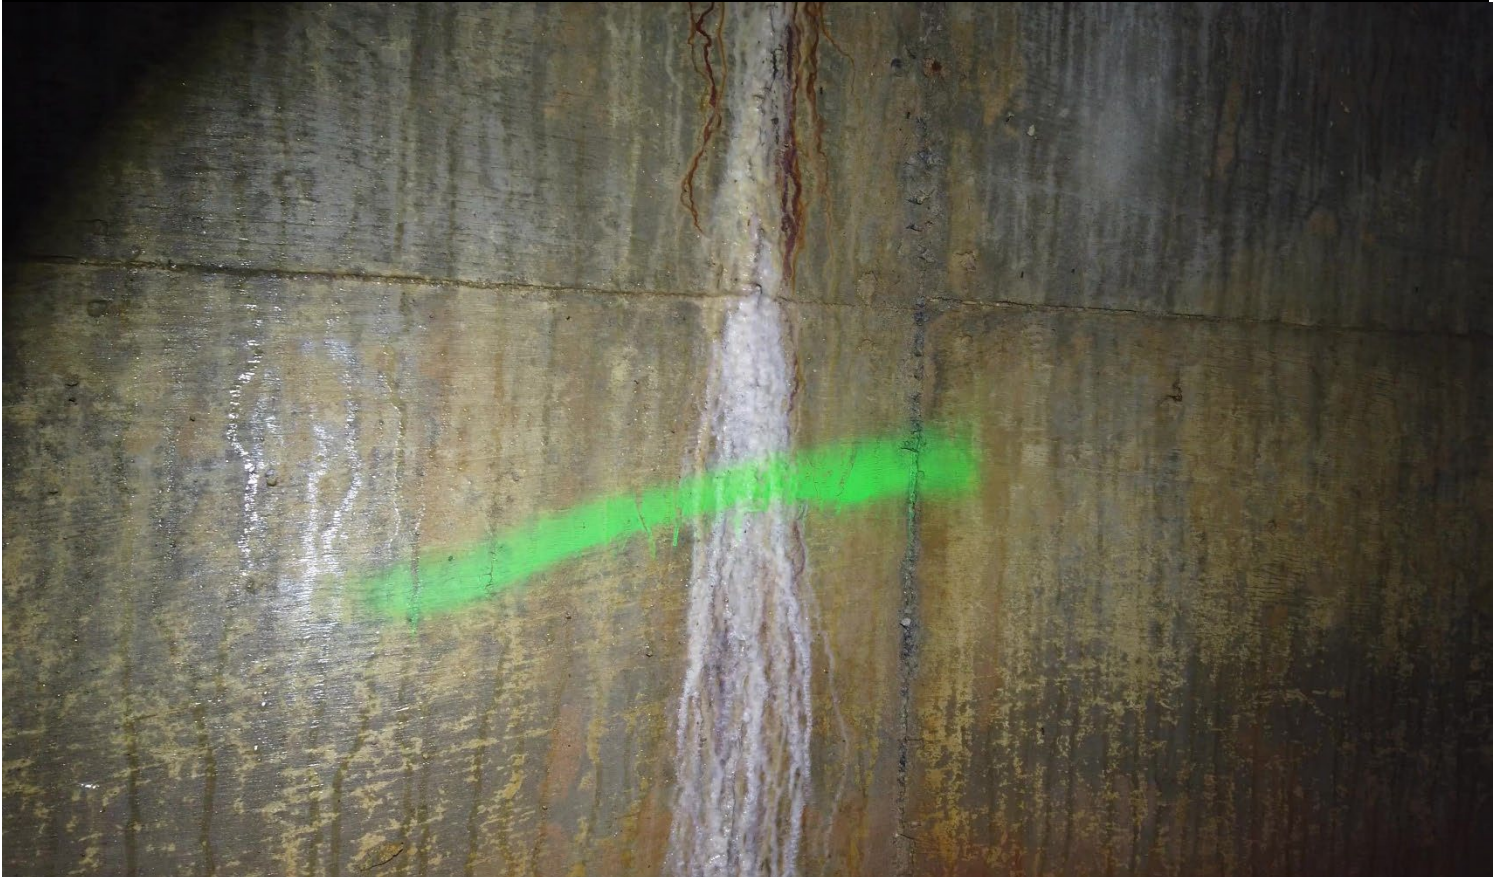
Footage	Defect Description	Top	Right	Left	Bottom
214 ft	Crack		Y

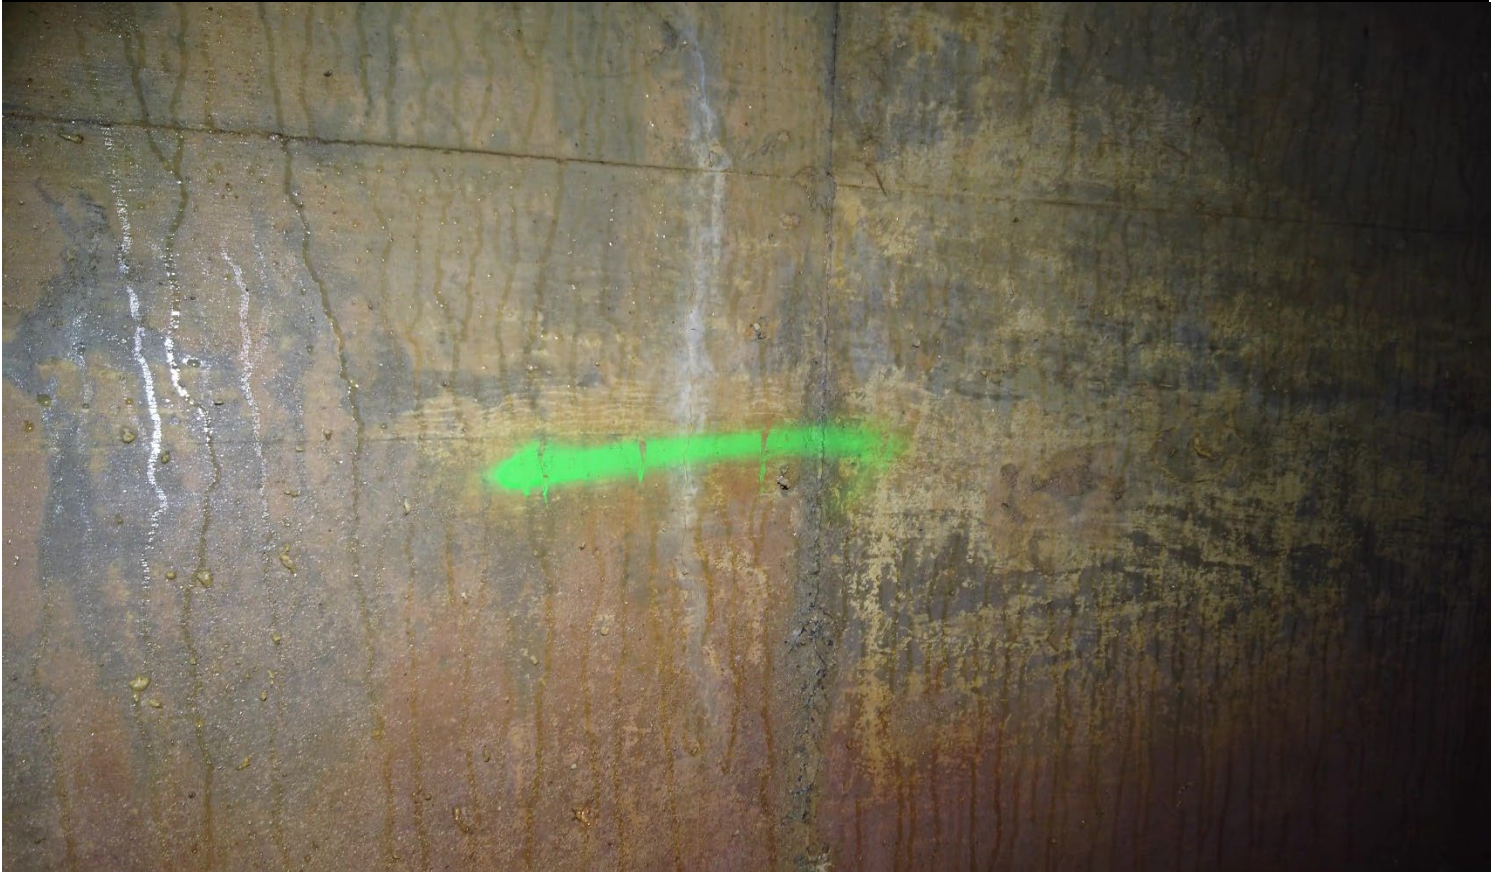
Footage	Defect Description	Top	Right	Left	Bottom
246 ft	Crack and Infiltration		Y

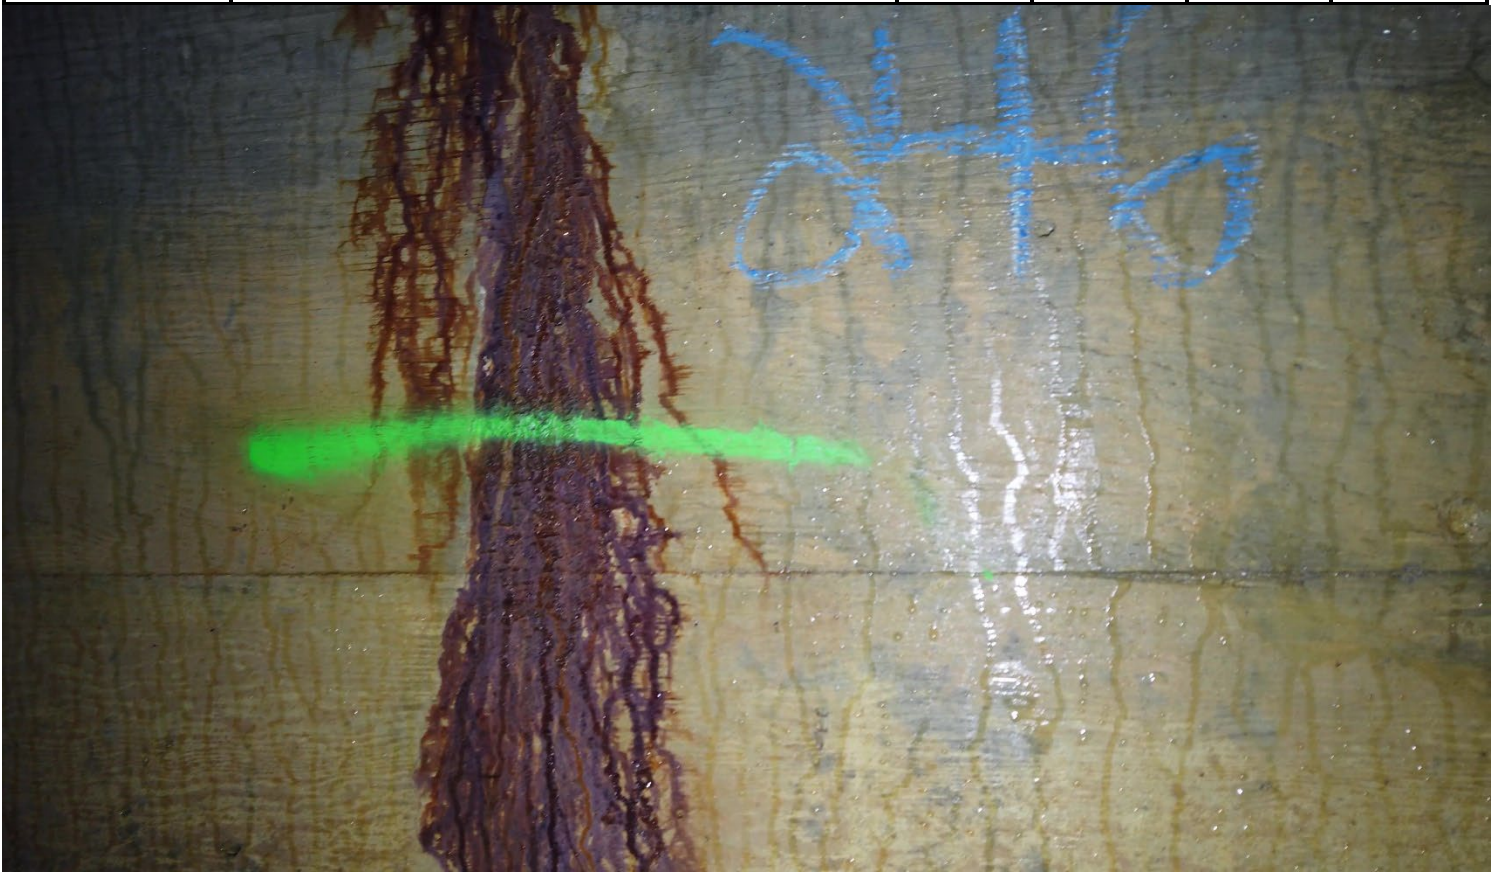
Footage	Defect Description	Top	Right	Left	Bottom
246 ft	Crack and Infiltration	Y

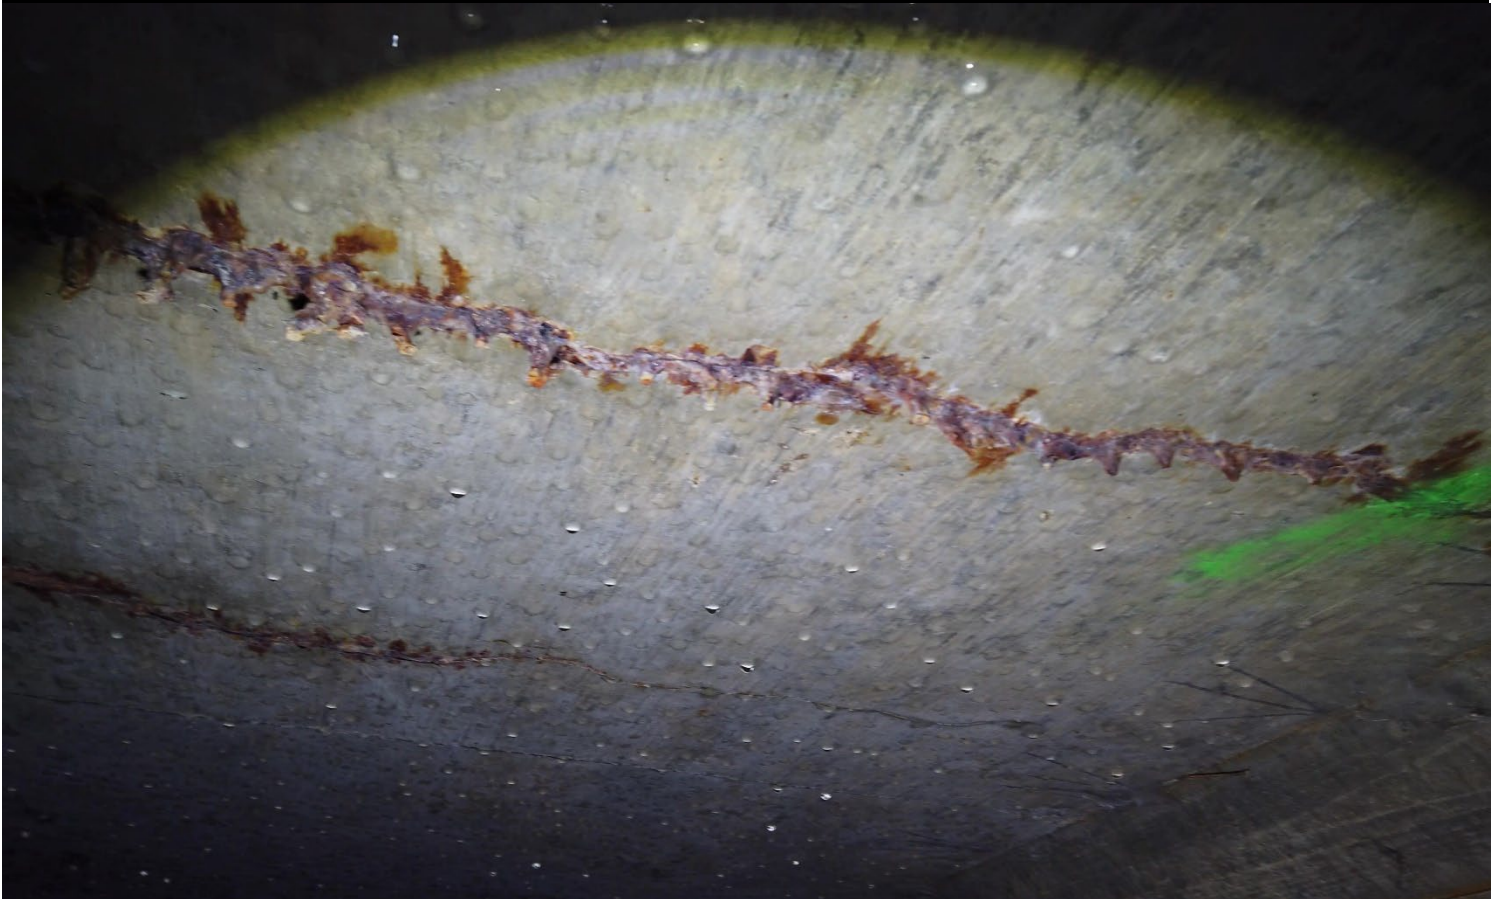
Footage	Defect Description	Top	Right	Left	Bottom
254 ft	Crack			Y

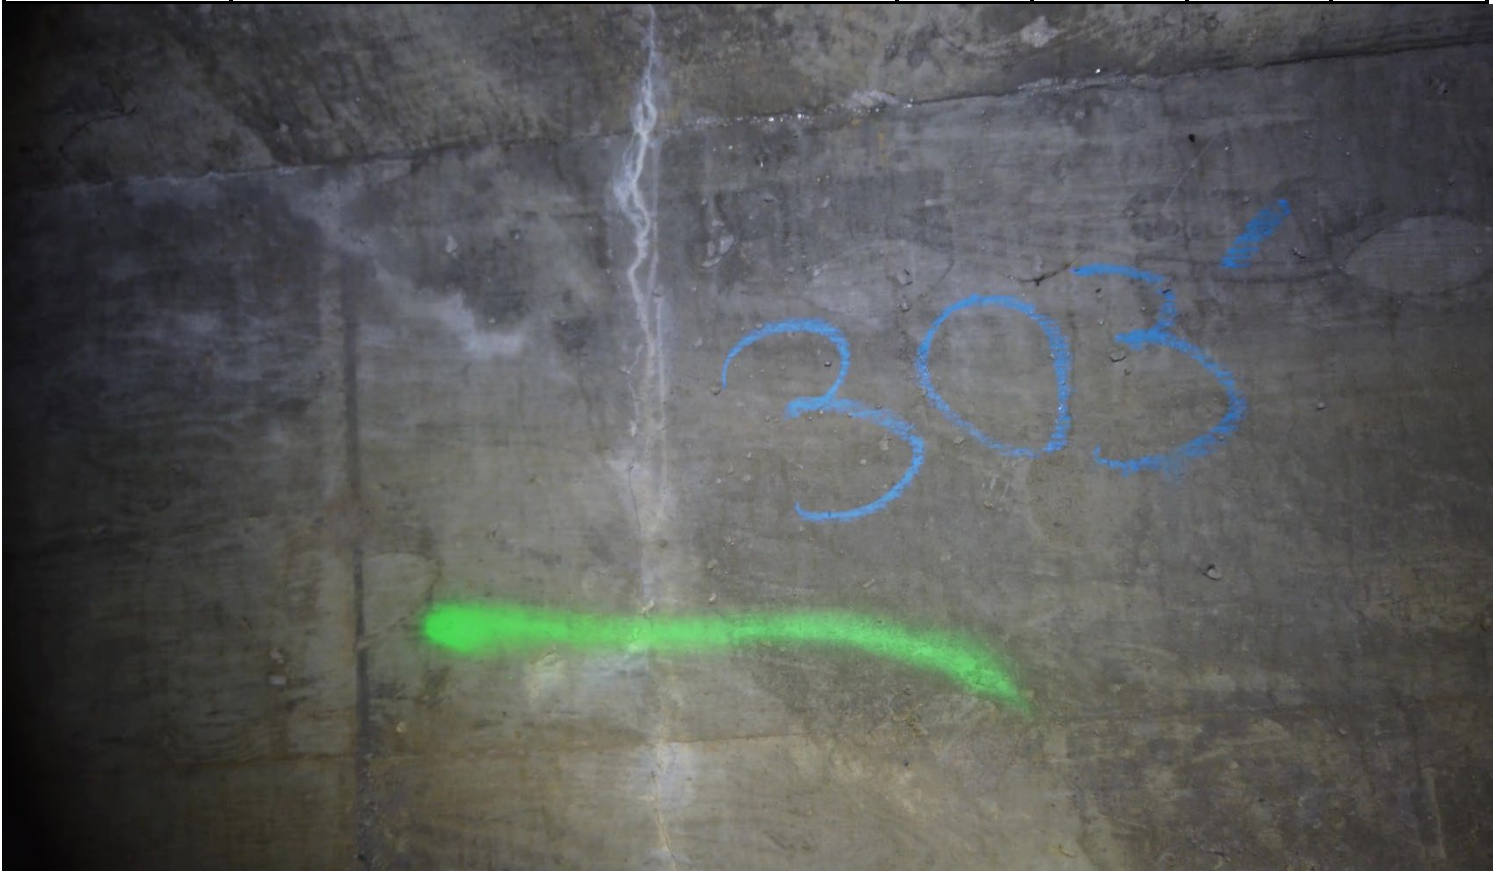
Footage	Defect Description	Top	Right	Left	Bottom
306 ft	Crack and Infiltration			Y

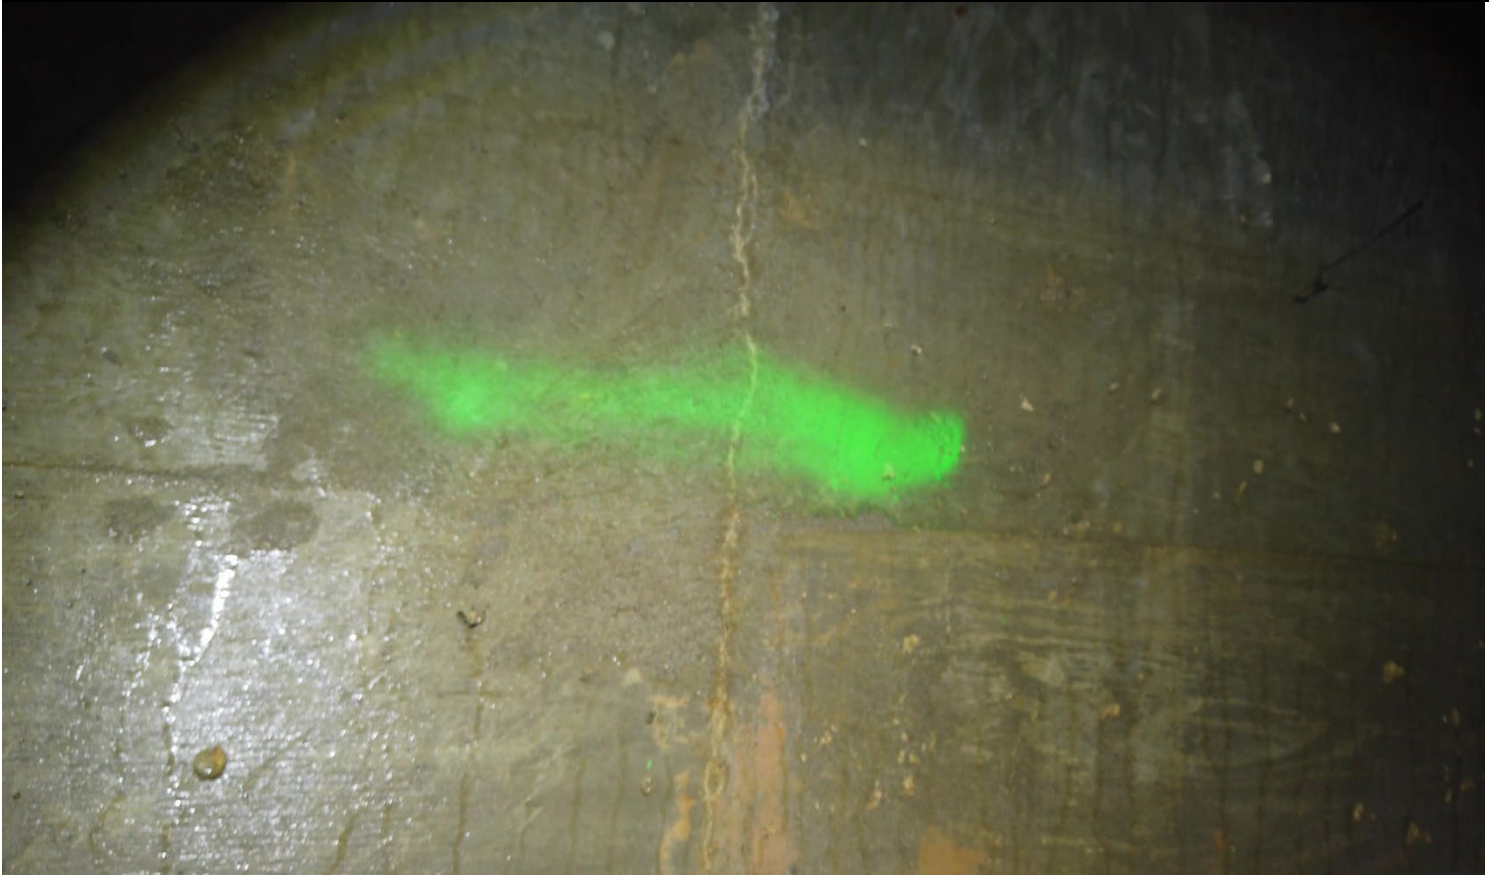
Footage	Defect Description	Top	Right	Left	Bottom
329 ft	Crack		Y
