I-26 & I-95 INTERCHANGE IMPROVEMENTS

June 29, 2023

PIPE INSPECTION REPORT

This report contains the results of the video pipe inspection and assessment of the existing storm water drainage pipes within the project area in Orangeburg and Dorchester Counties.

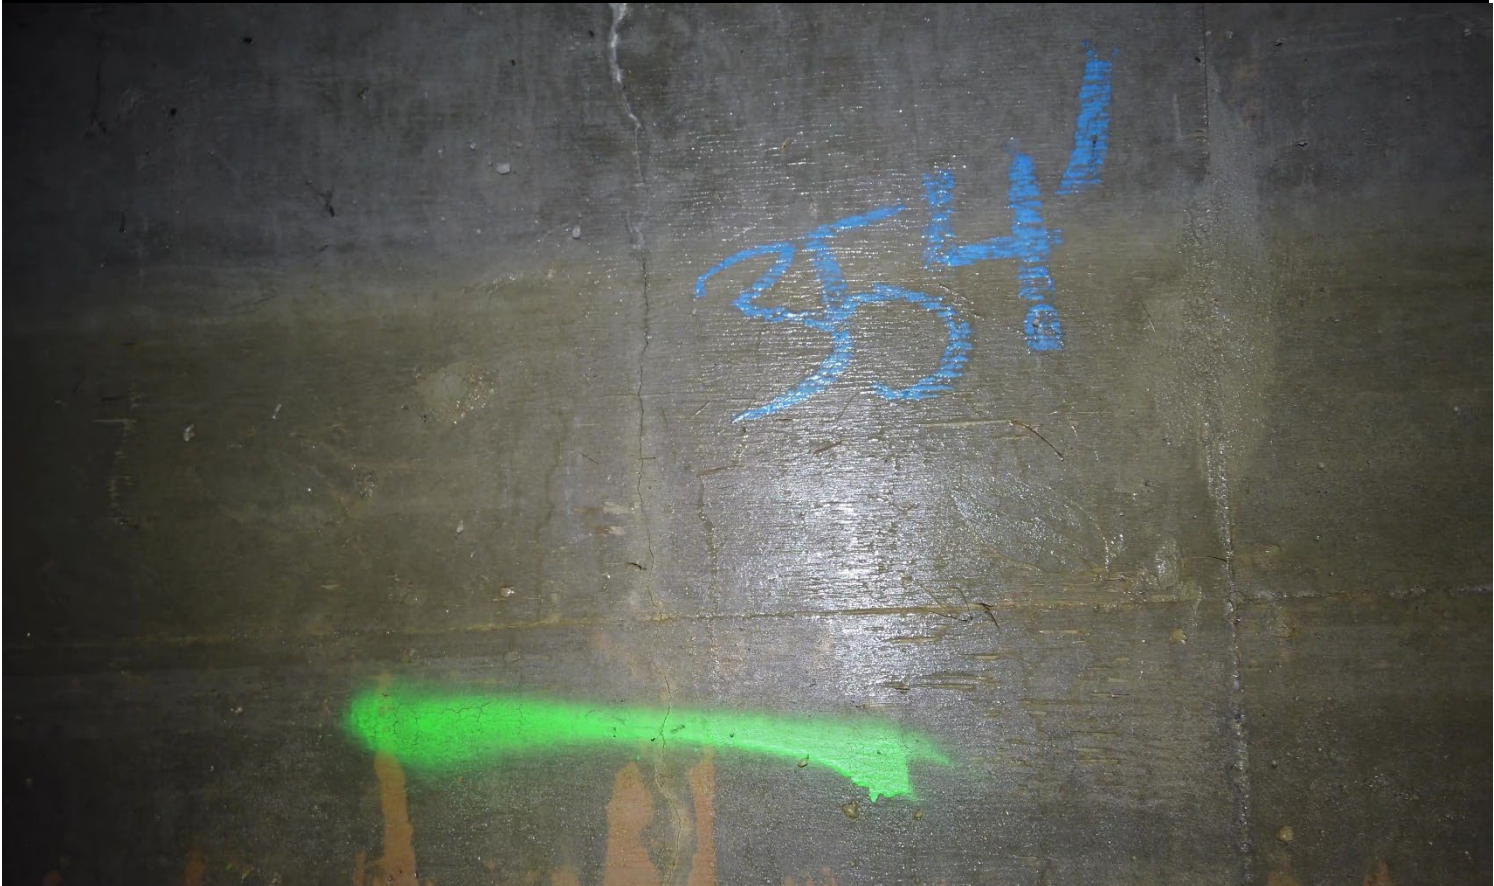
Footage	Defect Description	Top	Right	Left	Bottom
354 ft	Crack and Infiltration	Y
