**ASBESTOS & LEAD-BASED PAINT  
ASSESSMENT REPORT  
I-77 BRIDGES OVER I-77 RAMP  
STRUCTURE NOS. 4010007731500 AND 4010007711500  
COLUMBIA RICHLAND COUNTY, SOUTH CAROLINA  
S&ME Project No. 1461-14-046**

**Reference: Asbestos and Lead-Based Paint Assessment Report**  
I-77 Bridges Over I-77 Ramp  
Structure Nos. 4010007731500 and 4010007711500  
Columbia Richland County, South Carolina  
S&ME Project No. 1461-14-046

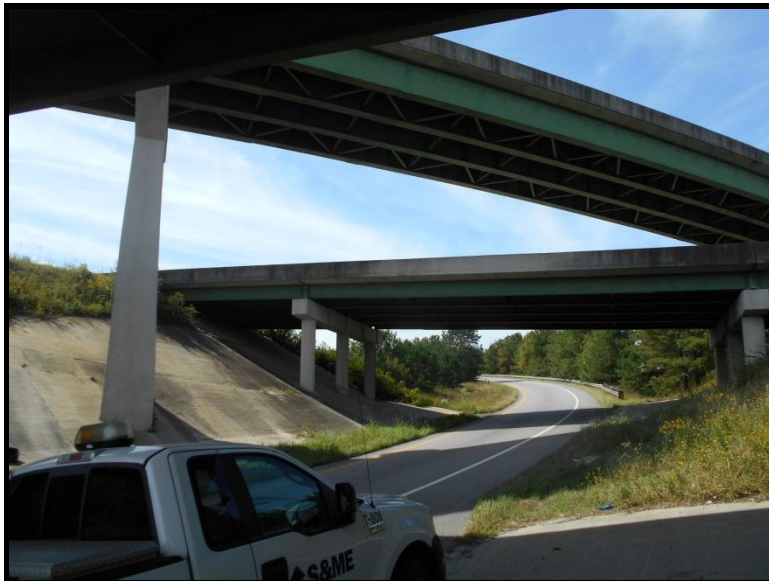
1 View of the southbound I-77 bridge over I-77 Ramp. No ACMs were identified.

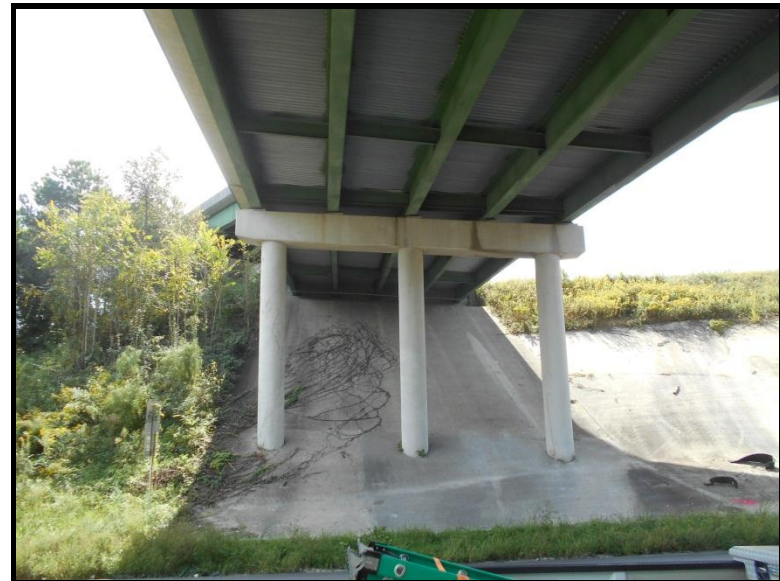
2 View of the northbound I-77 bridge over I-77 Ramp. No ACMs were identified.

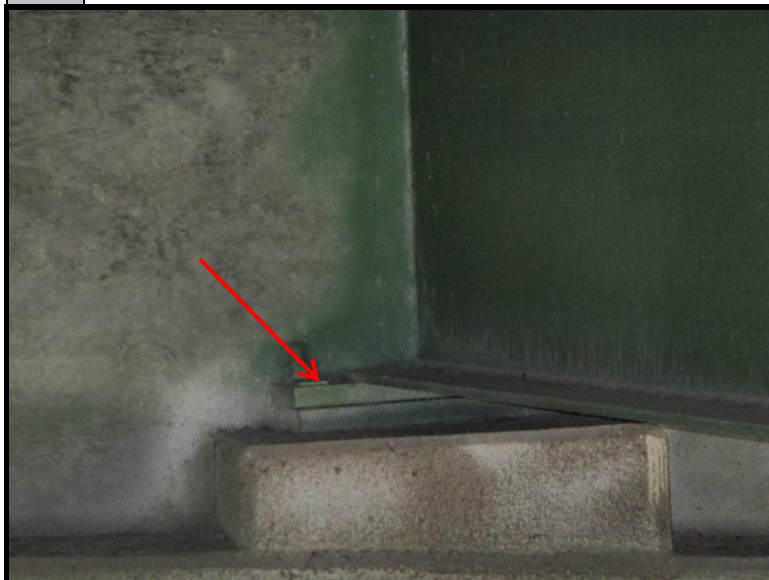
The **green painted I-beams and bolt plates** were identified as containing lead levels exceeding the SCDHEC disposal limit of  $0.7 \text{ mg/cm}^2$ . It is currently presumed the traffic striping on the I-77 roadway contains lead levels exceeding the SCDHEC disposal limit of  $0.7 \text{ mg/cm}^2$ . Additionally, painted components coated with lead containing paint applicable to OSHA regulation 29 CFR 1926.62 (Lead in Construction) was also detected. Destructive actions (sanding, burning, demolition, component removal, paint preparation) to the lead-containing paint surfaces will require the contractor to comply with the standards of SCDHEC and OSHA, including but not limited to proper disposal, initial exposure monitoring, the use of personal protective equipment, and medical surveillance. If additional painted components are discovered during renovation activities, the paint should be tested prior to any destructive actions (sanding, burning, demolition, component removal, paint preparation) or disposal.

3 The green paint on the bolt plate tested positive for lead-based paint (0.8-2.0 mg/cm<sup>2</sup>).

SCDHEC Regulation 61-107.19 permits demolition materials painted with lead-based paint ( $\geq 0.7 \text{ mg/cm}^2$ ) to be disposed in a permitted Class Two (C&D) or Class Three Subtitle D, Municipal Solid Waste (MSW) landfill. However, accumulations of paint waste (chips, dust, or flakes) from the identified areas of lead-based paint may be classified as hazardous waste, which requires disposal in a Subtitle C (hazardous waste) landfill. The hazardous waste regulations include Title 40 Code of Federal Regulations parts 260 through 272. A sample of accumulated paint waste should be collected for analysis via Toxicity Characteristic Leaching Procedure (TCLP) to determine the waste's lead content and hazardous waste characteristics.

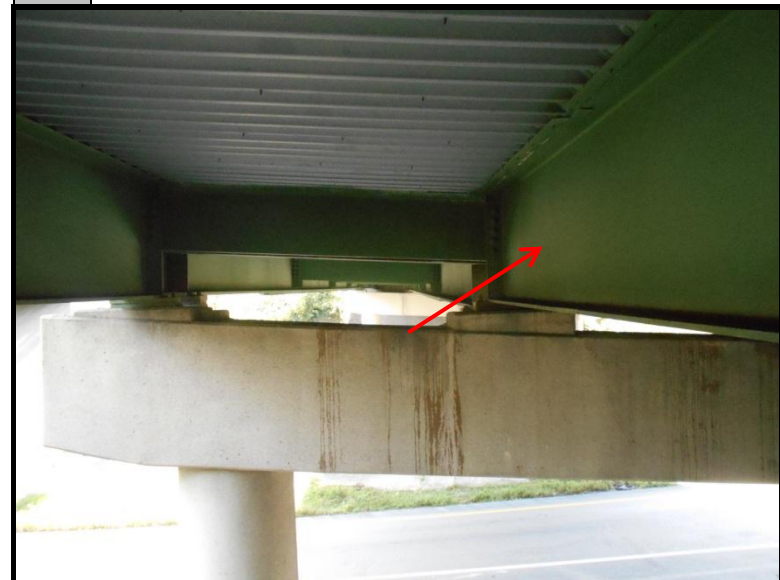
4 The green paint on I-beams tested positive for lead-based paint (0.8 mg/cm<sup>2</sup>).
