**ASBESTOS & LEAD-BASED PAINT
ASSESSMENT REPORT
I-77 BRIDGE OVER WINDSOR LAKE
STRUCTURE NOS. 4010007711700; 4010007731700
COLUMBIA, RICHLAND COUNTY, SOUTH CAROLINA
S&ME Project No. 1461-14-046**

Reference: Asbestos and Lead-Based Paint Assessment Report
I-77 Bridges Over Windsor Lake
Structure Nos. 4010007711700 and 4010007731700
Columbia, Richland County, South Carolina
S&ME Project No. 1461-14-046

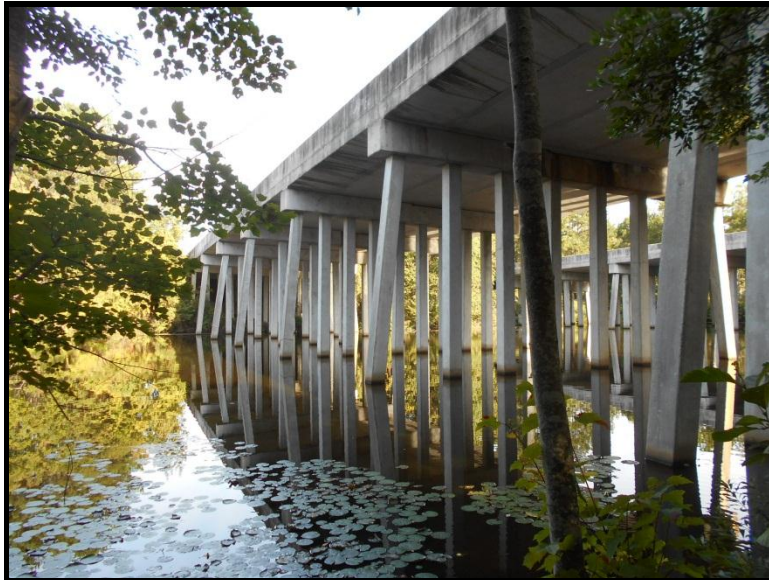
1 View of the I-77 bridge over Windsor Lake.

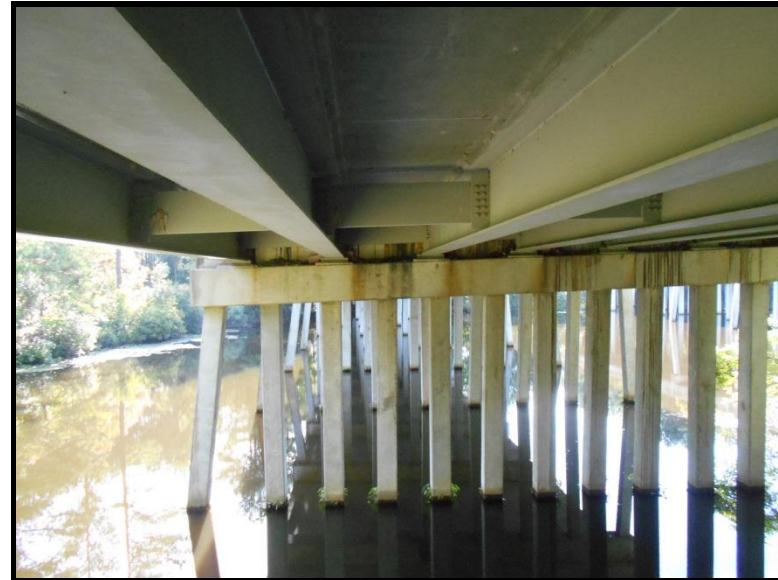
2 View of the north end of the north bound I-77 bridge over Windsor Lake.

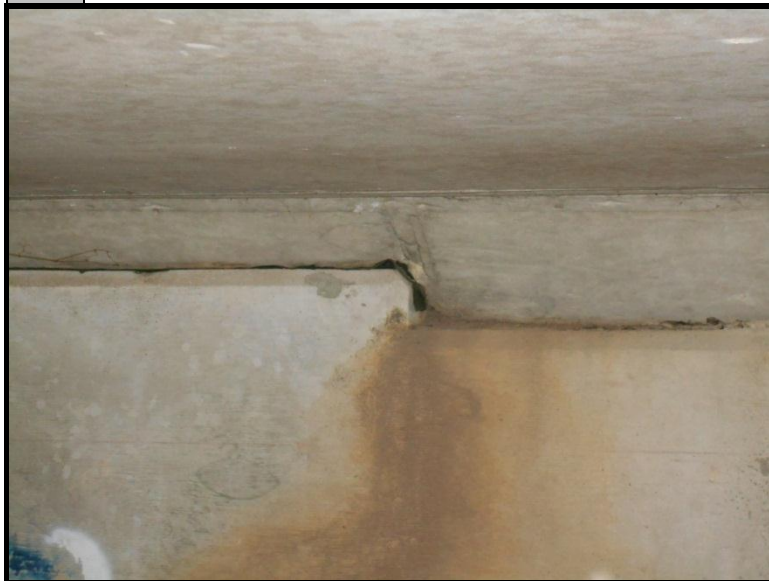
The TEM analyses confirmed that no asbestos is present in concentrations > 1% in the samples that were analyzed. No additional TEM analysis was warranted in this assessment.

3 View of the tar paper associated with the I-77 bridges over Windsor Lake. The tar paper tested negative for asbestos.

The asbestos and lead-based paint assessment conducted on the north and south bound I-77 Bridges over Windsor Lake in Columbia, Richland County, South Carolina, **did not** identify asbestos-containing materials. If additional suspect materials are discovered during the planned renovation activities, bulk samples must be collected and analyzed for asbestos content prior to continuation of work. A copy of this report should be provided to the contractor(s) to assist with compliance with applicable State and Federal regulations.
