Asbestos Inspection Report
I-20 Road Widening & Bridge Replacement Project
I-20 Bridges over Norfolk Southern Railroad
& Meat Plant Road
Lexington County, South Carolina

Prepared For:
ICA Engineering
Columbia, South Carolina

May 26, 2015

RE: Asbestos Inspection Report
I-20 EB over NSRR - Structure No. 3210002020300
I-20 WB over NSRR - Structure No. 3210002040300
Lexington County, South Carolina

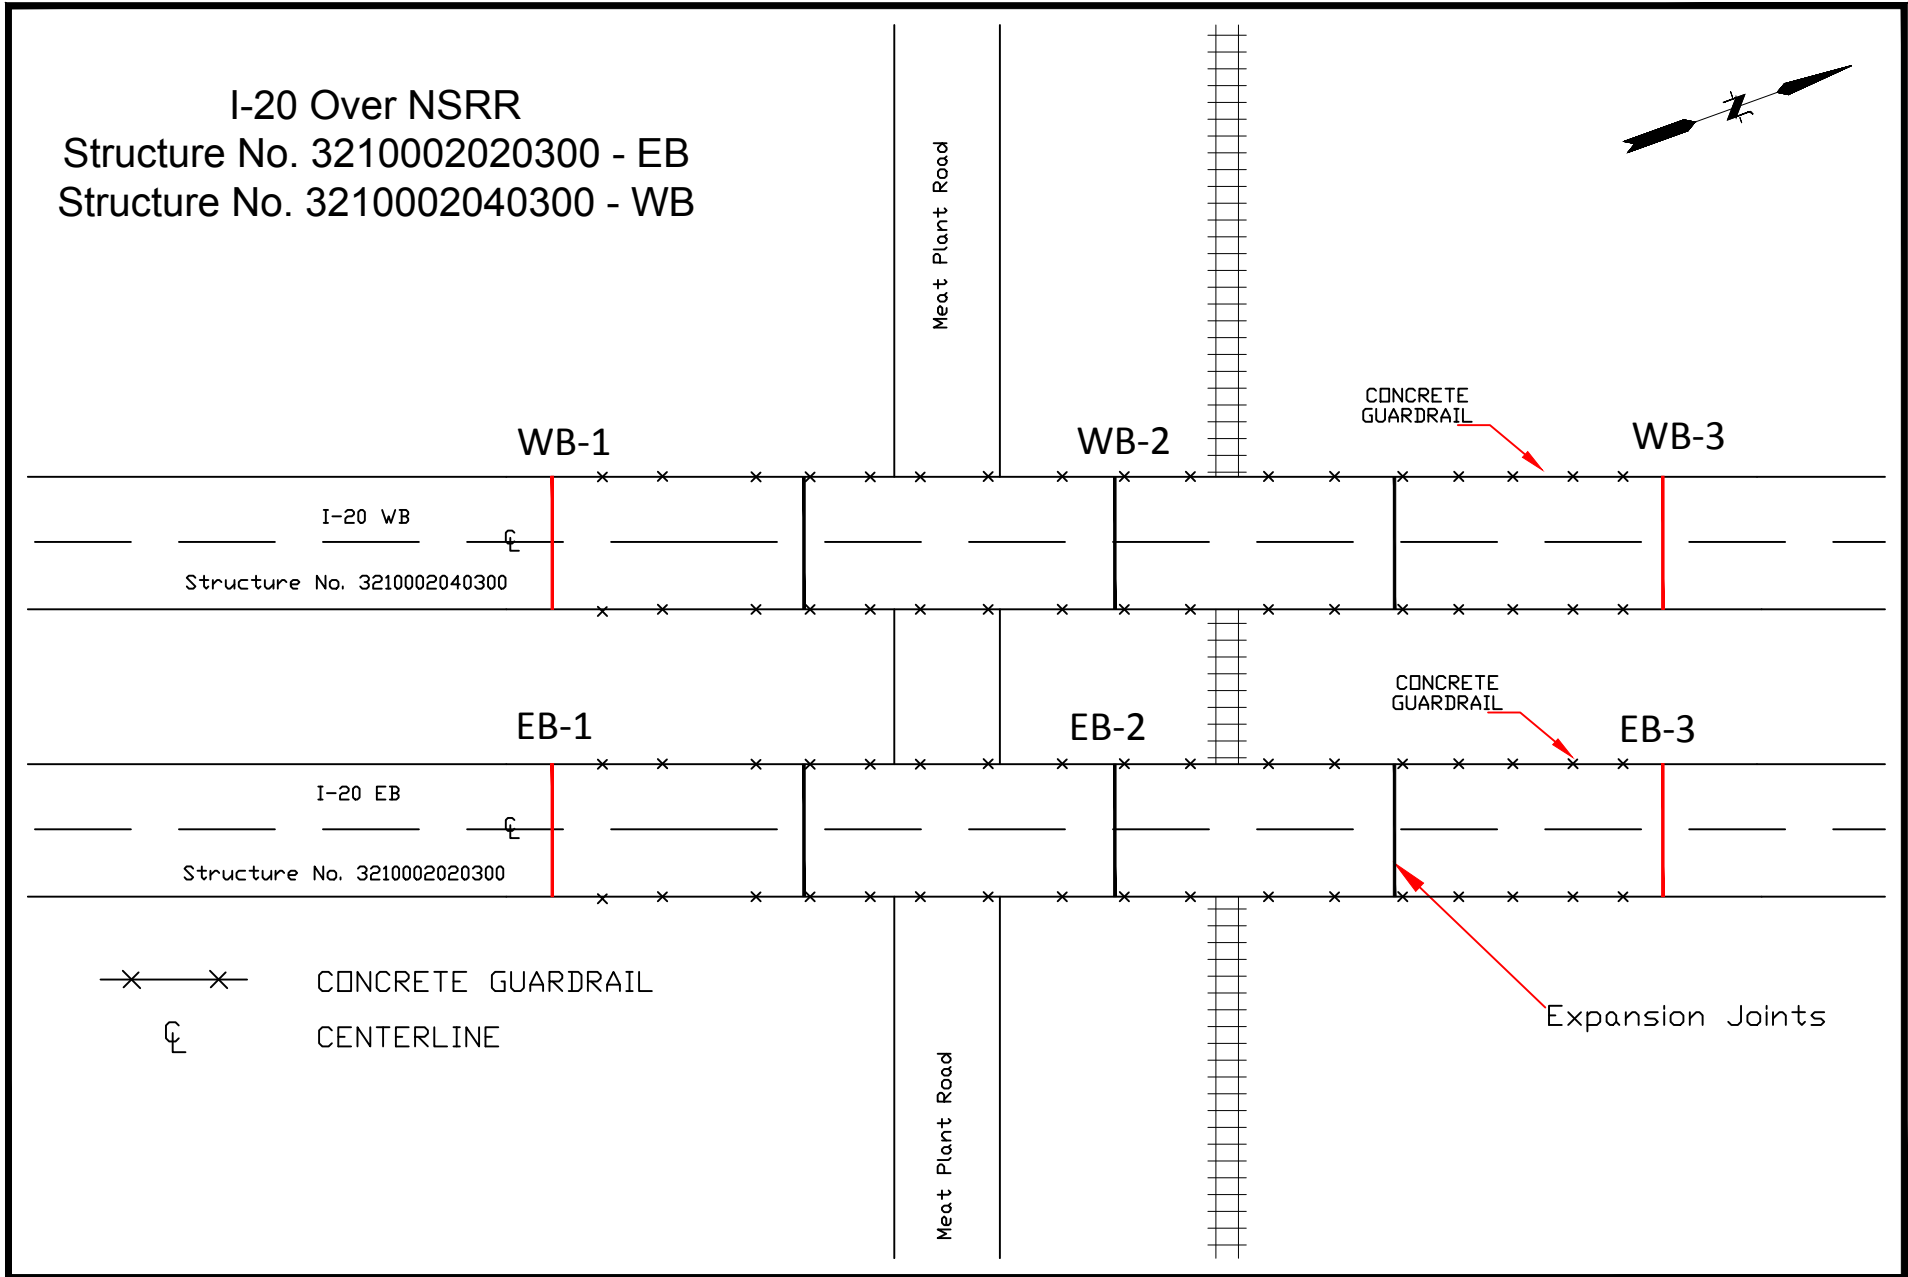
Figure 1

Note: See *Figure 1* for locations

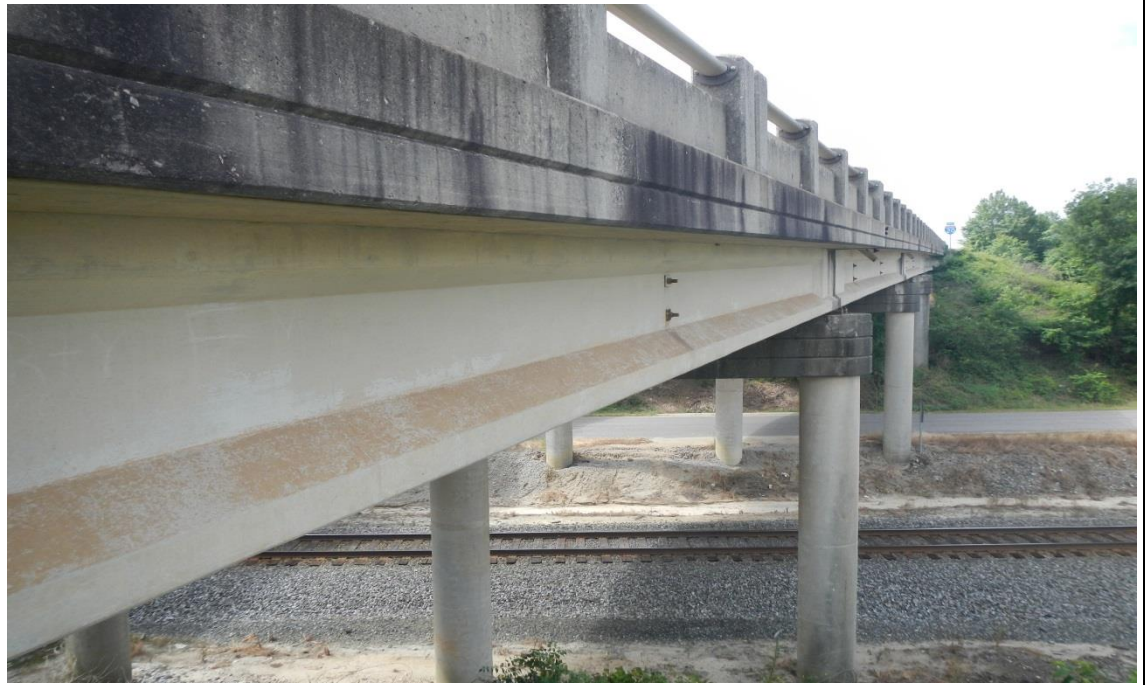
Photo No. 3

I-20 Bridges over NSRR

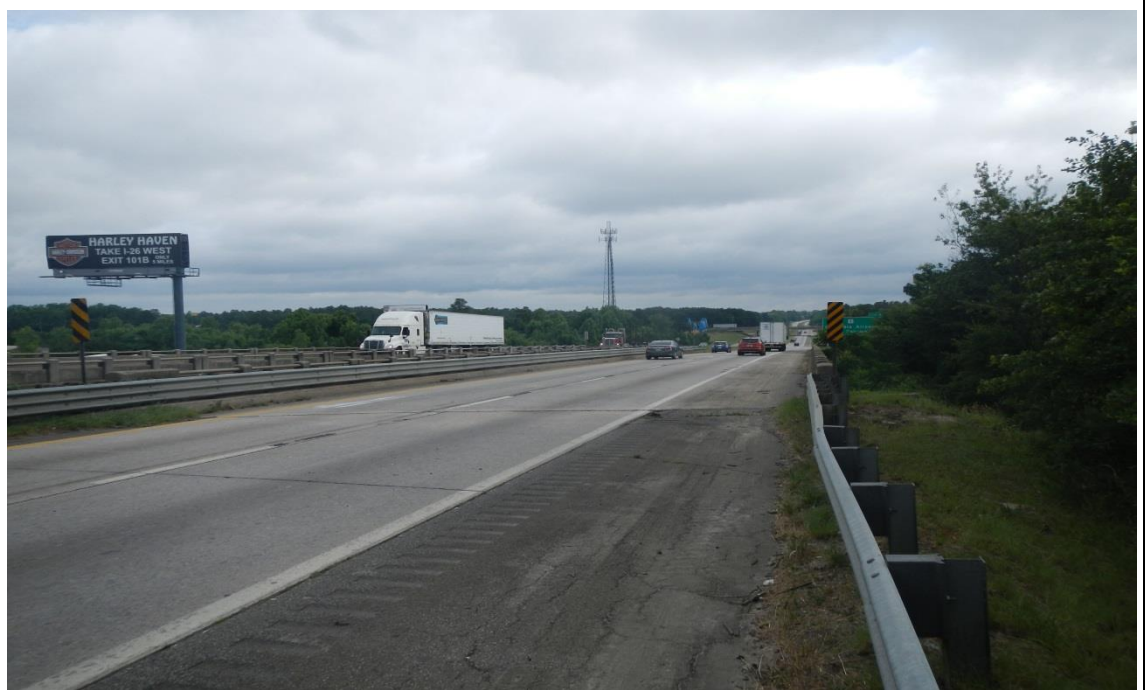
Photo No. 4

Bridge Deck
