**Asbestos & Lead-Based Paint  
Assessment  
Bear Creek Bridge  
Route S-11-119  
Structure No. 1170011900100  
Cherokee County, South Carolina  
S&ME Project No. 1361-20-048**

**Asbestos & Lead-Based Paint Assessment**

**Bear Creek Bridge**

S&ME Project No. 1361-20-048

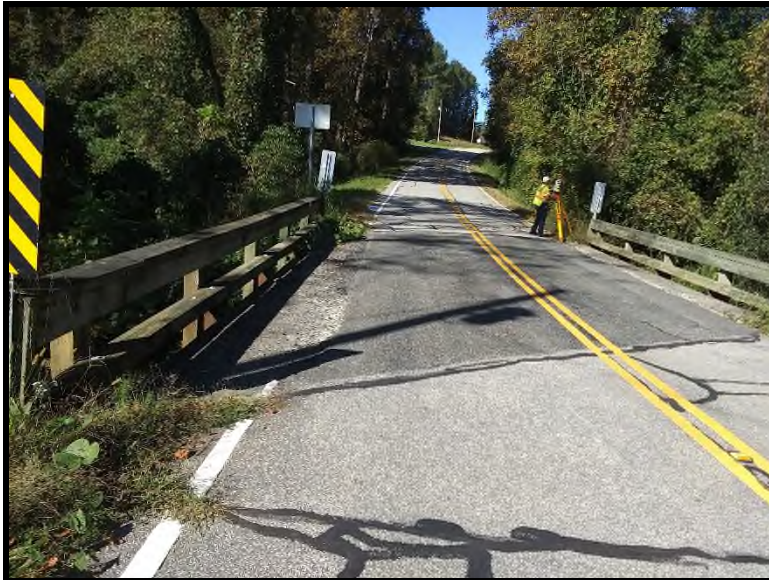
1 View of the subject bridge.

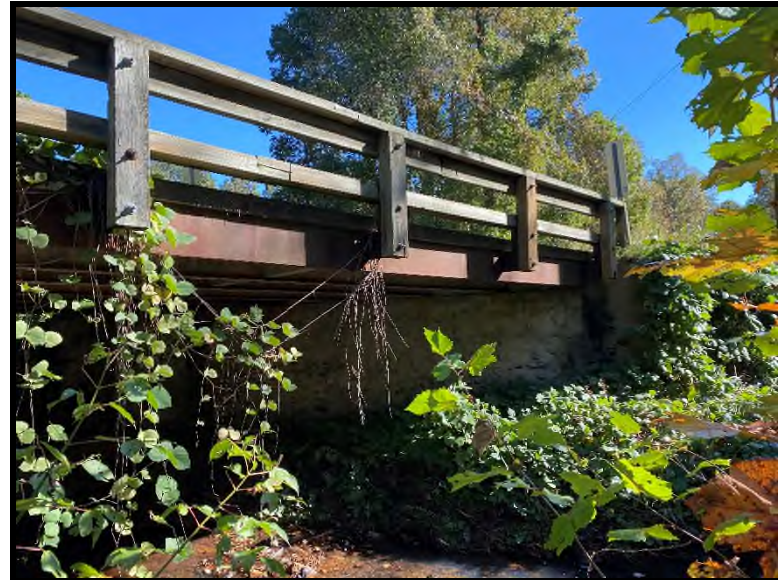
2 View of the subject bridge.

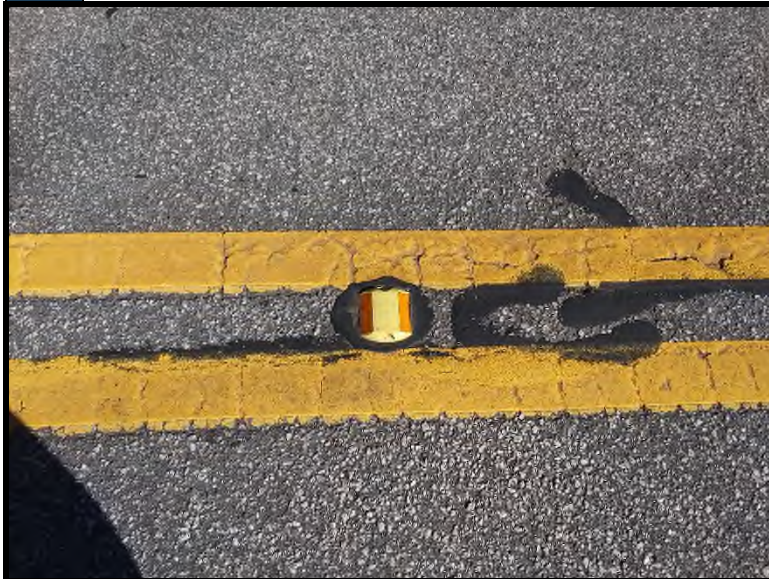
Of the representative materials sampled and analyzed during this assessment, asbestos in concentrations >1% was **not** identified.

3 Black mastic tested negative for asbestos.

No asbestos-containing materials were identified on the structure. If additional suspect ACMs not addressed in this report are discovered during destructive activities, bulk samples should be collected by a SCDHEC licensed inspector and analyzed for asbestos content prior to disturbance or disposal of the suspect materials. This report should also be provided to the contractor(s) to assist with compliance with applicable State and Federal regulations.

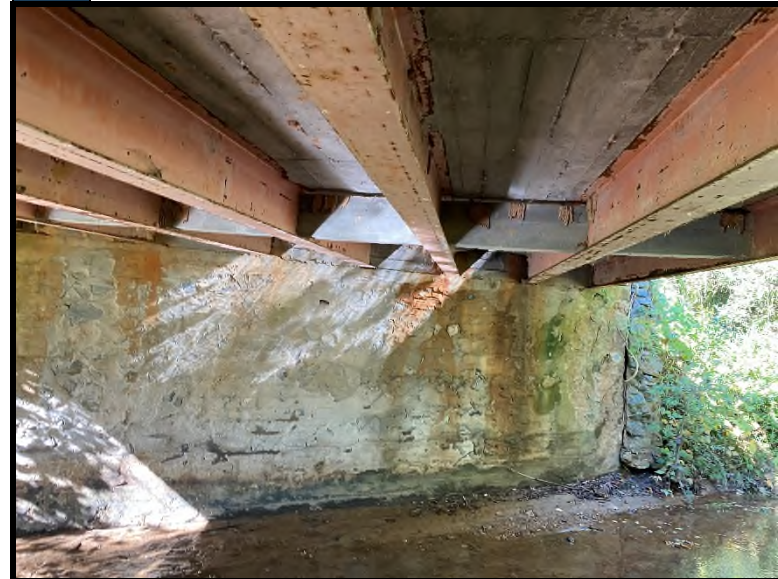
- Orange painted structural I-beams (7.3 – 10.1 mg/cm<sup>2</sup>).

4 Orange I-beams tested positive for lead-based paint (7.30-10.1 mg/cm<sup>2</sup>).

The client is advised that OSHA does not recognize a threshold level of lead for definition purposes, only the presence or absence of lead. Consequently, the OSHA regulations governing worker protection for lead-based paint may apply to work practices including the disturbance of paint systems with detectable levels of lead. Destructive actions (sanding, burning, demolition, component removal, paint preparation) to the lead-containing paint surfaces will require the contractor comply with the standards of OSHA, including but not limited to initial exposure monitoring, the use of personal protective equipment, and medical surveillance.

SCDHEC Regulation 61-107.19 permits demolition materials painted with lead-based paint ( $\geq 0.7$  mg/cm<sup>2</sup>) to be disposed in a permitted Class Two (C&D) or Class Three Subtitle D, Municipal Solid Waste (MSW) landfill.

Accumulations of paint waste (chips, dust, or flakes) must be tested by the Toxicity Characteristic Leaching Procedure (TCLP) to determine if the waste is classified as hazardous, which requires disposal in a Subtitle C (hazardous waste) landfill. Lead waste, at a minimum, must be disposed in a Class Two or Three landfill.
