**Asbestos & Lead-Based Paint  
Assessment  
Padgetts Creek Bridge  
Route S-44-87  
Structure No. 447008700100  
Union County, South Carolina  
S&ME Project No. 1361-20-048**

**Travis Knight & Bobby McAllister  
SCDHEC Lic. BI-00885 & BI-01429  
Inspection Dates: October 14, 2020**

**December 16, 2020**

Reference: **Asbestos & Lead-Based Paint Assessment**  
**Padgett's Creek Bridge**  
Route S-44-87  
Structure No. 4470008700100  
Union County, South Carolina  
S&ME Project No. 1361-20-048

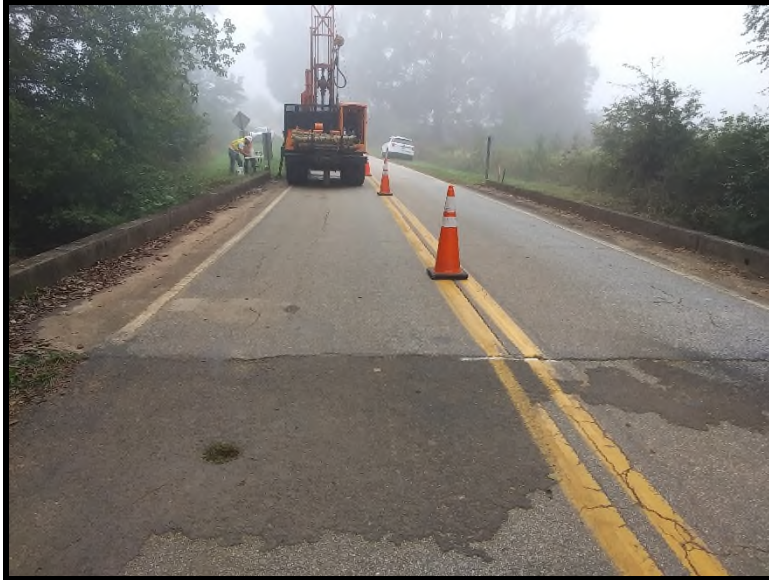
**1** View of the subject bridge.

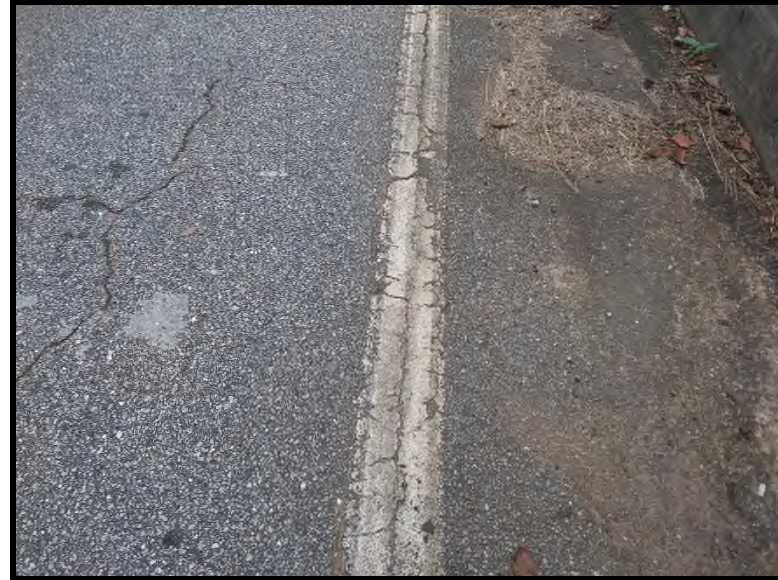
**2** White stripes tested negative for lead-based paint.

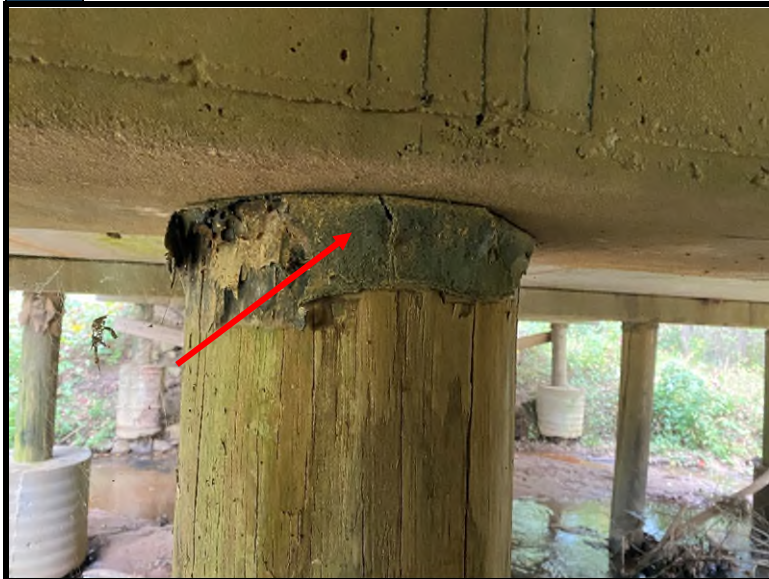
**3** Felt paper tested negative for asbestos.

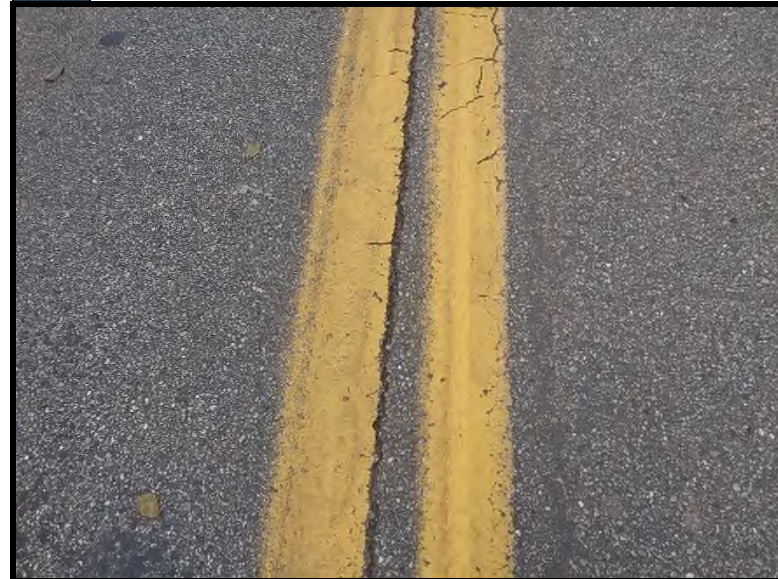
**4** Yellow stripes tested negative for lead-based paint.
