COMPREHENSIVE ASBESTOSLEAD-BASED PAINT SURVEY

Cross Island Parkway Toll Plaza/Tunnel
4 Marshland Drive
Hilton Head, SC 29926

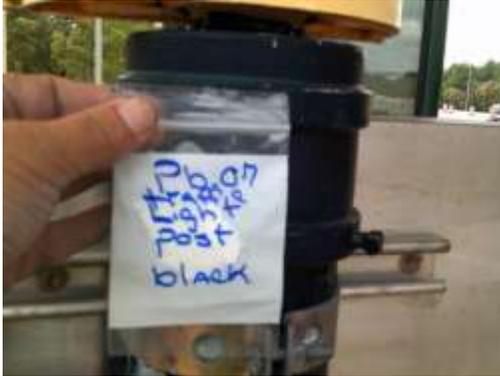
Pb-07
TRAFFIC LIGHT POST (BLACK)

Lead-based paint was not identified by XRF readings. Paint chip analysis on the black stop light posts meet the OSHA definition of lead-based paint. Destructive actions to lead-based, painted finishes that may create a lead exposure hazard (sanding, torching, blasting, etc.) require compliance with OSHA, including proper training and exposure monitoring.

Destructive actions to lead-based paint finishes that may create a lead exposure hazard (sanding, manual demolition, torch cutting, blasting, etc.) require compliance with OSHA, including proper training, exposure monitoring and proper disposal. OSHA considers all lead containing paints applicable to enforcement, and would require training, engineering controls, and administrative controls in accordance with 29 CFR 1926.62. In the event building components that tested positive for lead are disturbed during renovations, then contractors and workers should be informed as to the presence of LBP. Air monitoring for airborne lead concentrations is recommended during any lead abatement activities.
