**ASBESTOS CONTAINING
MATERIALS INVESTIGATION
REPORT**

**US-21 (SEA ISLAND PARKWAY)
BRIDGE OVER HARBOR RIVER
BEAUFORT COUNTY, SC
SCDOT BRIDGE #072002100200
SCDOT PROJECT # P026862**

F&ME Consultants
3112 Devine Street
Columbia, South Carolina 29205
(803) 254-4540

February 10, 2017

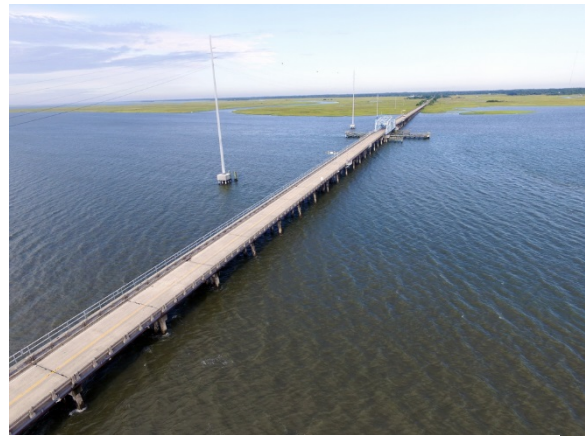
Photo 1 – US Highway 21 over the Harbor River.

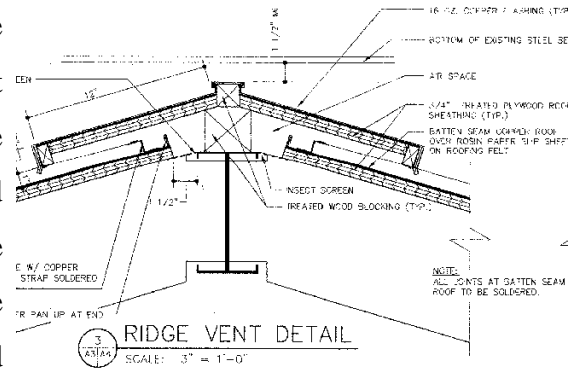
- HA-1 – Roofing Felt/Vapor Barrier (~1,000 SF)

Review of the original construction drawings for the control house dated February 1997 showed that a felt vapor barrier was utilized behind the siding on the exterior metal walls, on top of the concrete slab and under the existing copper roofing system of the control house. Due to the damage that would be necessary to access this material it has been assumed positive for asbestos content. Also, due to the inaccessibility the condition of the material is unknown. This material is to be removed, handled and disposed of as ACM by a licensed abatement contractor during the demolition of the existing bridge structure.

Photo 2 – Roofing Felt/Vapor Barrier noted on original construction drawings for control house.

It is our understanding that the subject structure is to be demolished in anticipation of constructing a new bridge. All accessible suspect materials have been sampled and analyzed by an accredited laboratory and found to contain no asbestos containing materials (ACM). However, two (2) materials were identified that were assumed positive for asbestos content and will need to be address during the demolition operations. Contractor should plan on hiring a licensed abatement contractor to remove and handle these materials as asbestos containing materials.

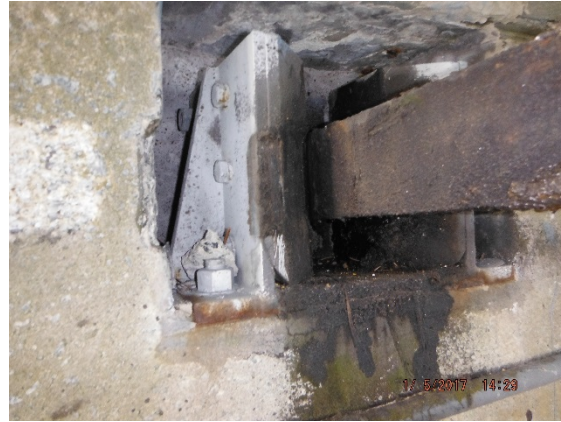
- HA-2 – Swing Bridge Brake Pads (~ 4 SF)

In addition, the underside of the existing swing bridge was reviewed during the investigation. The locking mechanism that locks the bridge in place when the bridge is open to road traffic was noted to have brake pads. Due to the destructive measures required to collect samples of this type of material and the potential for damage to the mechanical systems, samples were not collected of the brake pads and they have been assumed to be positive for asbestos content for the purposes of this report. Overall, the brake pads appeared intact with no damage being noted. This material is to be removed, handled and disposed of as ACM by a licensed abatement contractor during the demolition of the existing bridge structure.

Photo 3 – Brake pads associated with the mechanical locking mechanism for the swing bridge.
