**LEAD-BASED PAINT  
INVESTIGATION REPORT**

**US-21 (SEA ISLAND PARKWAY)  
BRIDGE OVER HARBOR RIVER  
BEAUFORT COUNTY, SC  
SCDOT BRIDGE #072002100200  
SCDOT PROJECT #P026862**

**February 14, 2017**

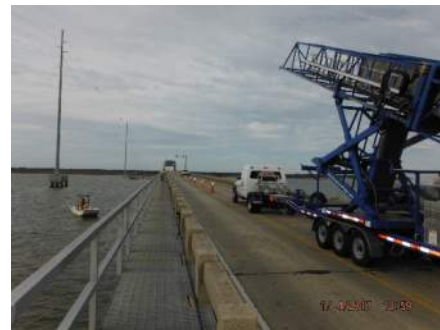
Photo 1 – Top view of SC-21 Bridge over Harbor River.

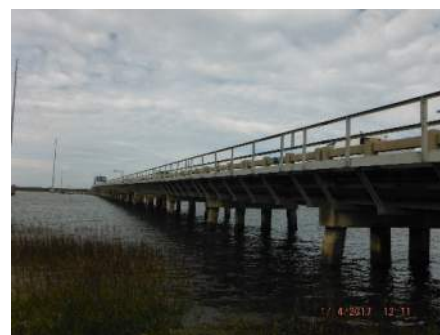
Photo 2 – Side view of SC-21 Bridge over Harbor River.

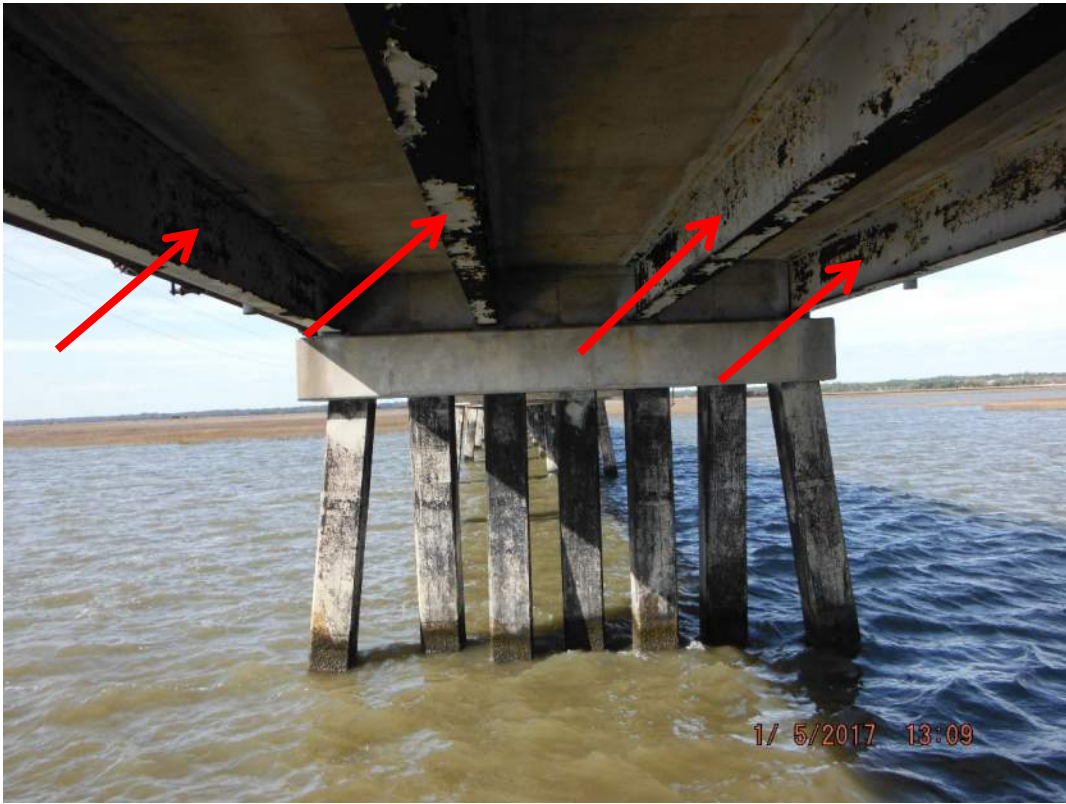
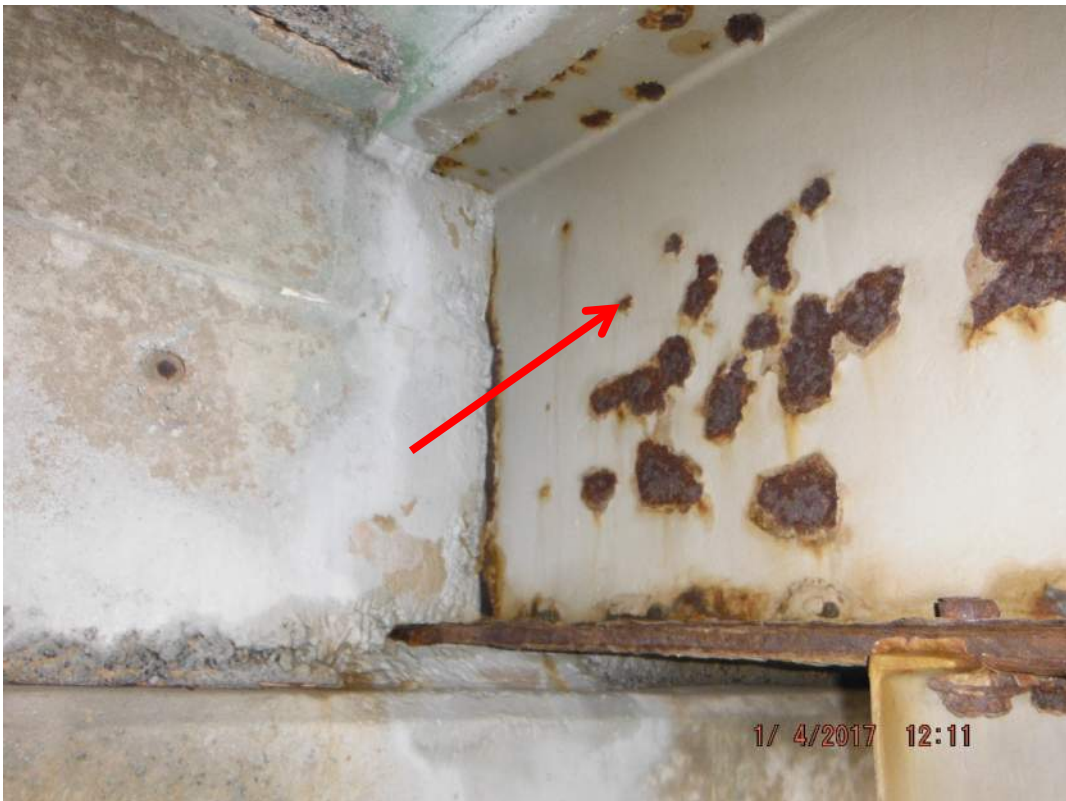
Bridge beams

As reported herein, lead-based paint was identified in concentrations above both the SCDHEC and OSHA limits on the steel beams, beam plates and pads, scupper pipes, swing bridge framing and gaurd rail, and the bridge traffic control arm framing. It is important to ensure that the debris generated from the demolition activities are handled and disposed of appropriately. The proper handling and disposal procedures depend on the type of substrate (i.e., metal, wood, masonry block, etc.). Intact removal is recommended in order to reduce and/ or eliminate the generation of lead-containing dust and *residue*. Metal components painted with and/ or containing lead, such as the beams, beam to diaphragm angle iron brackets, beam plates, scupper pipes, etc. may be recycled if they are taken to a recycling facility that accepts lead painted and/or lead-containing material.

Components found to contain lead should be handled appropriately. It is recommended that work tasks which require grinding, sanding, torch cutting or other disturbance of the lead-based painted surfaces identified herein be performed in accordance with federal regulations pertaining to worker protection from exposure to LBP. When lead containing items are disturbed or begin to decay they become a concern with regard to human and environmental health. The typical routes of exposure to lead are through the inhalation or ingestion of lead-contaminated materials. In cases where the lead-containing paint/ coating is intact (i.e. has not been aerosolized and free of chipping or flaking), there is minimal risk to people.
