Underwater Inspection Report

South Carolina Department of Transportation

US 21

Bridge ID No. 0720002100200

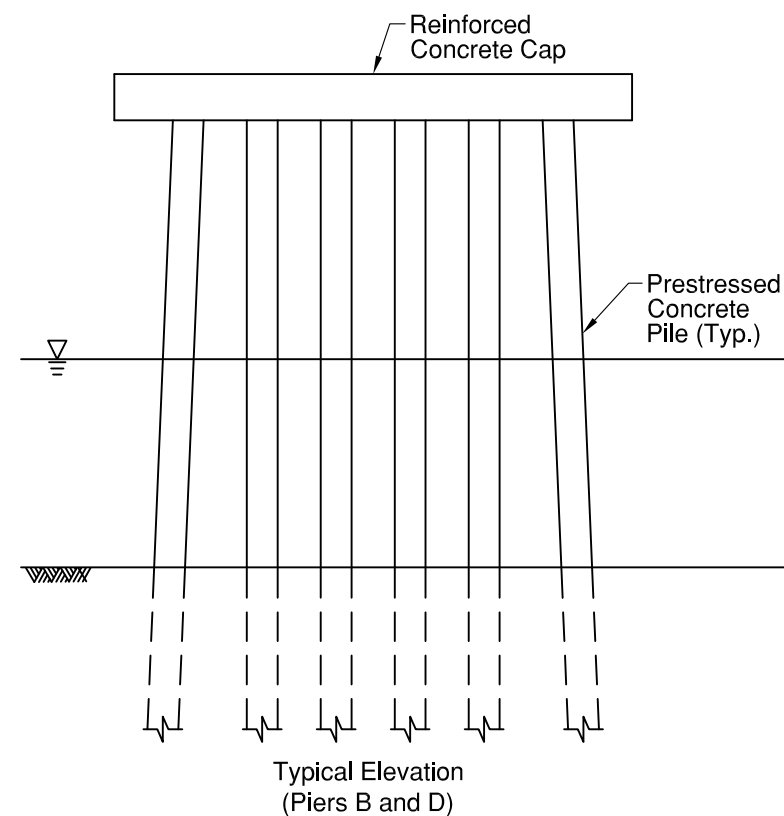
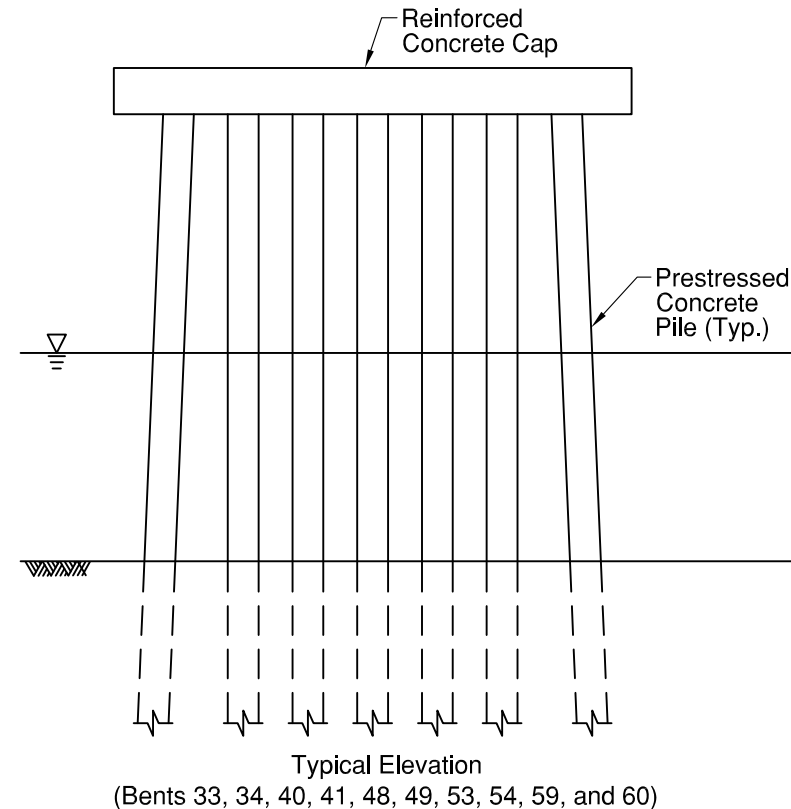
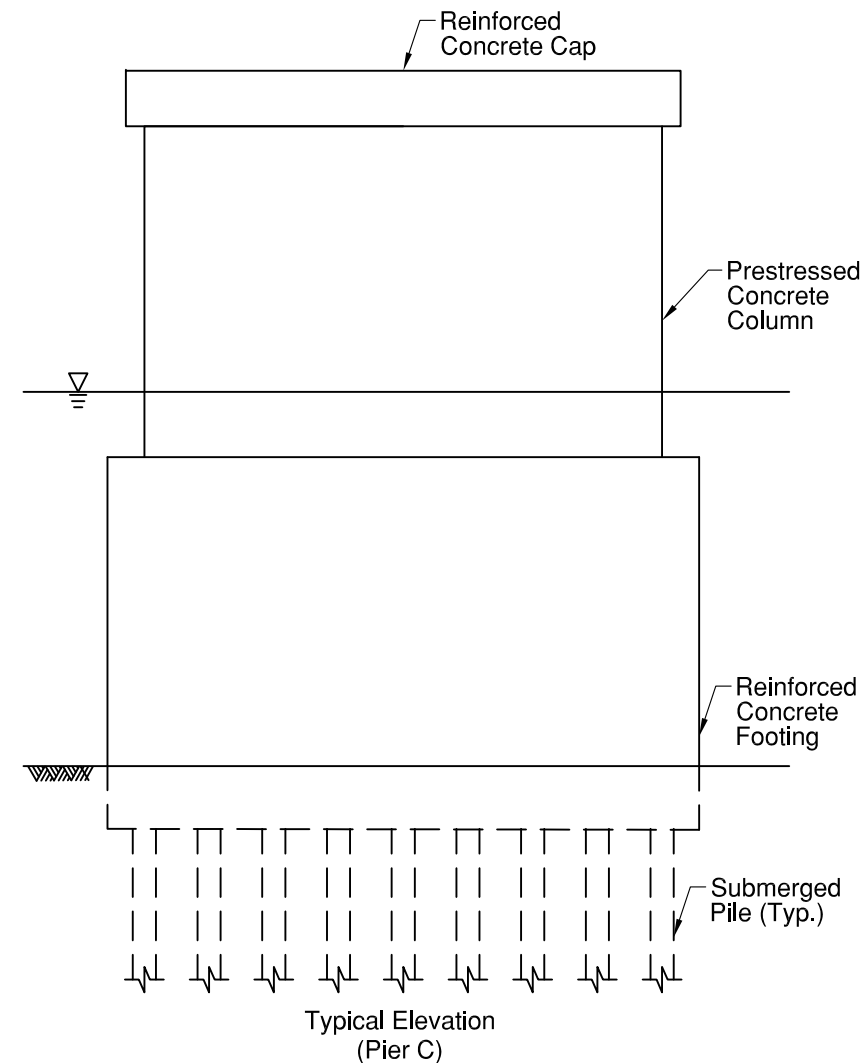
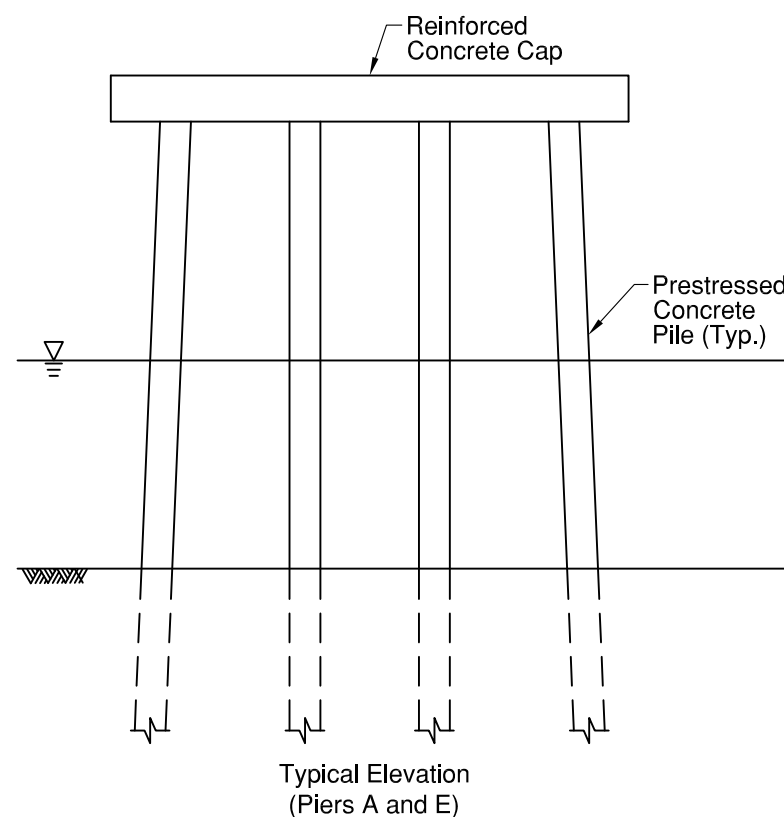
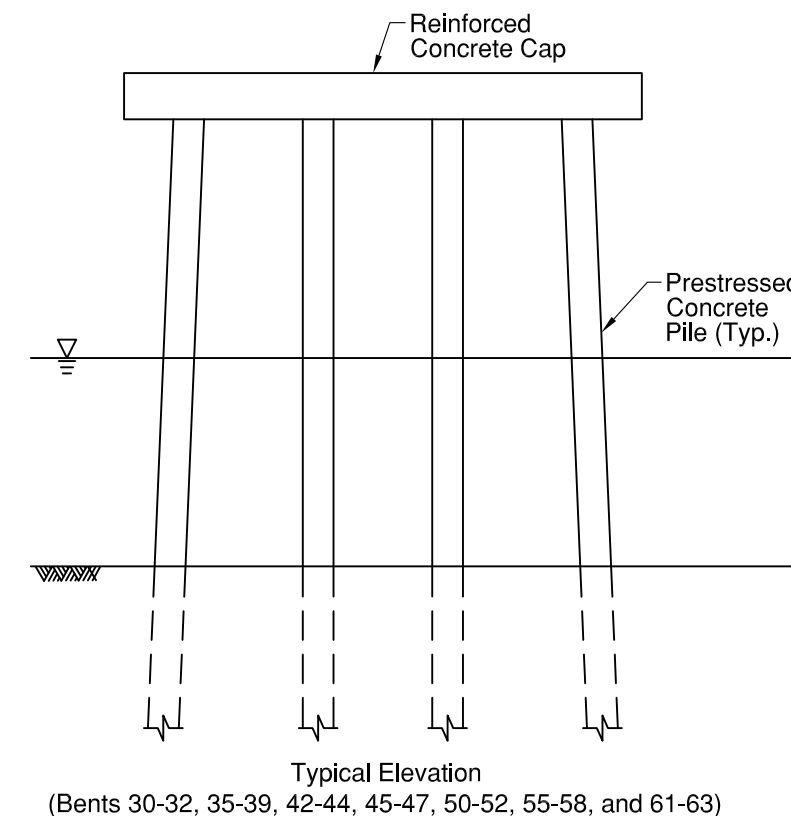
FIG NO.
4

- ① Hairline to 1/16-in. wide vertical cracks with rust stains extending from the marine growth up 3 ft.
- ② 1/8-in. to 1/4-in. wide vertical cracks with rust stains extending from the marine growth up 3 ft.
- ③ Up to 1/2-in. wide by 2 ft long vertical crack with rust stains on the north face at the waterline.
- ④ 1 ft long by 1 1/2-in. wide void with 4 in. of penetration in the column on the east face at the column/footing interface.
- ⑤ Up to 1 in. wide by 6 ft long vertical crack on the northeast corner at the waterline.
- ⑥ 2 ft long by 1 ft high spall with 4 in. of penetration and exposed reinforcing on the east face of the cap.
- ⑦ 1/2-in. wide by 4 ft long vertical crack with rust stains on the south face at the waterline.
- ⑧ 5 ft long by 1 ft high spall with 6 in. of penetration and exposed reinforcing on the west face of the cap.

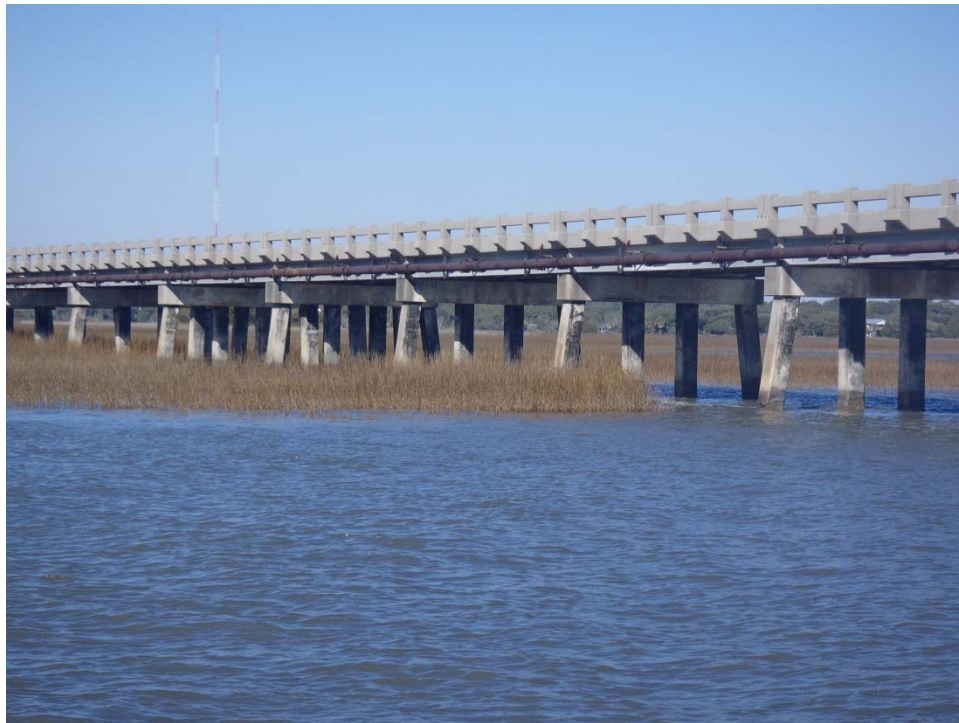
The banks along Harbor River in the bridge vicinity are in stable condition. Embankment protection in the form of riprap and vegetation is present on the west and east banks. There is no sign of active erosion. Refer to Photographs 6 and 7 in Appendix B for a view of the west and east embankments, respectively. The channel bottom in the bridge vicinity primarily consists of sand and shells.

Photograph 6. West Embankment.

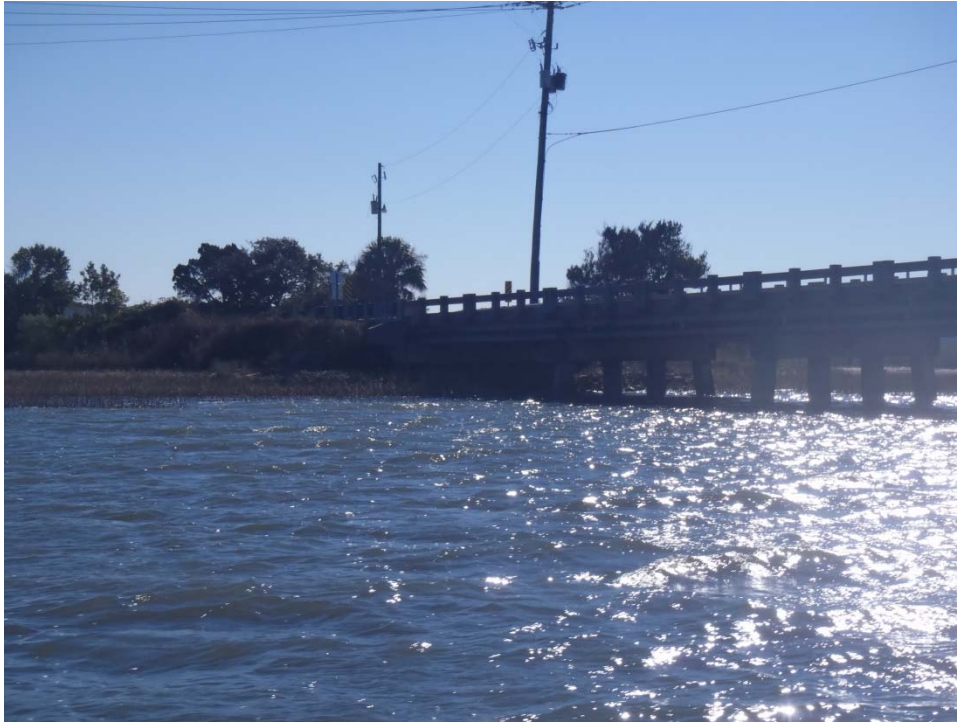
Photograph 7. East Embankment.

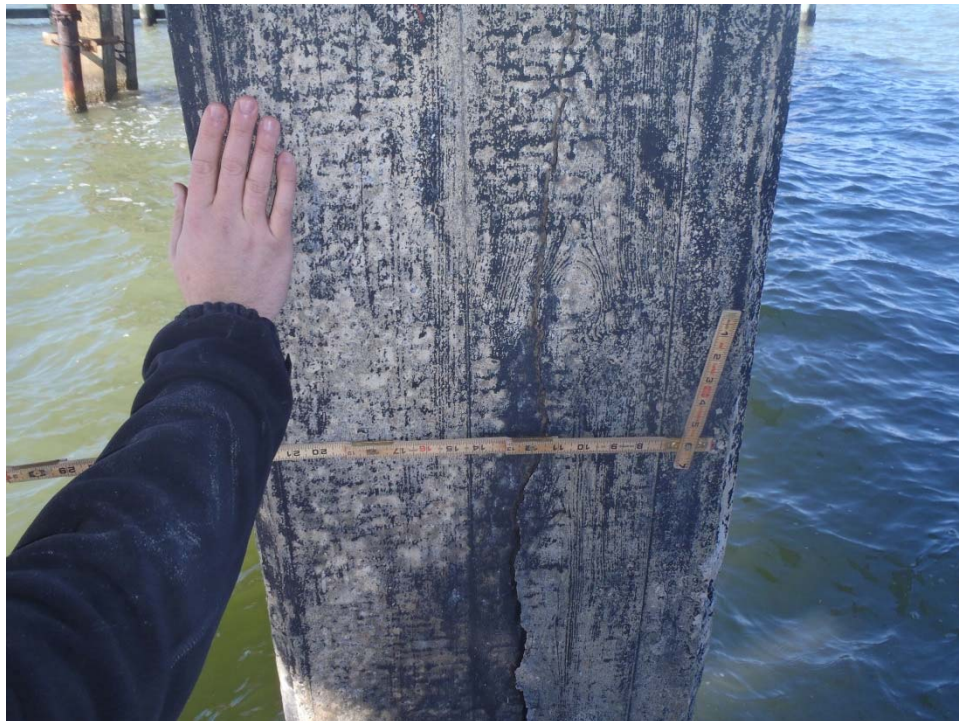
- A 1 in. wide vertical crack with rust staining on Pile 2 at Bent 45 and a 1/2-in. wide vertical crack with rust staining on Pile 5E at Pier B.
- 1/8-in. to 1/4-in. wide vertical cracks on piles at Bents 30, 33, 34, 36, 40, 44, 45, 48, 52 through 58, 61, 62, and Pier B.
- Spalling up to 1 ft. high by 5 ft. long with up to 6 in. of penetration in the caps at Bents 56 and 63.

Photograph 10. 1/4-in. wide vertical crack in Pile 2 at Bent 45.

- Vertical cracks wider than 1/16-in. should be cleaned and sealed.
- Clean spalls and voids to sound concrete and patch with a grout suitable for a marine environment.

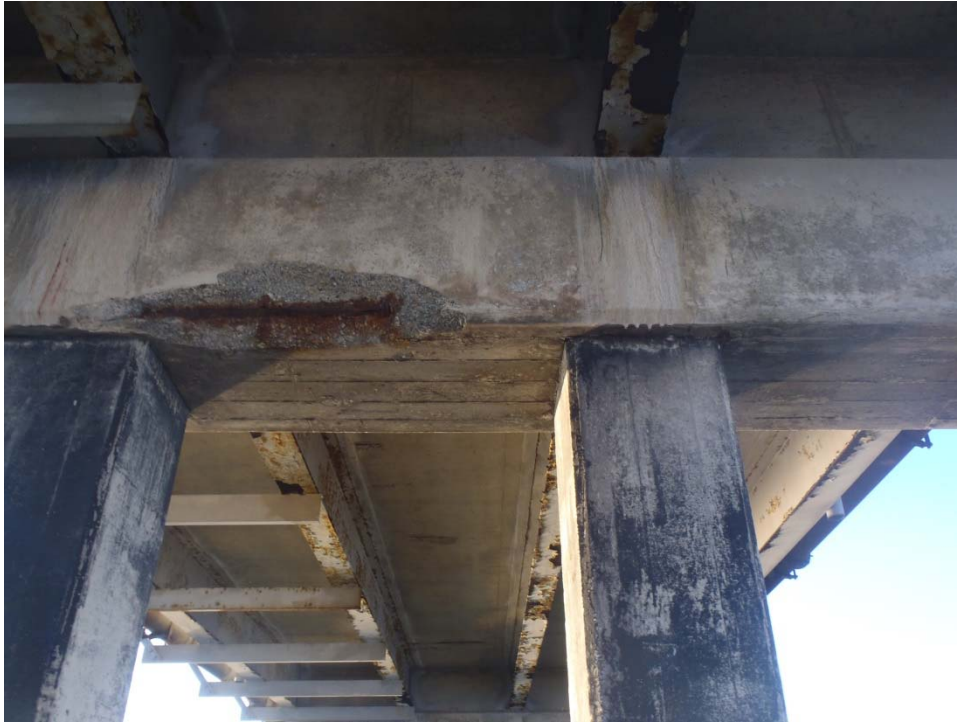
An area of voiding, 1 ft. long by 1 1/2-in. wide with 4 in. of penetration, is located at the column/footing interface on the east face of Pier C. There is a spall, 2 ft. long by 1 ft. high with 4 in. of penetration with exposed reinforcing, on the east face of the cap at Bent 56. Refer to Photograph 11 in Appendix B for a view of the spall on the cap at Bent

56. There is a spall, 5 ft. long by 1 ft. high with 6 in. of penetration with exposed reinforcing, on the west face of the cap at Bent 63. Refer to Figure 1 in Appendix A for detailed inspection notes and a plan view showing the existing conditions at each of the inspected bents and piers.

Photograph 11. Spall with 4 in. of penetration on the cap at Bent 56.
