SCDOT BRIDGE INSPECTION FORM

(008) BRIDGE ID: **072002100200**
(005) ROUTE: BEAUFORT US 21
(006) CROSSING: HARBOR RIVER

**SOUTH CAROLINA DEPARTMENT OF TRANSPORTATION
BRIDGE MANAGEMENT SYSTEM
Bridge Inspection Addendum**

10/14/2016

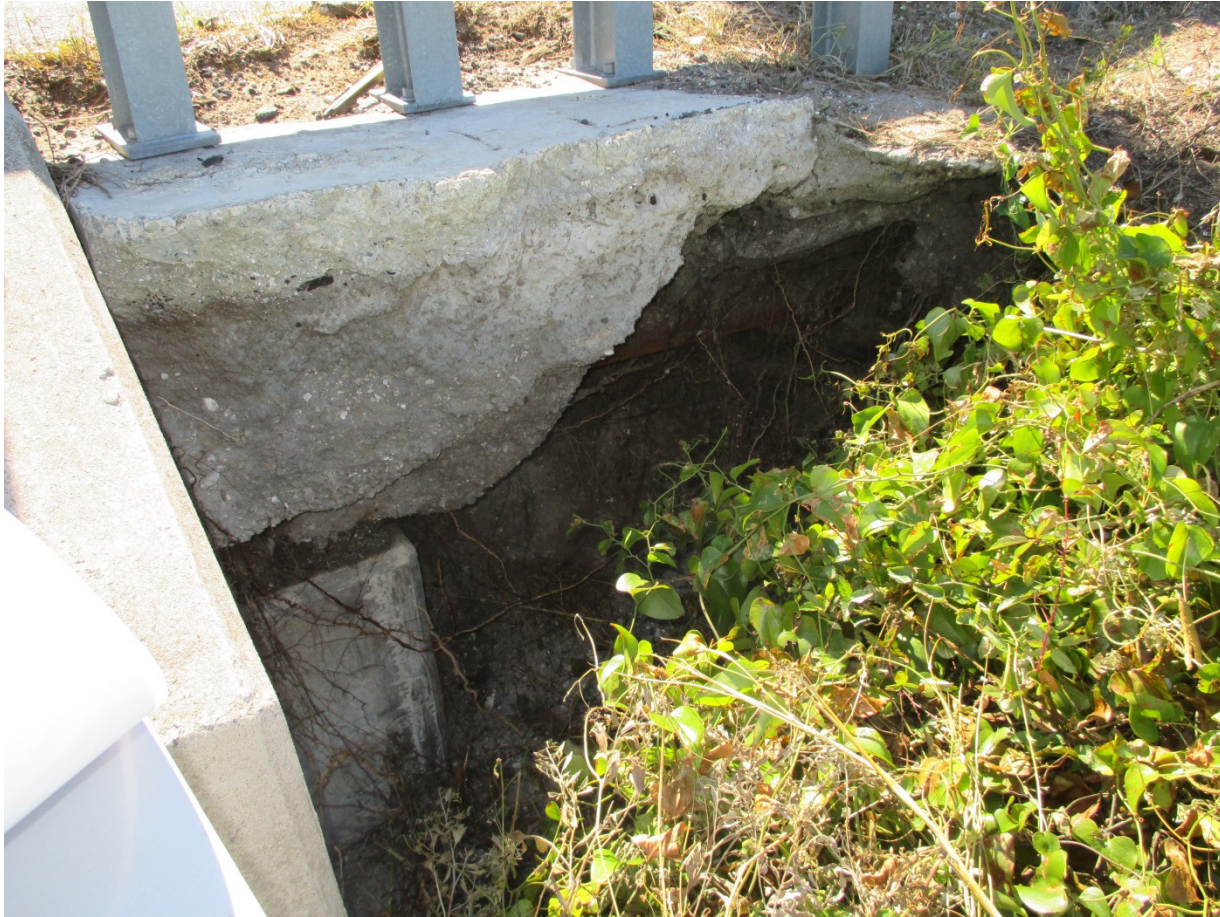
Abutments and/or Headwalls- Photo 1

[4] POOR – The northwest corner of Abutment 1, adjacent to the wingwall, exhibits an 8 ft. x 8 ft. x 5 ft. undermined and washed out area extending under the westbound lane of US-21. Refer to Photo 1.

The northwest corner of Abutment 1, adjacent to the wingwall, exhibits an 8 ft. x 8 ft. x 5 ft. undermined and washed out area.

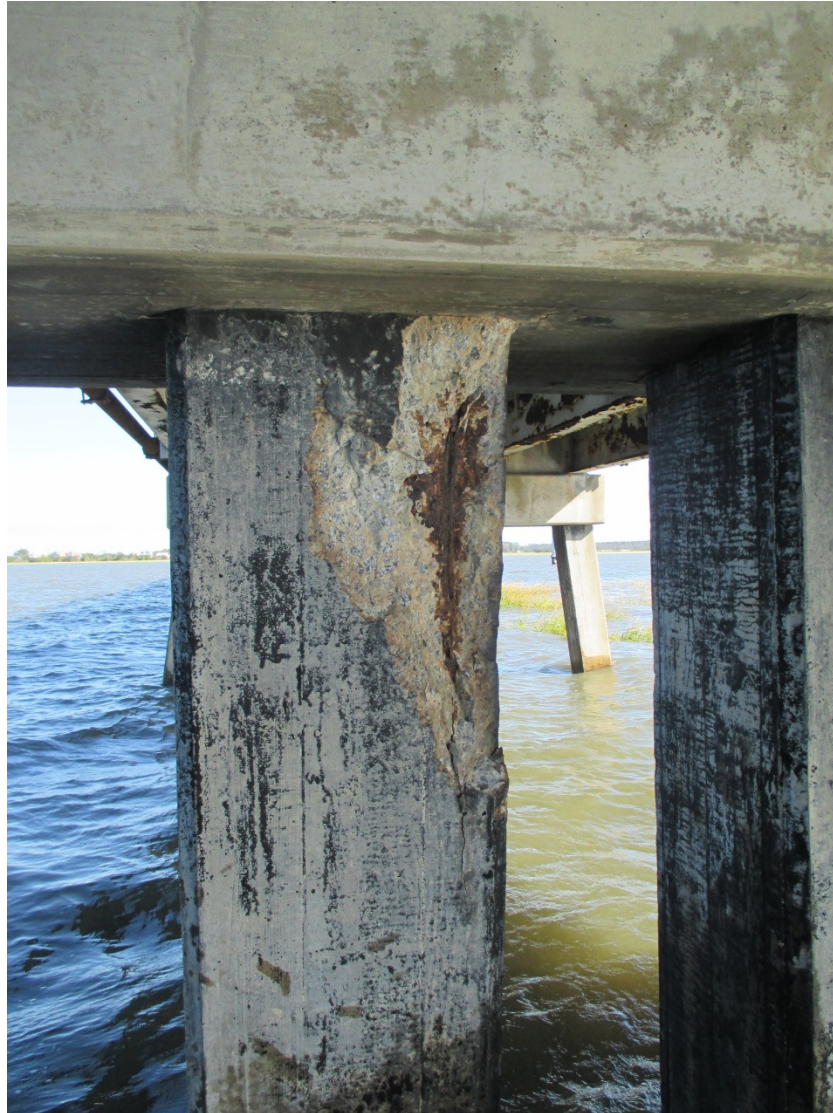
Bents and/or Piers- Photo 2

[4] POOR – Many piles exhibit delaminations and spalls some with exposed steel, and cracks with corrosion bleed out throughout the structure. Refer to Photo 2.

Many piles exhibit delaminations and spalls some with exposed steel, and cracks with corrosion bleed out throughout the structure (Pile 22-2, 2.5 ft. x 12 in. x 4 in. spall, delamination with exposed steel shown).

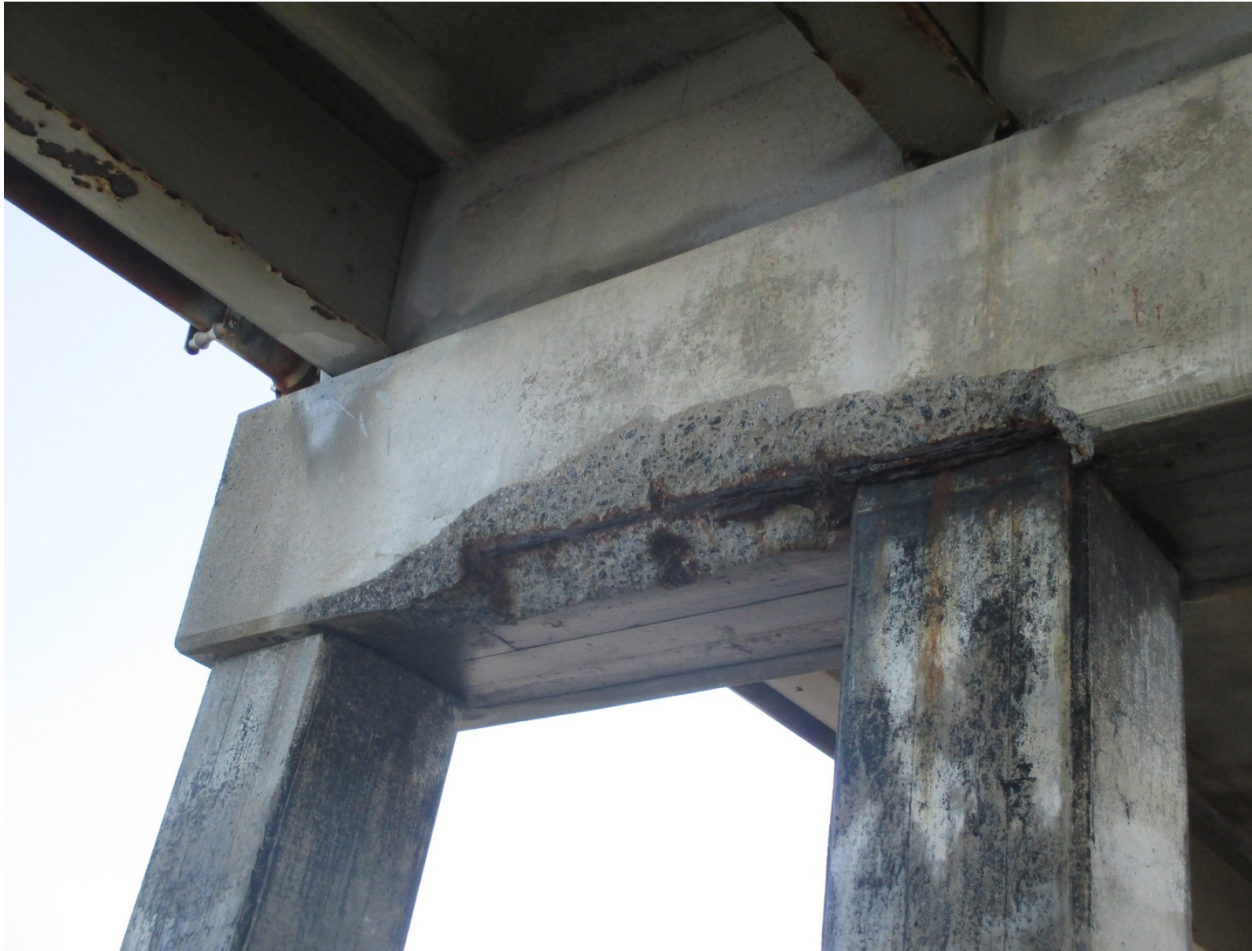
Bents and/or Piers- Photo 3

Numerous pier caps exhibit delaminations, and spalls with exposed steel, and cracks with corrosion bleed out throughout the structure. Refer to Photo 3.

Numerous pier caps exhibit delaminations, and spalls with exposed steel, and cracks with corrosion bleed out throughout the structure (Bent 66 between Piles 1 and 2, 6 ft. x 2 ft. x 4 in. spall with exposed steel shown).

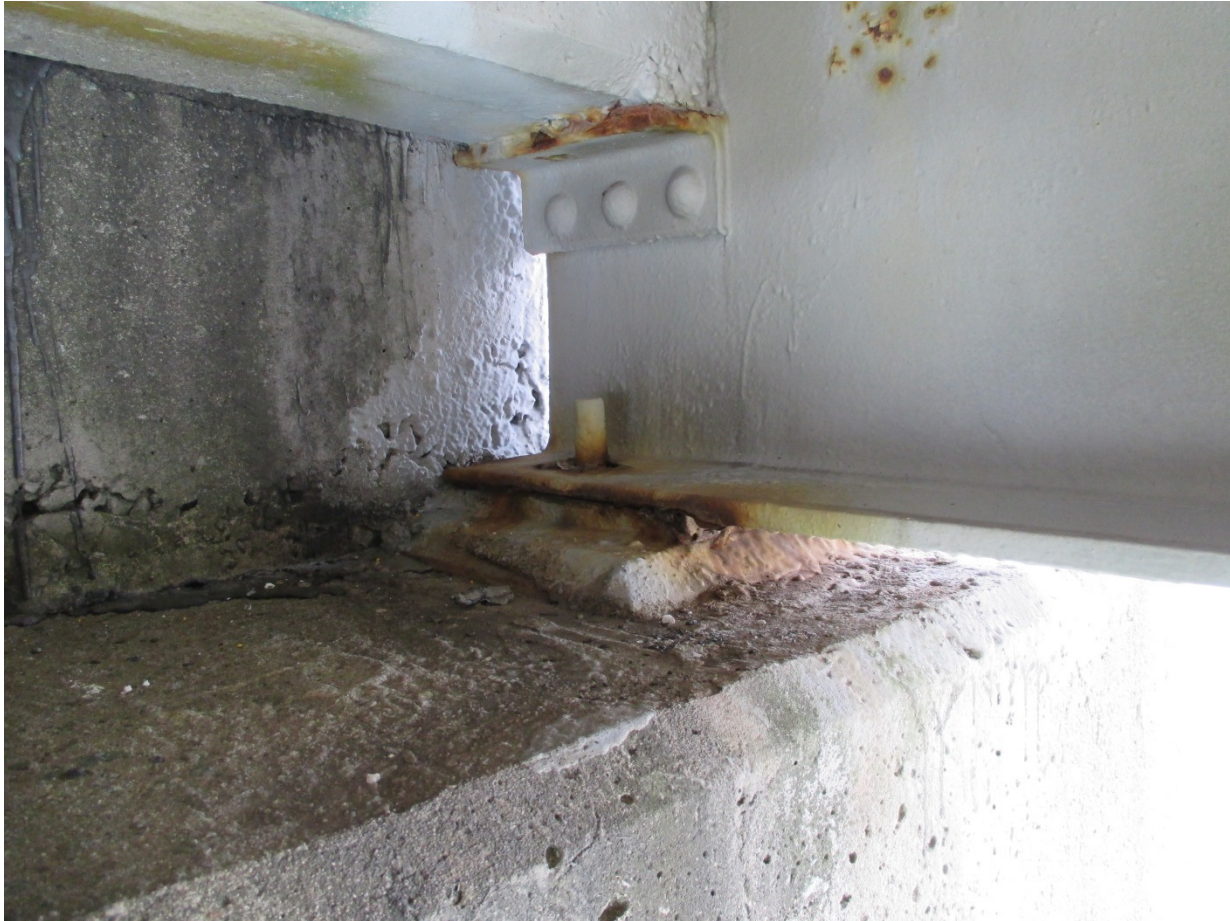
Bearings- Photo 4

[4] POOR – Bearings are generally highly corroded and indistinguishable from the bottom flange. The connecting hardware of a few bearings exhibits section loss to 100%. Refer to Photo 4.

Bearings are generally highly corroded and indistinguishable from the bottom flange. The connecting hardware of a few bearings exhibits section loss to 100% (Bearing 64-1 at Bent 63 shown).

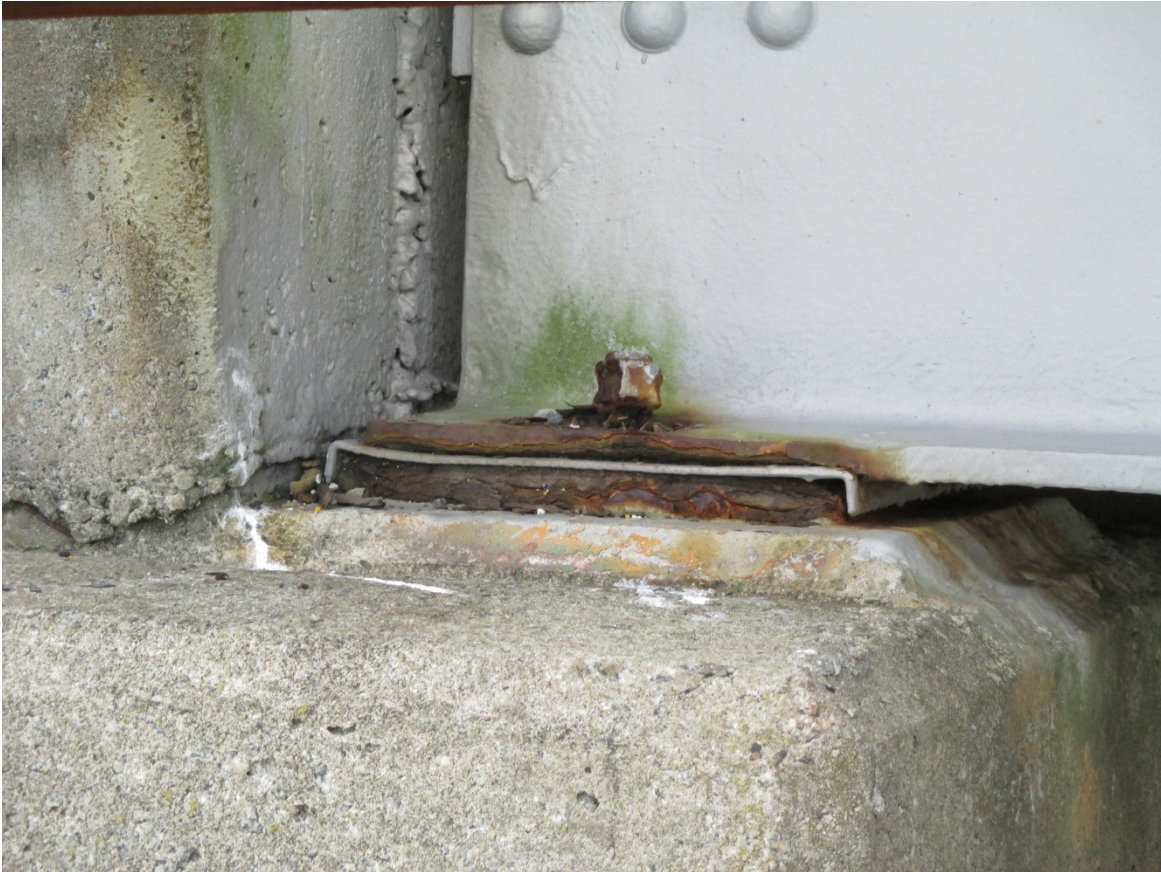
Bearings- Photo 5

The bearings exhibit heavy corrosion, section loss, and efflorescence. Refer to Photo 5.

The bearings exhibit heavy corrosion, section loss, and efflorescence (Bearing 42-1 at Bent 42 shown).

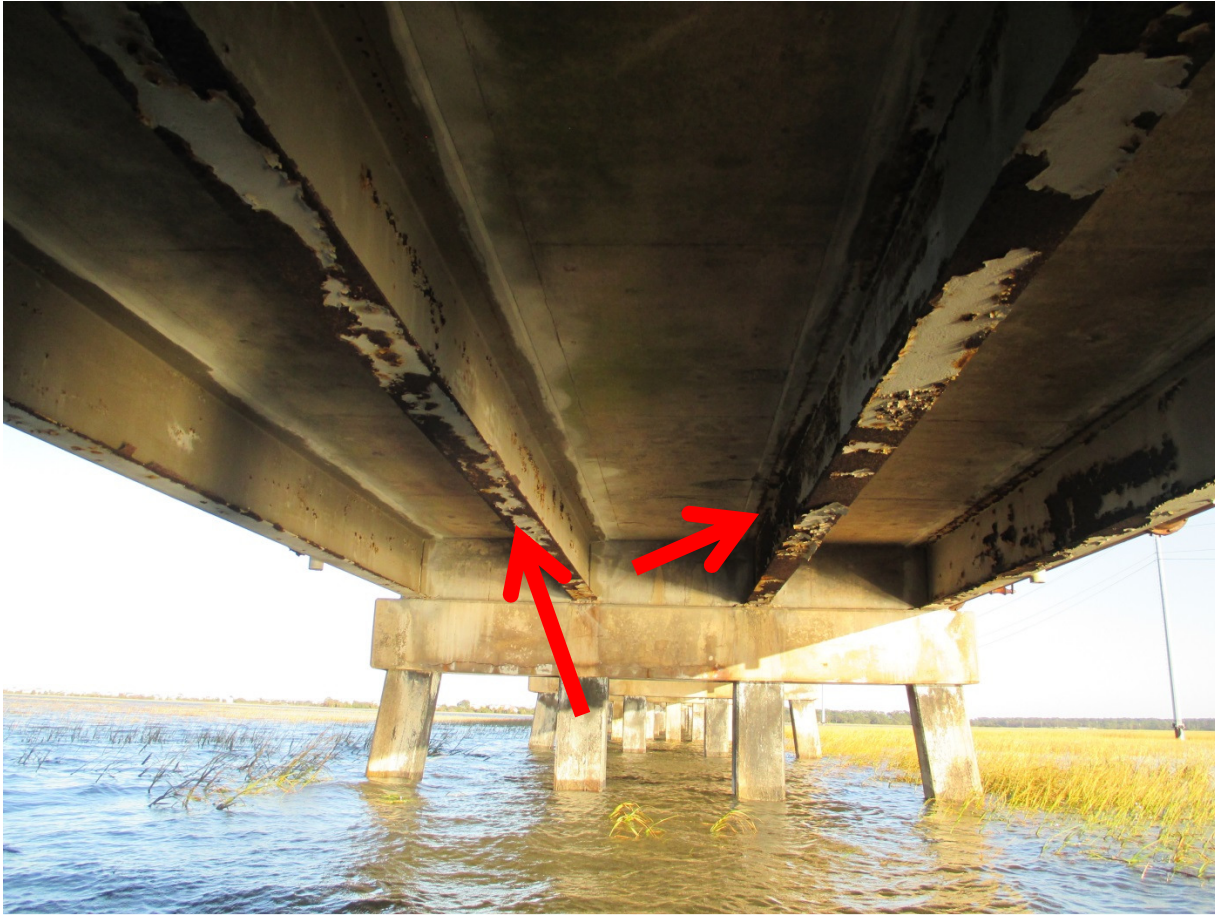
Girders/Floor Beams/Stringers and/or Beams- Photo 6

[4] POOR – The beams of the approach spans exhibit heavy corrosion, knife edging, section loss, resulting in reduced section near the ends of the beams throughout. Refer to Photos 6, 7, and 8.

Typical of heavy corrosion in the bottom flange and web of the approach span beams (Span 10 shown).

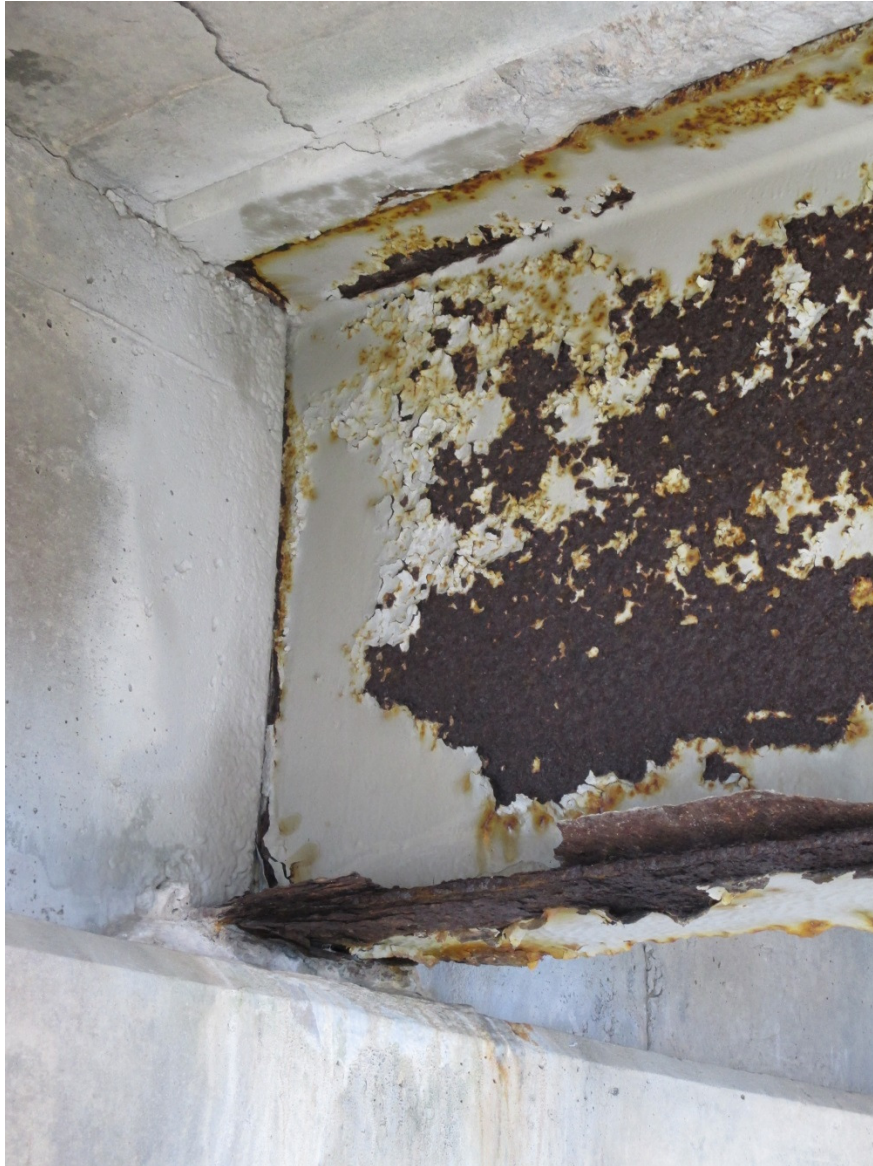
Girders/Floor Beams/Stringers and/or Beams- Photo 7

Typical of heavy corrosion in the web and both flanges of the approach span beams (Beam 24-2 shown).

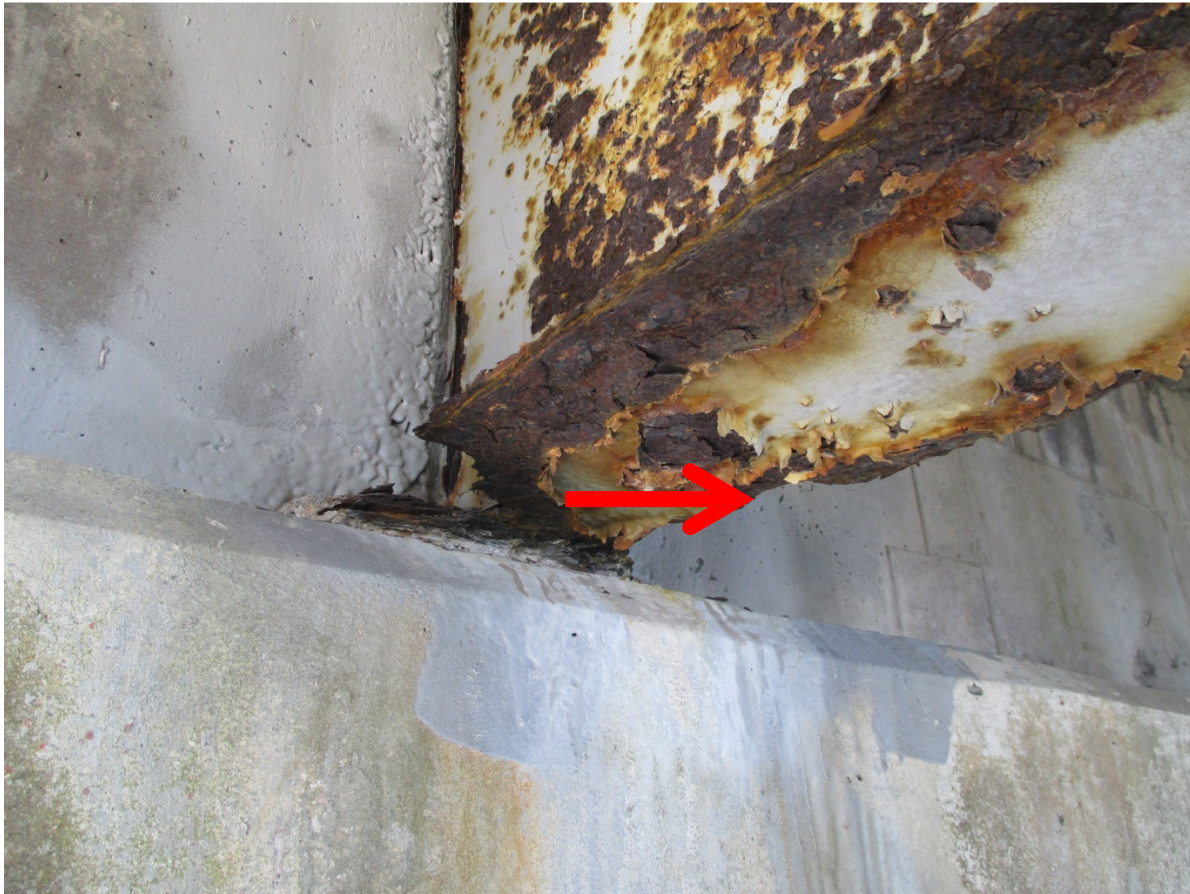
Girders/Floor Beams/Stringers and/or Beams- Photo 8

The beams of the approach spans exhibit heavy corrosion, knife edging, section loss, resulting in reduced section near the ends of the beams throughout (Beam 26-2 at Bent 25 shown).

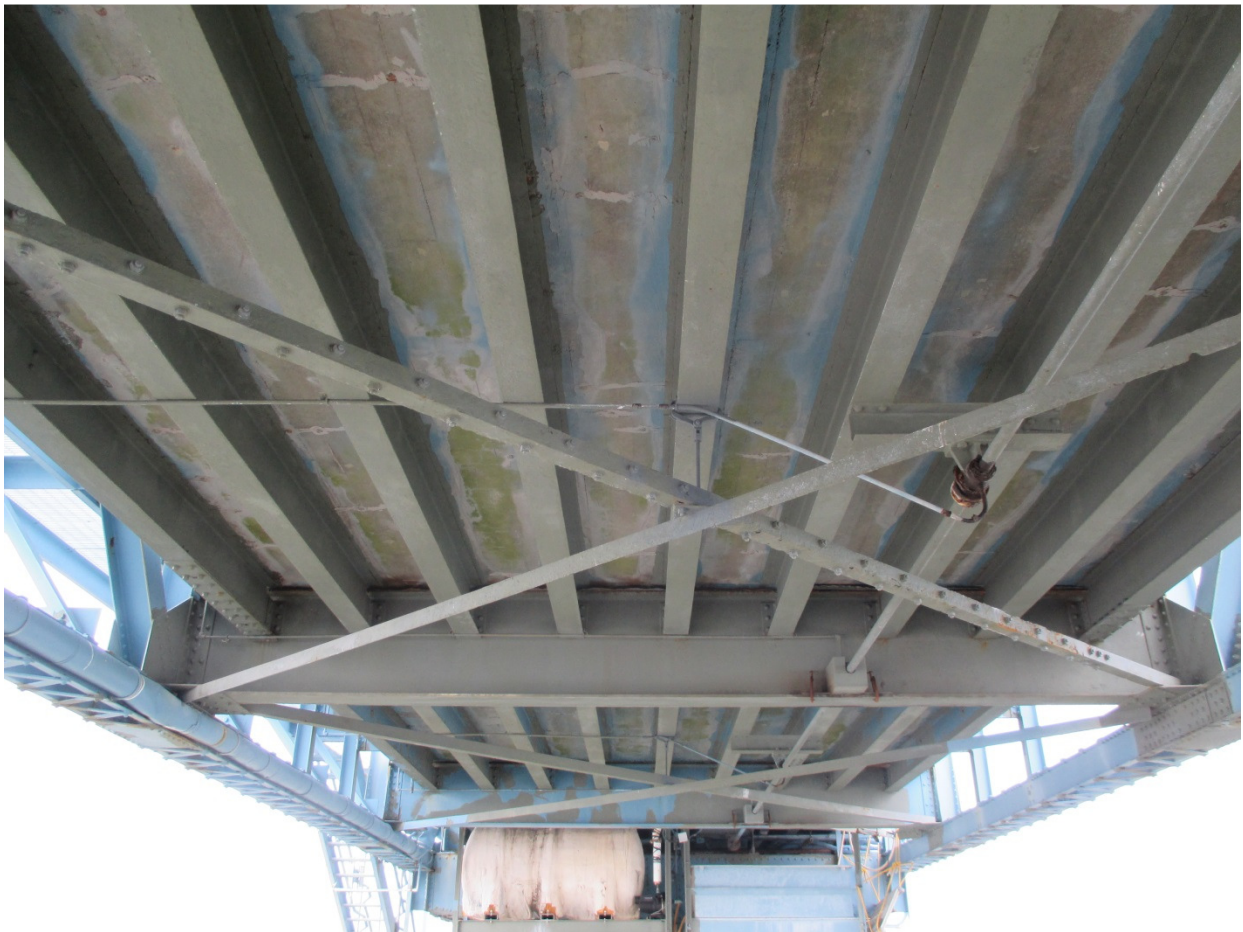
Girders/Floor Beams/Stringers and/or Beams- Photo 9

The stringers and floorbeams of the main span appear to have been repaired and painted since the 2014 inspection. Refer to Photos 9 and 10.

The stringers and floorbeams of the main span appear to have been repaired and painted since the 2014 inspection. (Span 47 East, looking West).

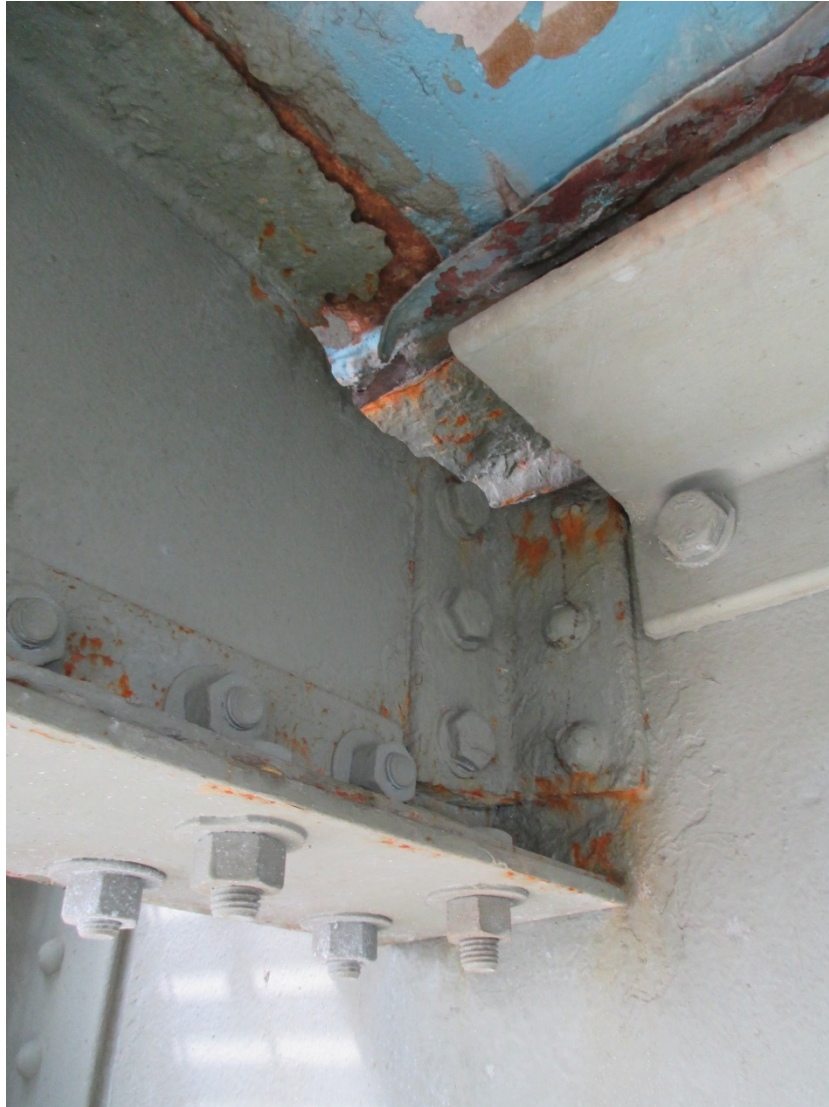
Girders/Floor Beams/Stringers and/or Beams- Photo 10

The stringer of the main span previously reported to exhibit heavy corrosion and section loss resulting in reduced section near the beam ends has been repaired. (Bottom flange of Stringer 46-9 at Floor Beam 46-2 shown).

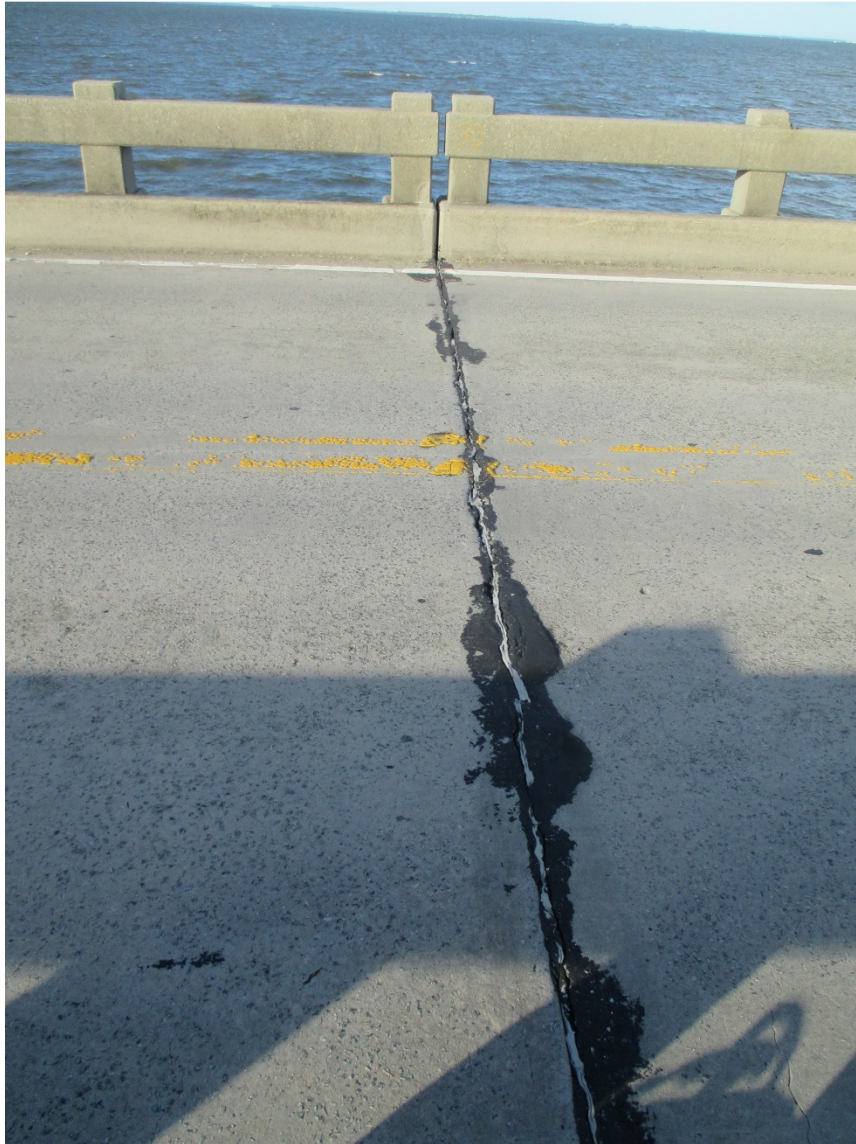
Expansion Joints- Photo 11

[4] POOR – Pourable joint sealant exhibits significant adhesion loss and missing sections of joint sealant at all bents. Refer to Photo 11.

Pourable joint sealant exhibits significant adhesion loss and missing sections of joint sealant at all bents (Bent 30 shown).

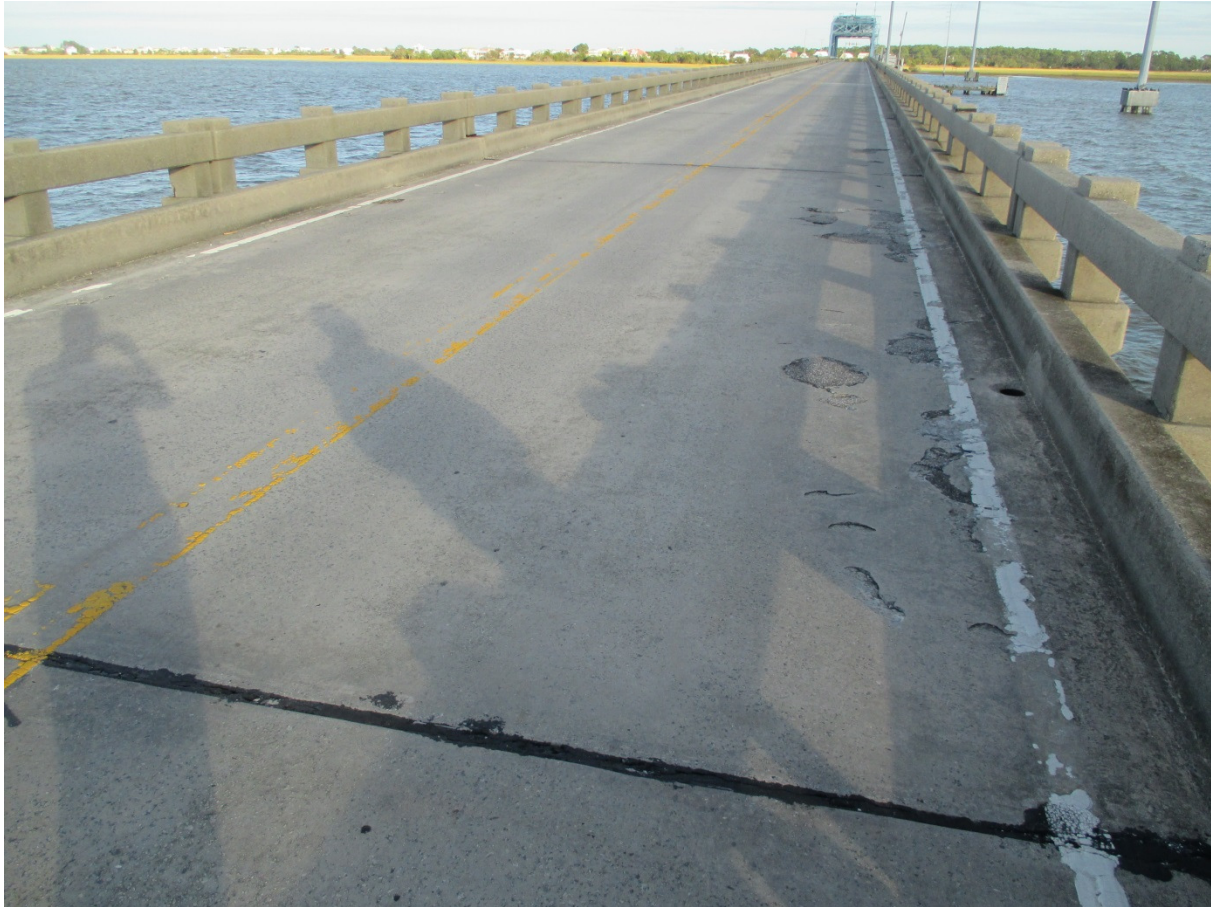
Decks and/or Slabs- Photo 12

[5] FAIR – Spans 9 and 31 exhibit failed patches and spalls some with exposed steel to 1 ft. dia. x 2 in. deep in Eastbound Lane. Refer to Photo 12.

Spans 9 and 31 exhibit failed patches and spalls some with exposed steel to 1 ft. dia. x 2 in. deep in Eastbound Lane (Span 31 shown).

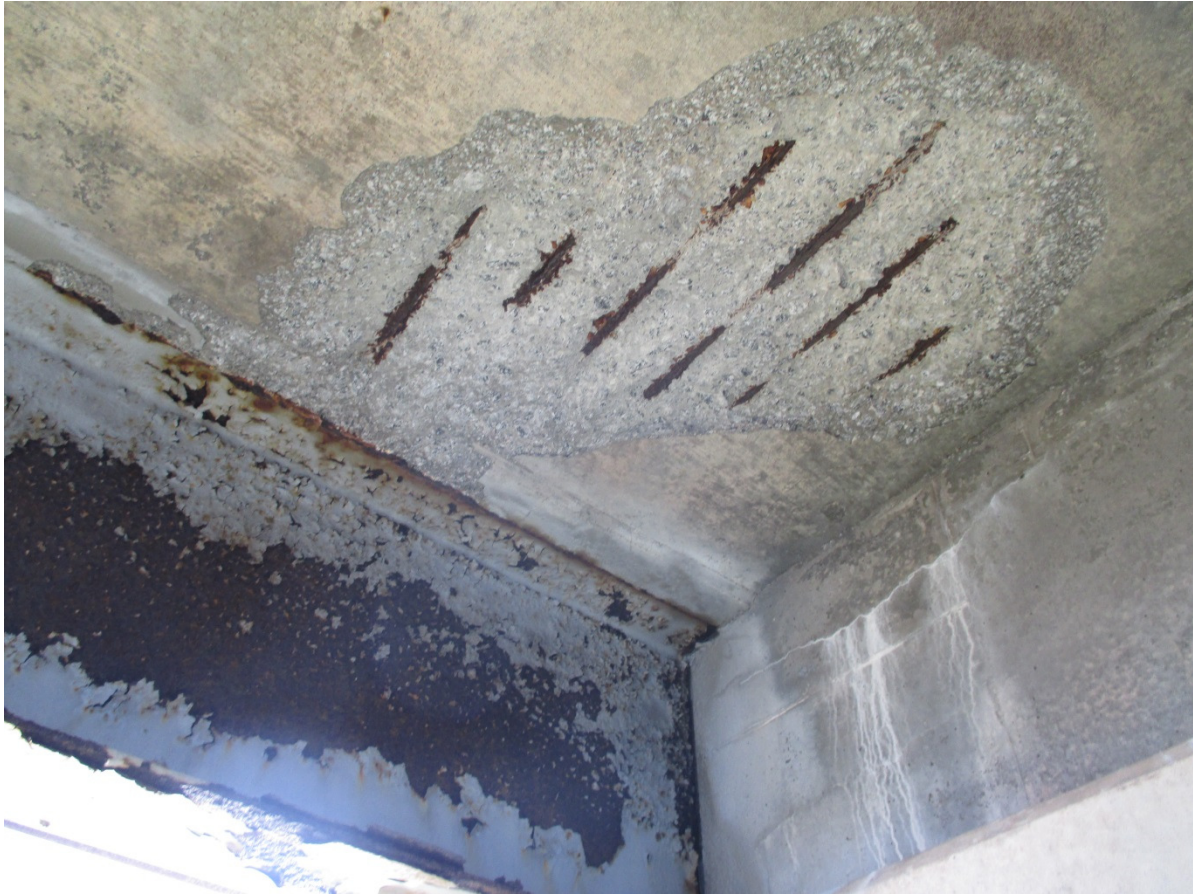
Decks and/or Slabs- Photo 13

The deck underside exhibits delaminations and spalls some with exposed rebar throughout the approach spans. Refer to Photo 13.

The deck underside exhibits delaminations and spalls some with exposed rebar throughout the approach spans (Bay 21-3, 4 ft. long x 3 ft. wide x 2 in. deep with exposed steel near mid-span shown).

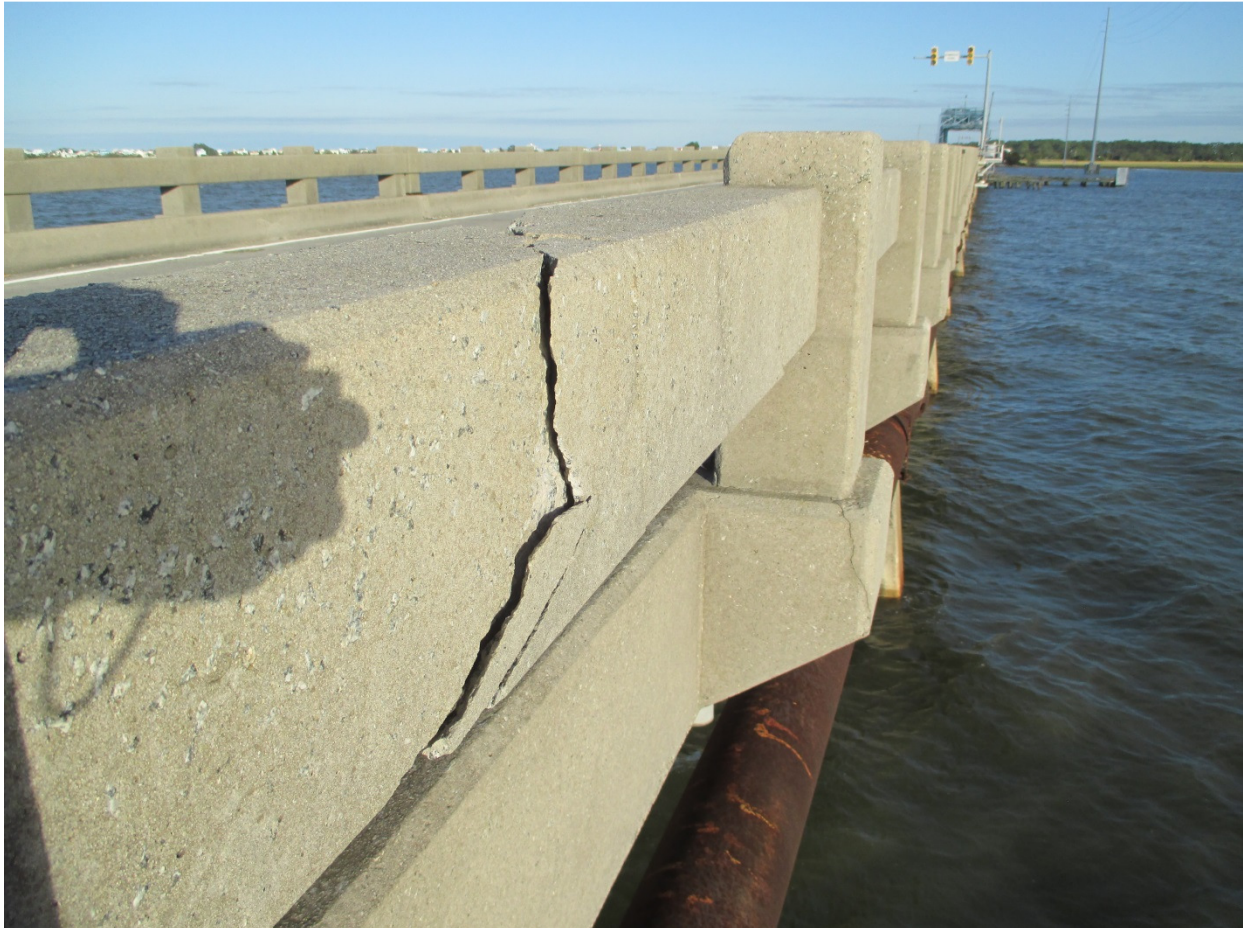
Bridge Railing/Parapets and/or Median Barriers- Photo 14

[6] SAT – Most bridge railings and rail posts exhibit spalls with exposed steel primarily at the base. The bridge railing exhibits isolated areas of impact damage and spalls with exposed steel. Refer to Photo 14.

Most bridge railings and rail posts exhibit spalls with exposed steel primarily at the base. The bridge railing exhibits isolated areas of impact damage and spalls with exposed steel. (Rail 31 right shown, 2 ft. east of Bent 31 shown).

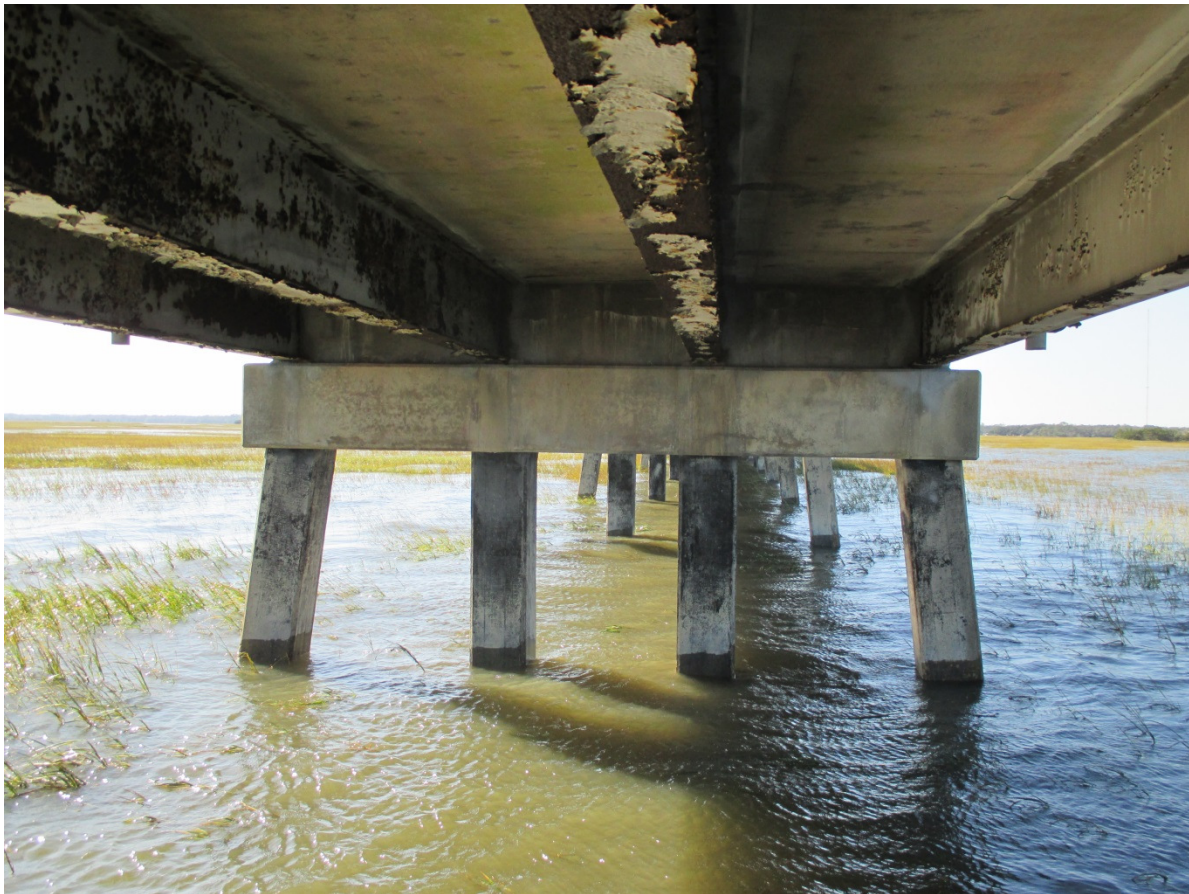
Paint Systems- Photo 15

[4] POOR – The beams of the approach spans exhibit heavy corrosion throughout. Refer to Photo 15.

Typical condition of the paint system of the approach spans steel beams (Span 21 shown).

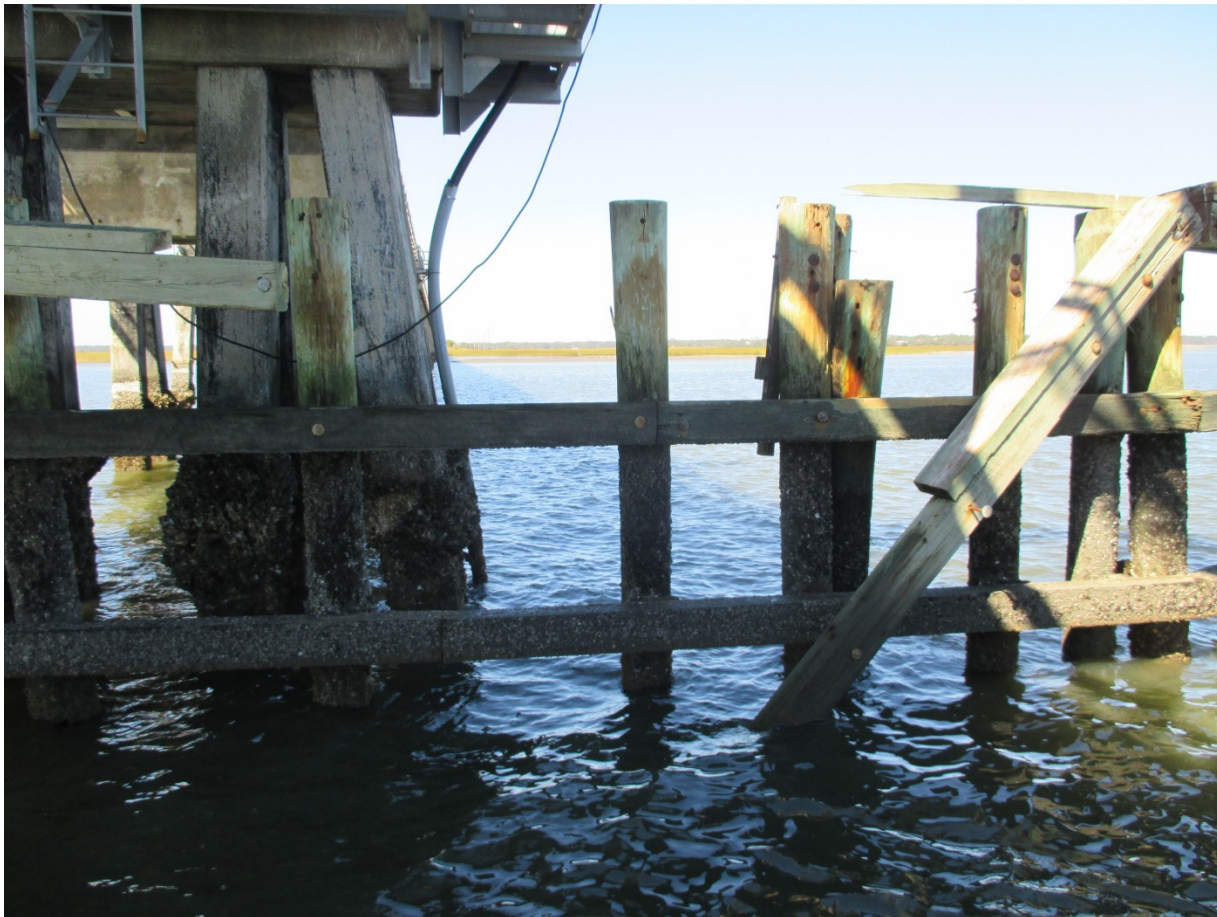
Fender System- Photo 16

[4] POOR – There are missing wales throughout, heavy corrosion on connecting hardware, overall loose connections, resulting in the west and east fenders being extremely unstable. Several wales were lost during Hurricane Matthew. Refer to Photo 16.

There are missing wales throughout, heavy corrosion on connecting hardware, overall loose connections, resulting in the west and east fenders being extremely unstable (west fender shown). Several wales were lost during Hurricane Matthew and the navigation lights were damaged.

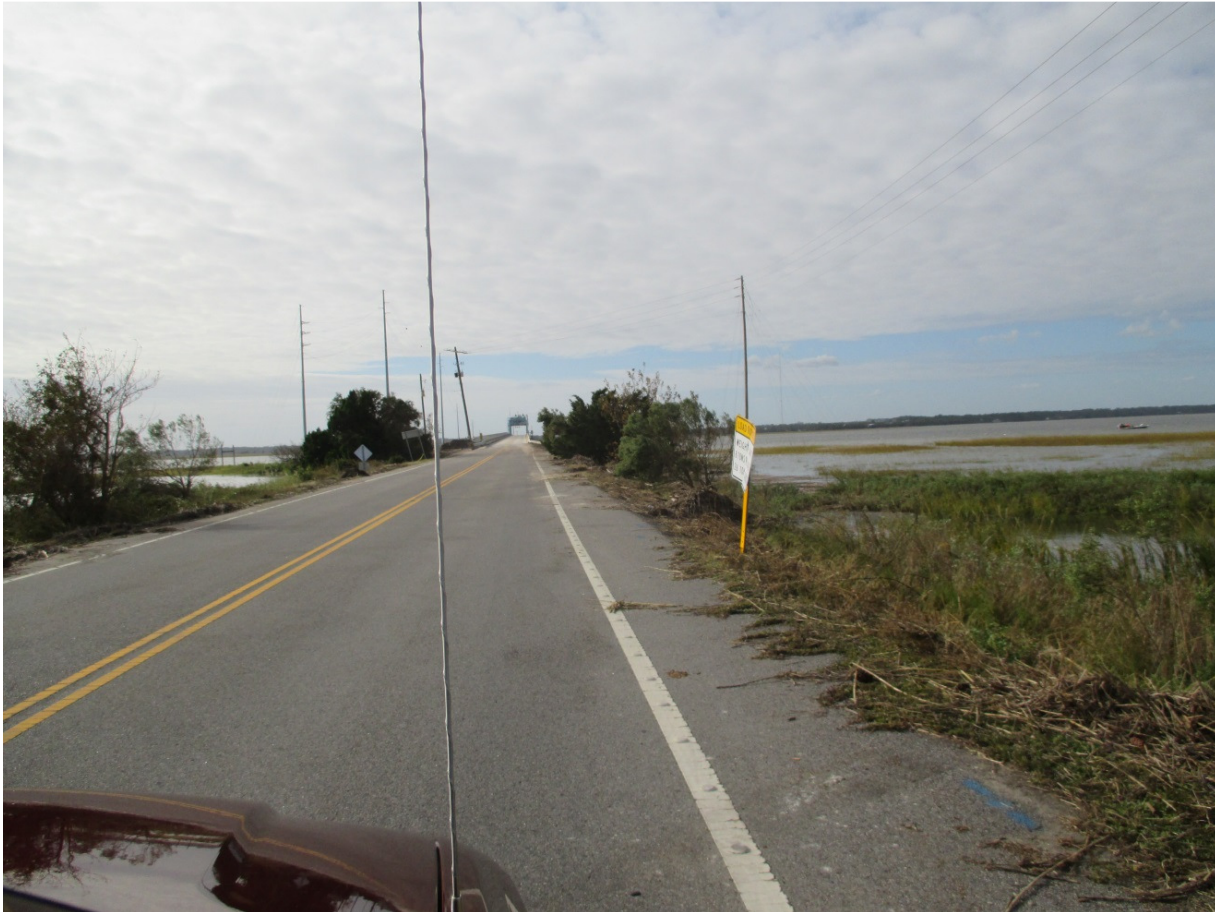
Traffic Signs - Photo 17

Traffic signs and load posting signs were damaged during Hurricane Matthew. See Photos 17 & 18.

Load posting signs were damaged during Hurricane Matthew. (East approach shown)

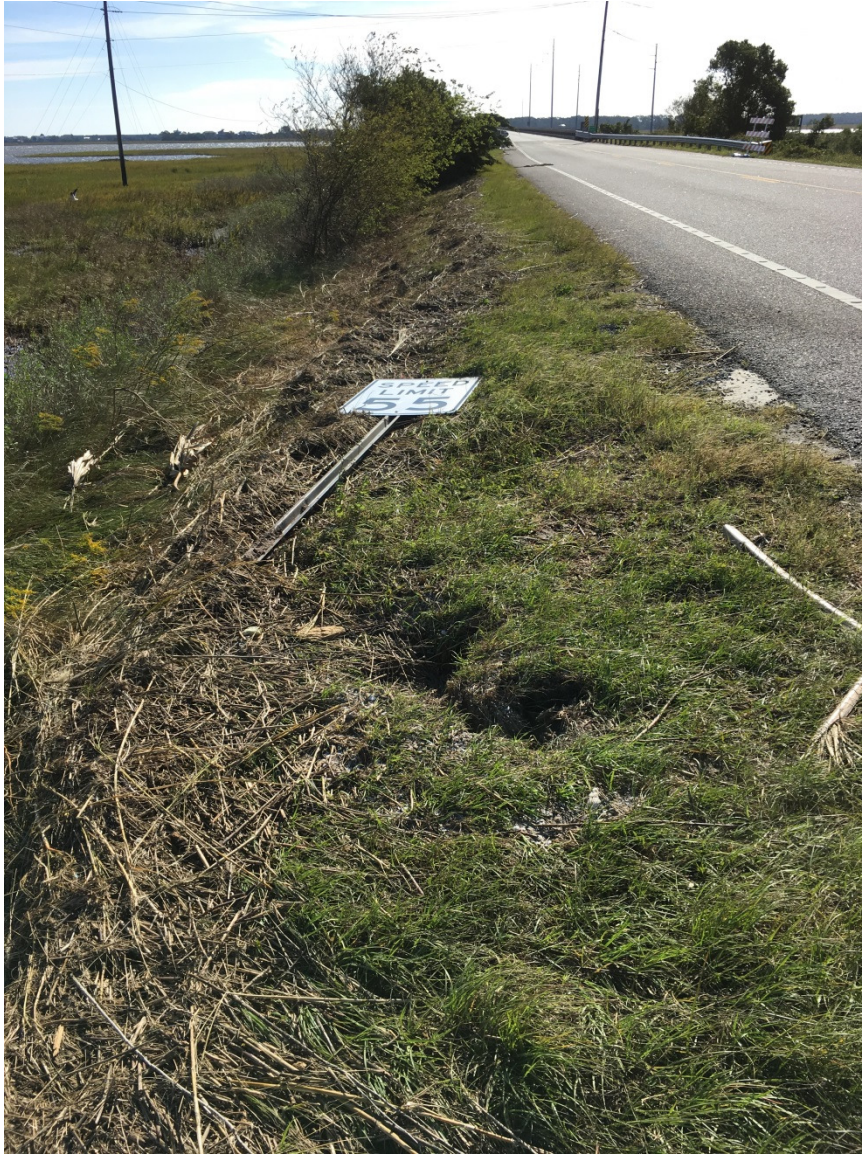
Traffic Signs - Photo 18

Traffic signs were damaged during Hurricane Matthew. (West approach shown)

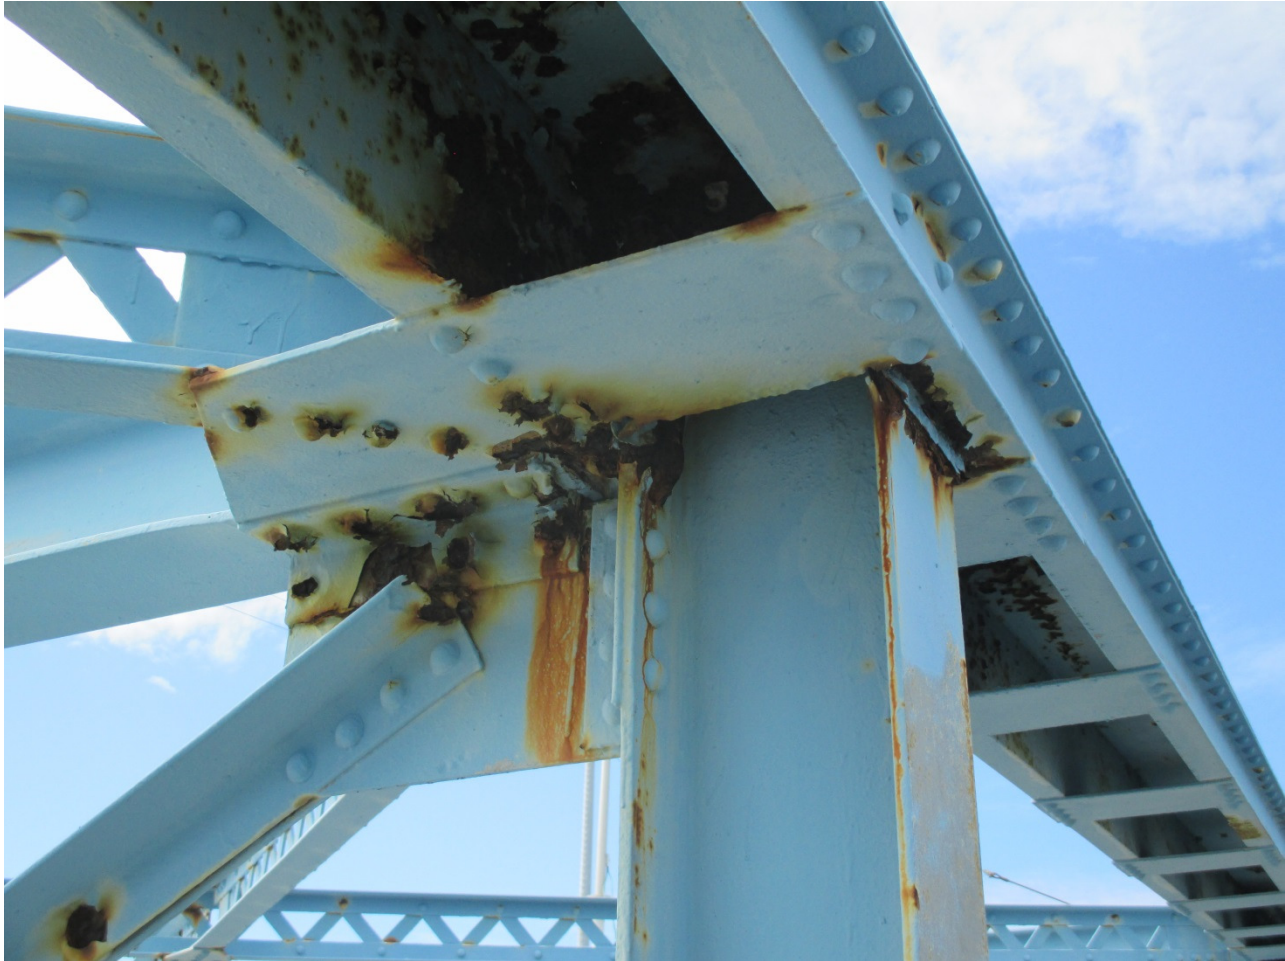
Truss Members - Photo 19

[5] FAIR – The top and bottom cords of both trusses exhibit isolated areas of minor surface corrosion. There were repairs made to the stringers noted in the 2014 report. Refer to Photos 10 and 19.

The top and bottom cords of both trusses exhibit isolated areas of minor surface corrosion. (North Truss, U6 shown).

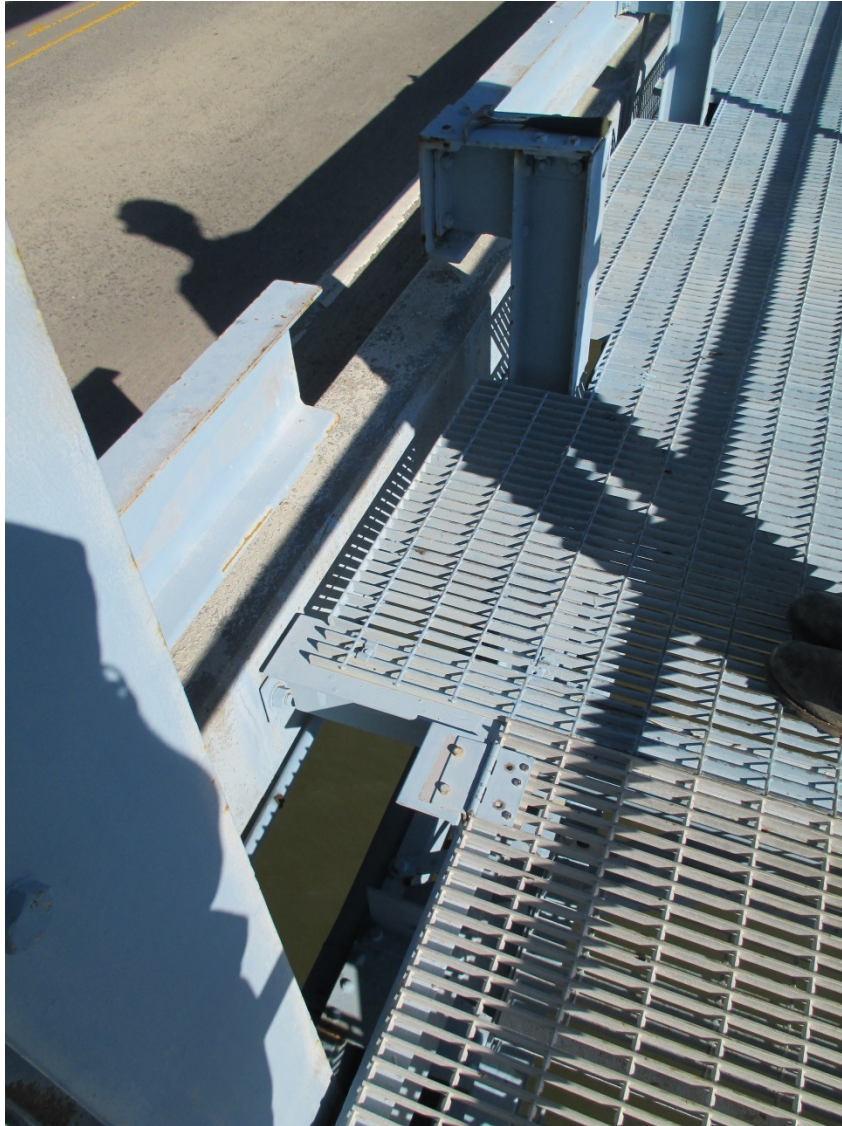
Miscellaneous (Safety Walk) - Photo 20

There is an open section of safety walk with no railing located at L5 of the South Truss presenting a safety concern. Refer to Photo 20.

There is an open section of safety walk with no railing located at L5 of the South Truss presenting a safety concern.
