SCDOT BRIDGE INSPECTION FORM

(008) BRIDGE ID: **072002100200**
(005) ROUTE: BEAUFORT US 21
(006) CROSSING: HARBOR RIVER

**SOUTH CAROLINA DEPARTMENT OF TRANSPORTATION
BRIDGE MANAGEMENT SYSTEM
Bridge Inspection Addendum**

10/14/2016

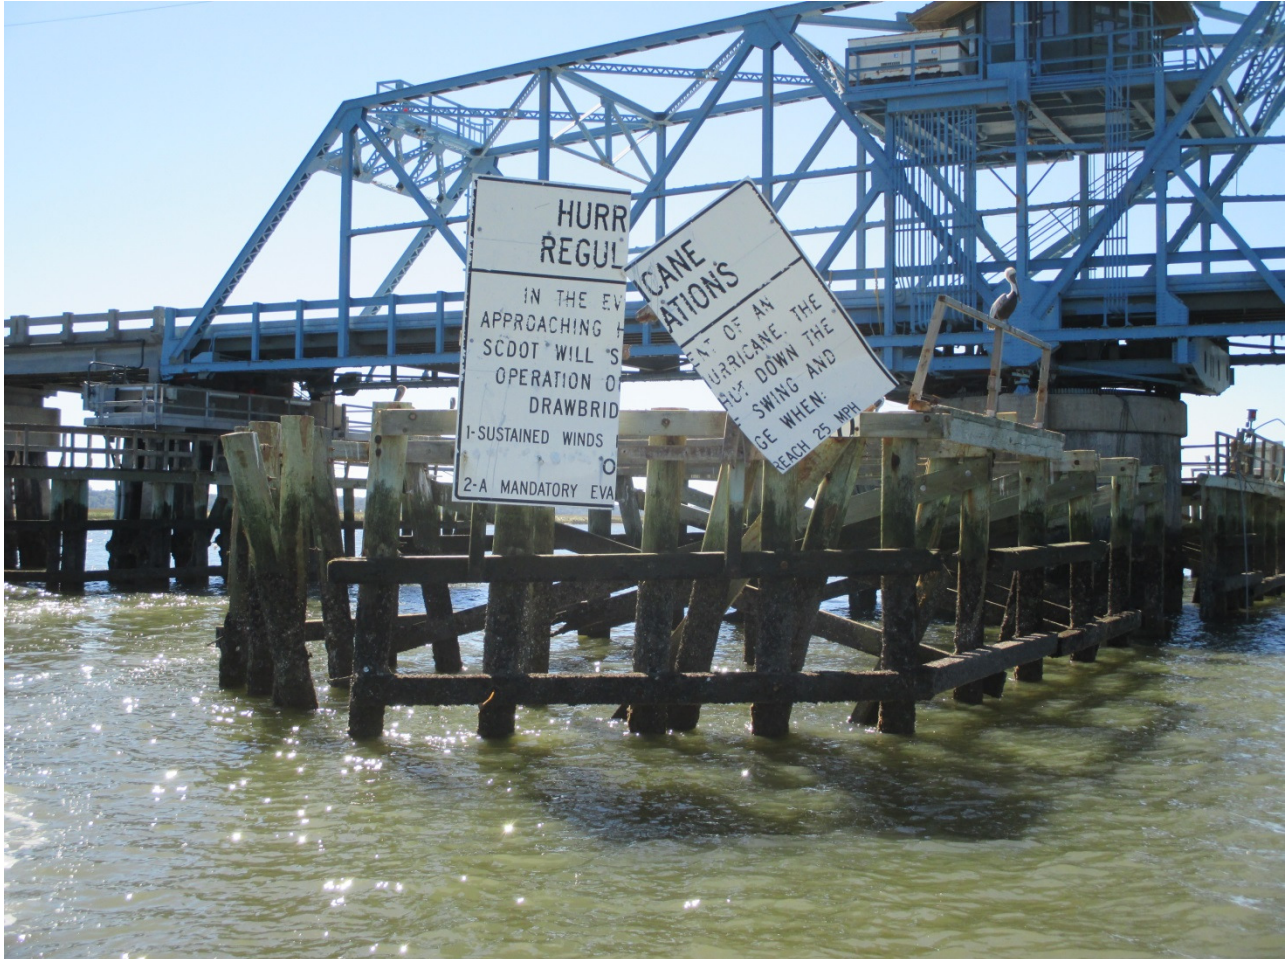
Miscellaneous (Navigation Signage) - Photo 21

The navigation signage on the North side of the bridge was damaged during Hurricane Matthew. Refer to Photo 21.

The navigation signage on the North side of the bridge was damaged during Hurricane Matthew.

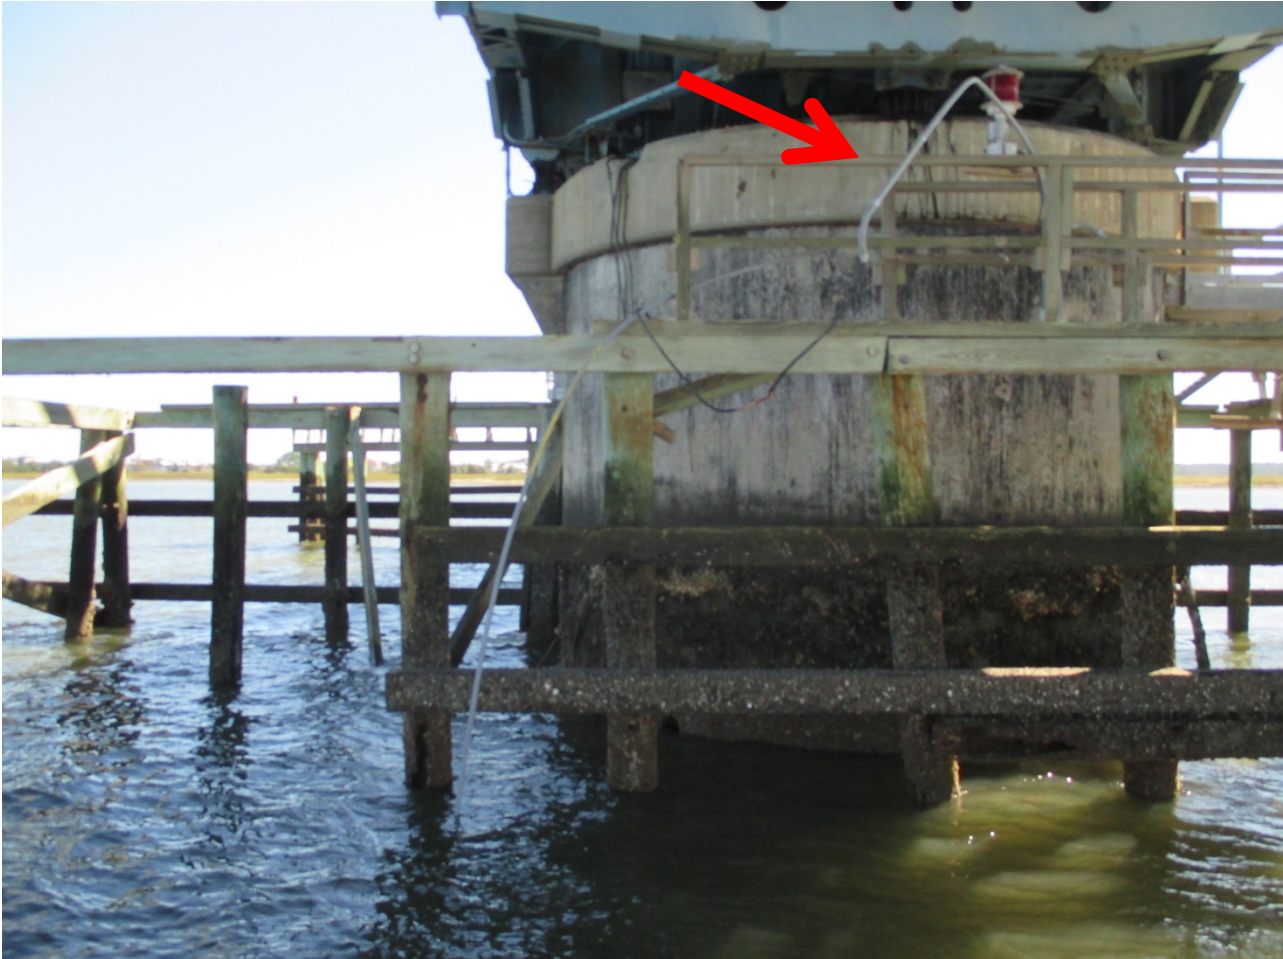
Miscellaneous (Navigation Signage) - Photo 22

The navigation lighting was damaged during Hurricane Matthew and not functioning at the time of inspection. Refer to Photo 22.

The navigation lighting was damaged during Hurricane Matthew and not functioning at the time of inspection. (West side of the Pivot Pier Shown)
