## LEAD-BASED PAINT INVESTIGATION REPORT

S-56 (MONTGOMERY DR.) RBO HORSE CREEK  
CHEROKEE COUNTY, SOUTH CAROLINA

**June 17, 2022**

F&ME Project No.: G6655.001

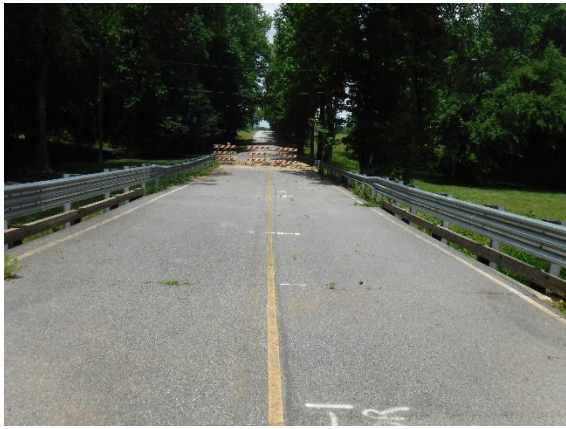
**Photo 1.** Top View of Bridge.

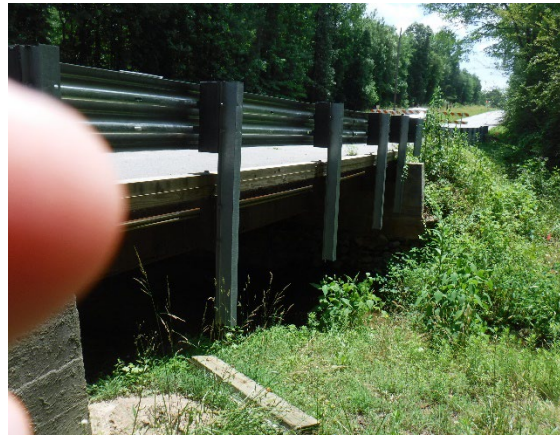
**Photo 2.** Northwest Side View of Bridge.

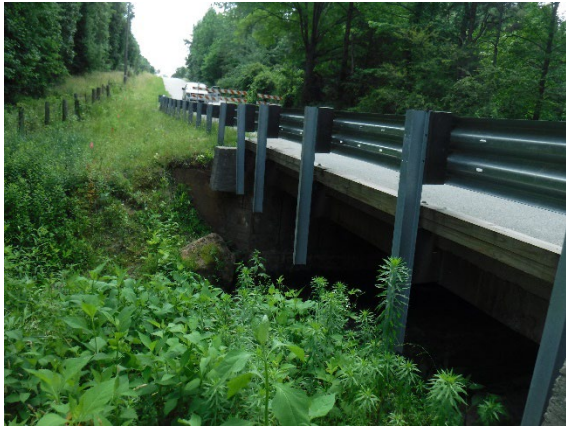
**Photo 3.** Southeast Side View of Bridge.

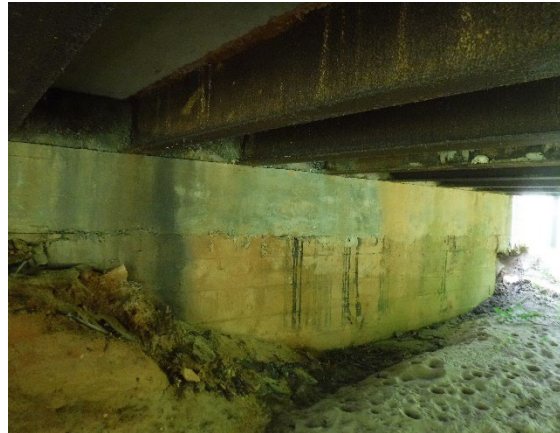
**Photo 4.** Southwest End of Underside of Bridge.

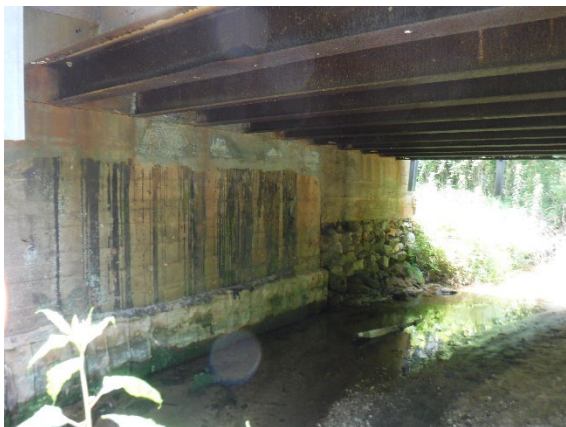
**Photo 5.** Northeast End of Underside of Bridge.

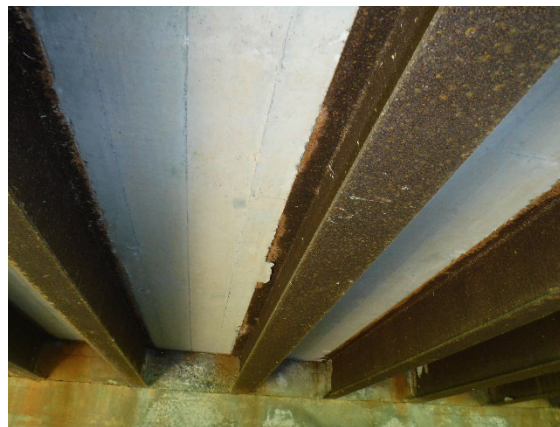
**Photo 6** Underside View of Bridge Deck and Beams.
