Substructure Foundation Investigation Report

SCDOT Structure Number: 2670015400100

Road Designation: S-26-154

Feature Crossing Name: Swash

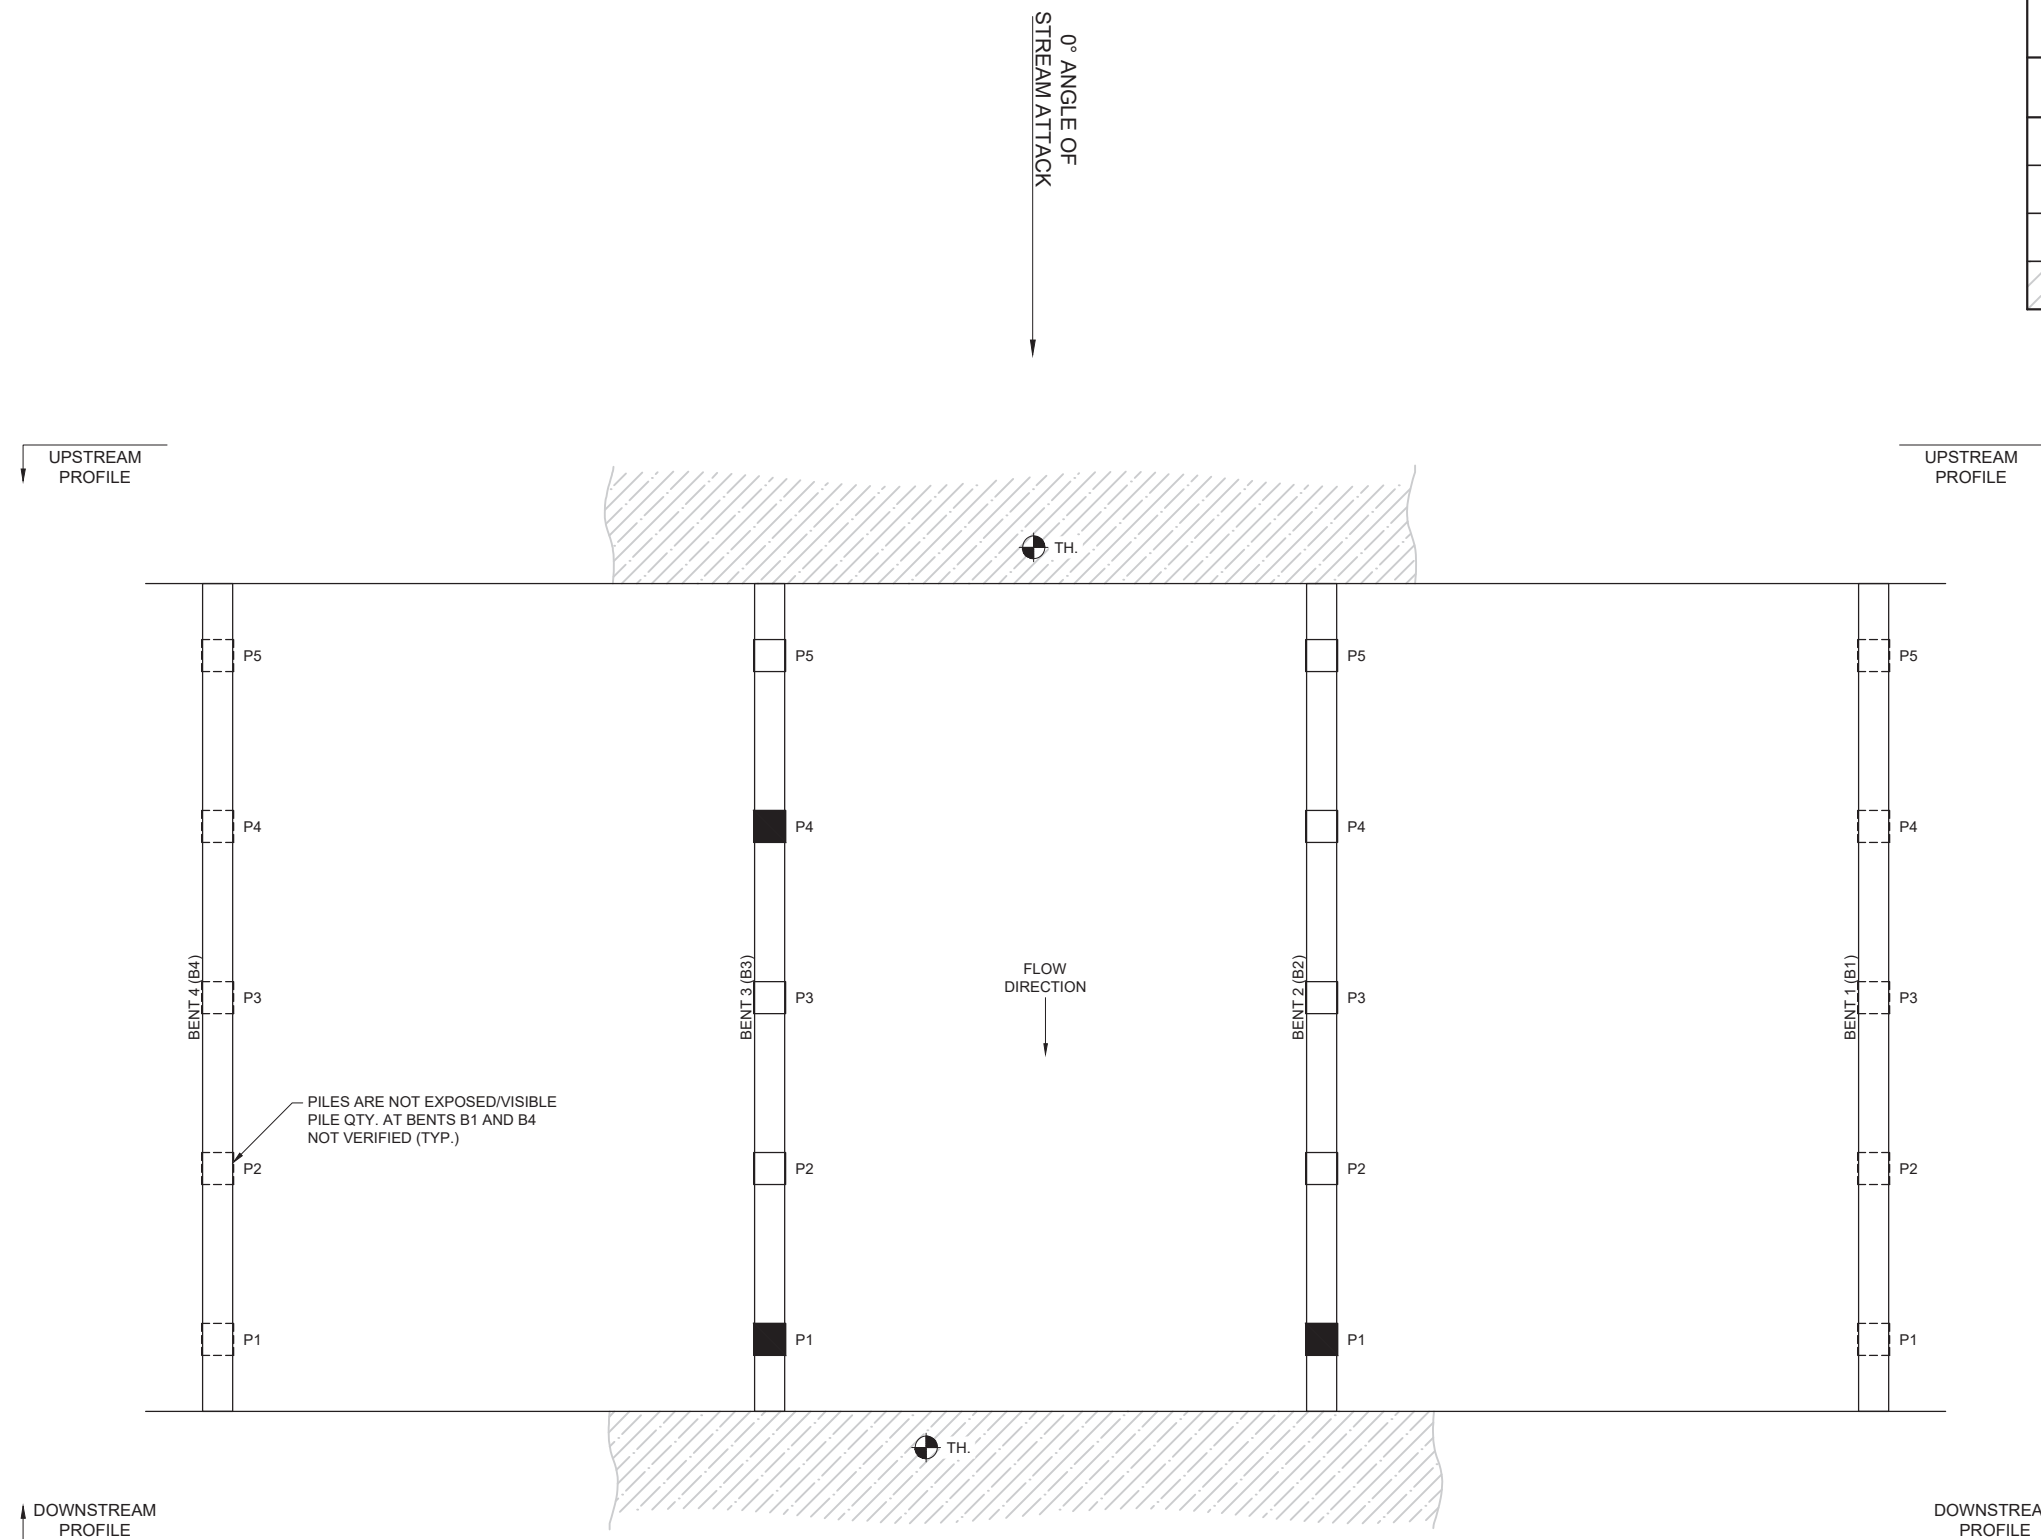
FIGURE 2: FOUNDATION PLAN
 NTS

Pile ID	Pile Size/Diameter (in)	Computed Overall Length (ft)	Top of Pile to Pile Tip (ft)	Exposed Length (ft)	Computed Embedment (ft)	Applicable Notes
B2P1	18.0 x 18.0	70.9	64.4	4.7	59.7	1,2,3,4,5
B3P1	18.0 x 18.0	68.7	62.2	5.6	56.6	1,2,3,4,5
B3P4	18.0 x 18.0	67.2	60.7	5.8	54.9	1,2,3,4,5

For the piles tested, the Bending Wave (BW) test results indicated pile lengths (top of pile to pile tip) from ~60.7 ft. - 64.4 ft and computed embedment lengths from ~54.9 ft. - 59.7 ft. These lengths correspond to the dominant features in the acquired accelerometer data. While the results of pile NDT investigations cannot be completely verified without performing direct length measurements, the consistency of Bending Wave test results at tested locations support the FDH calculated pile lengths. Available information on soil conditions, physical bridge features or tags, and/or experience with nearby bridges are considered along with the results of the testing in coming to these conclusions.

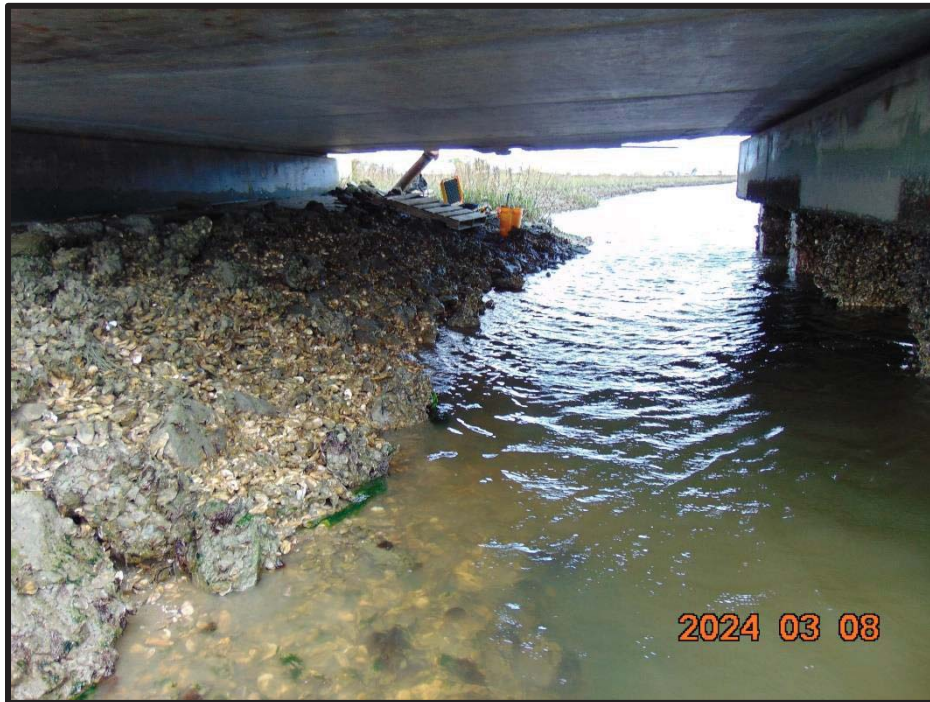
| 1. Any Scouring Noted: | Yes | See Photo(s): 19-25 |

Photo 19: Scour Present Between Bents 3 & 4

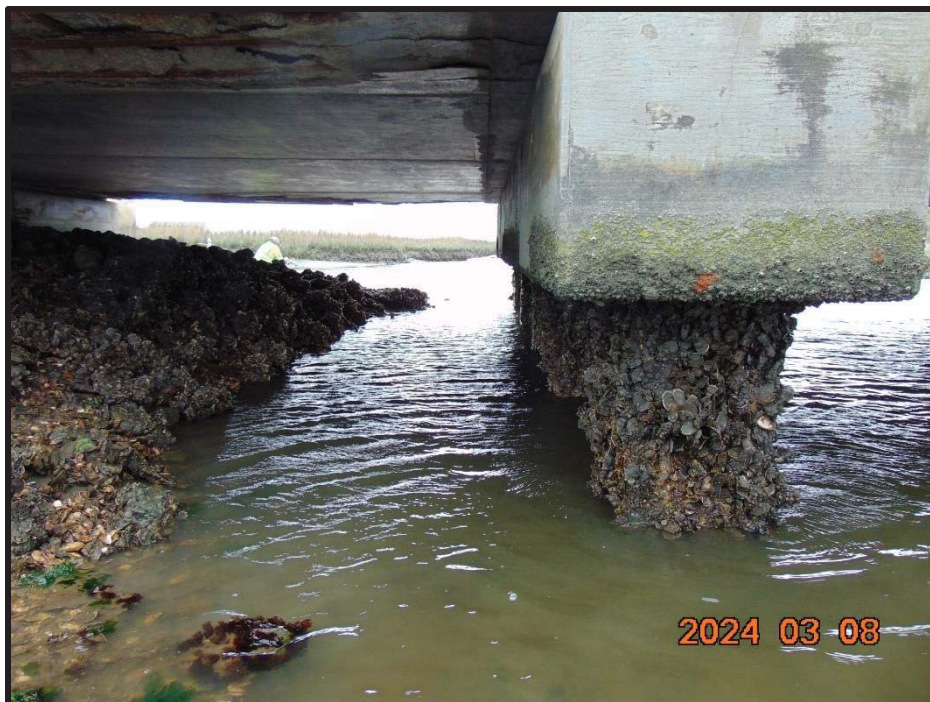
Photo 20: Scour Present Between Bents 1 & 2

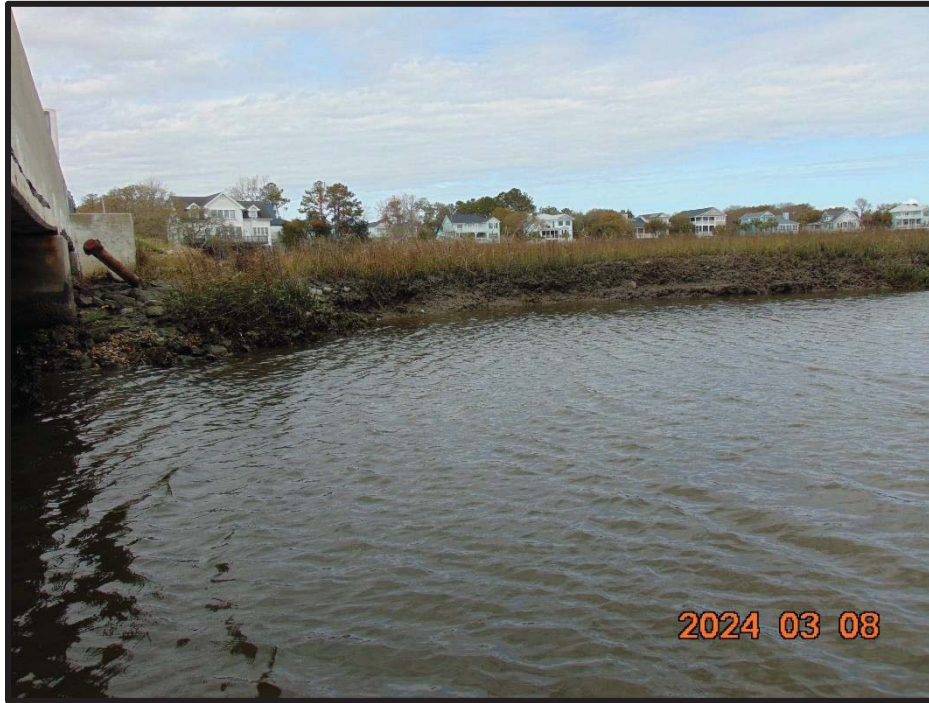
Photo 21: Erosion Present at Upstream Embankment

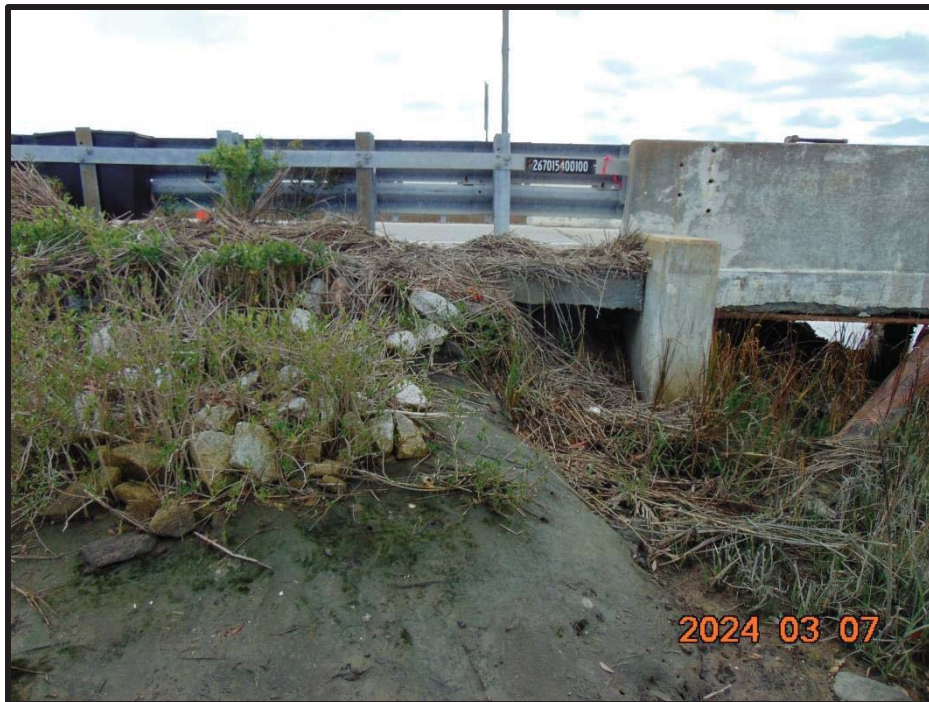
Photo 22: Erosion Present at Abutment 1

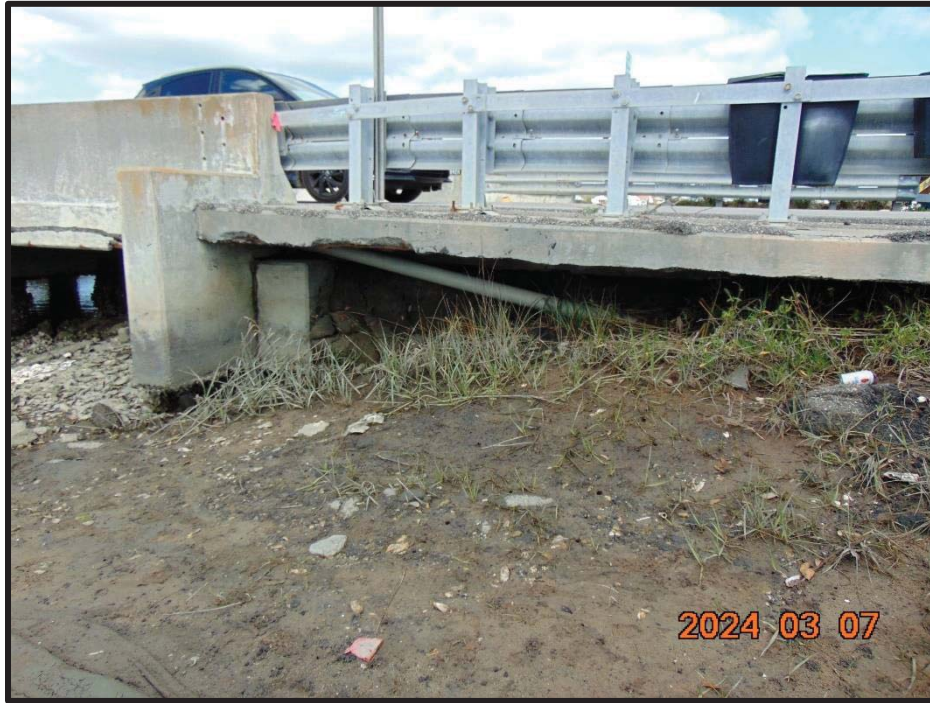
Photo 23: Erosion Present at Abutment 1

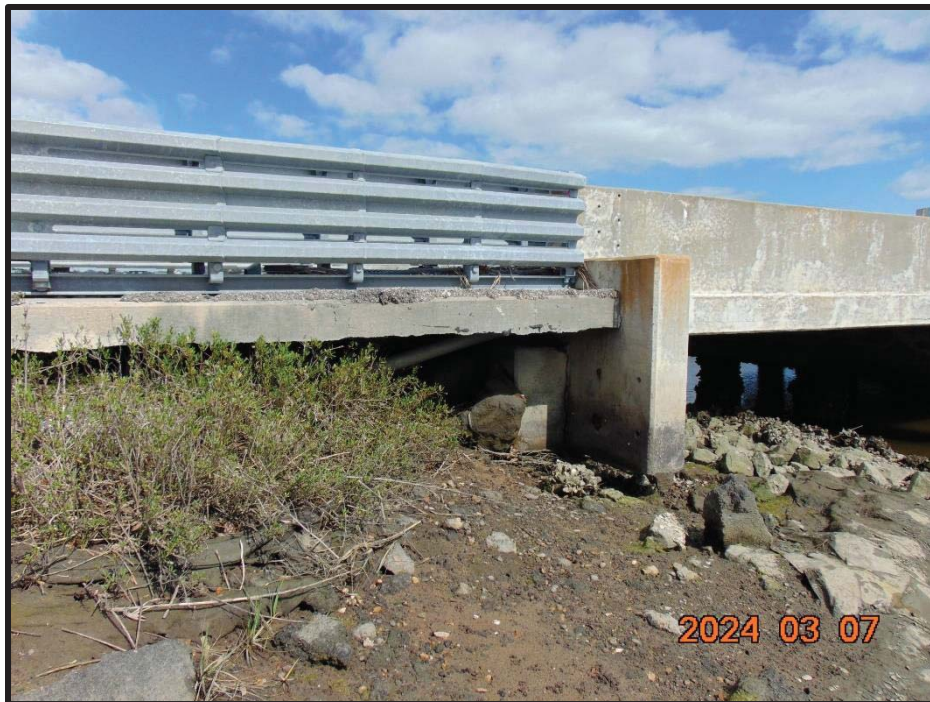
Photo 24: Erosion Present at Abutment 2

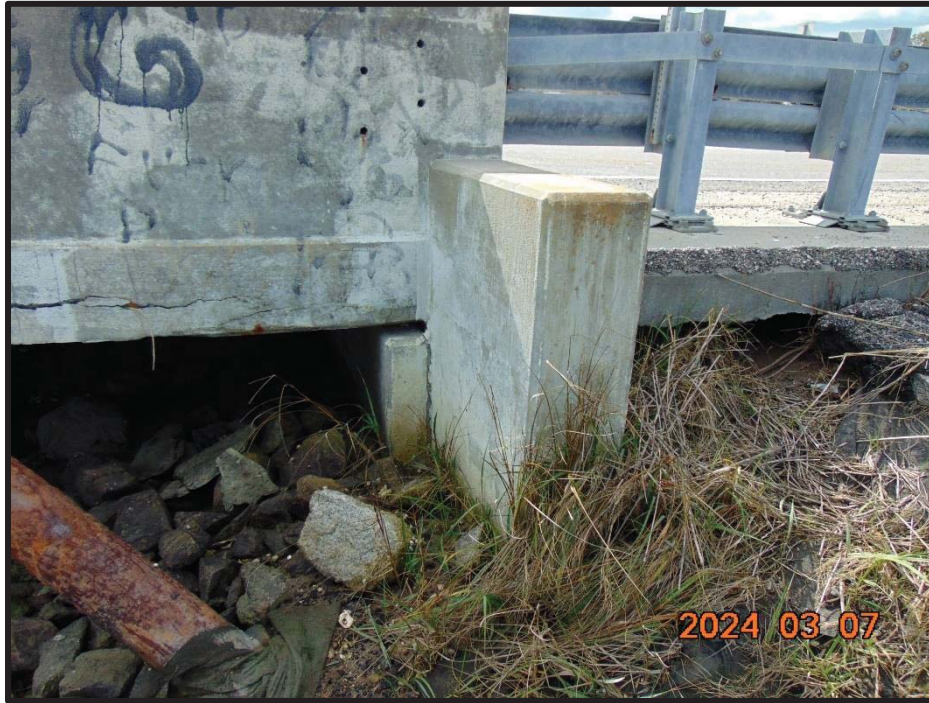
Photo 25: Erosion Present at Abutment 2

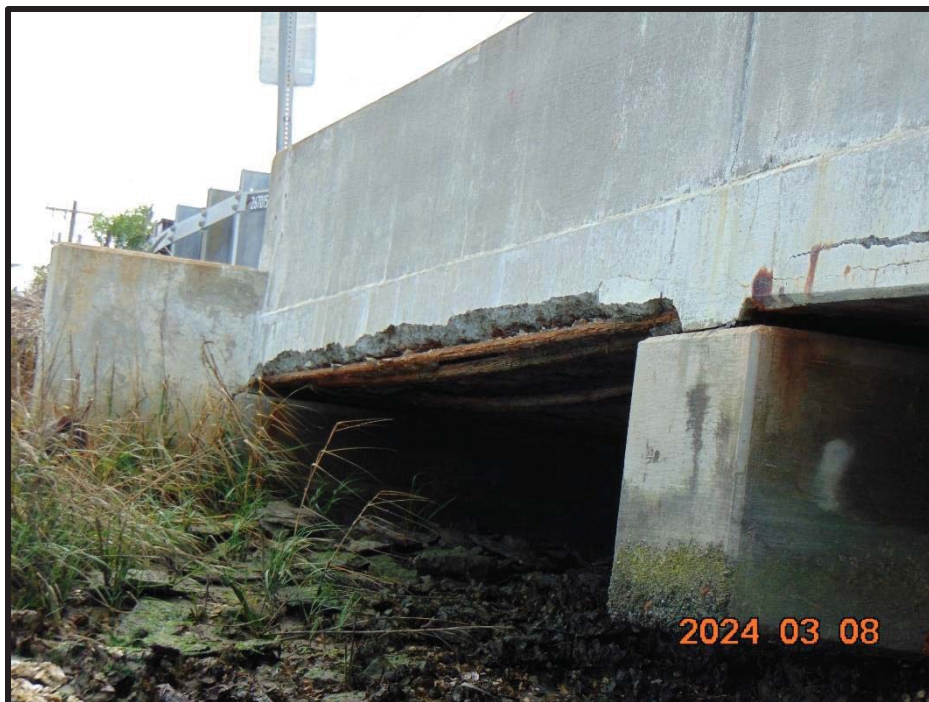
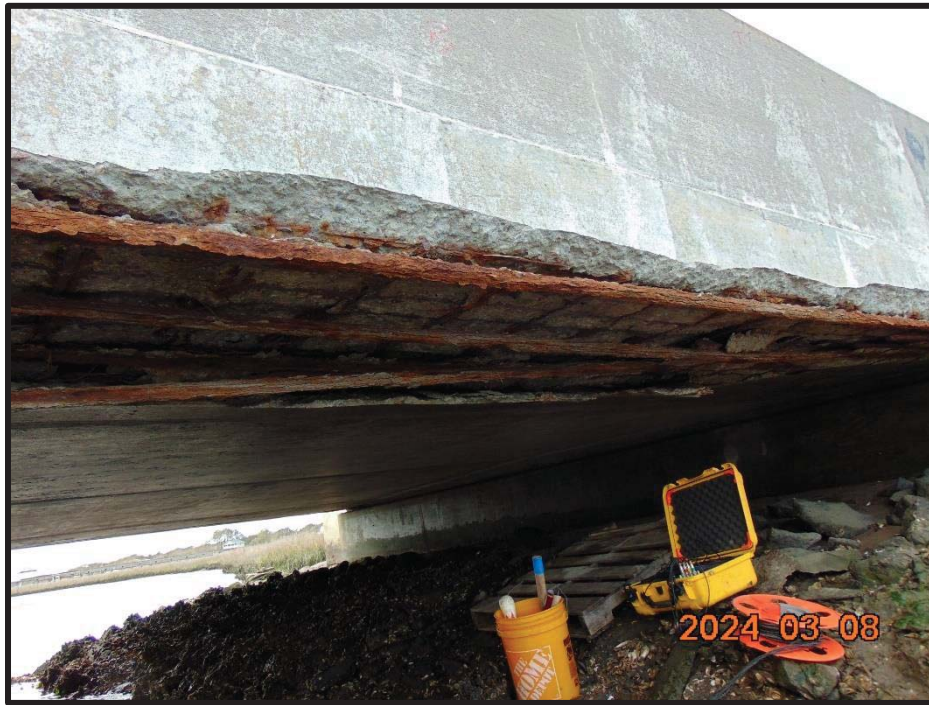
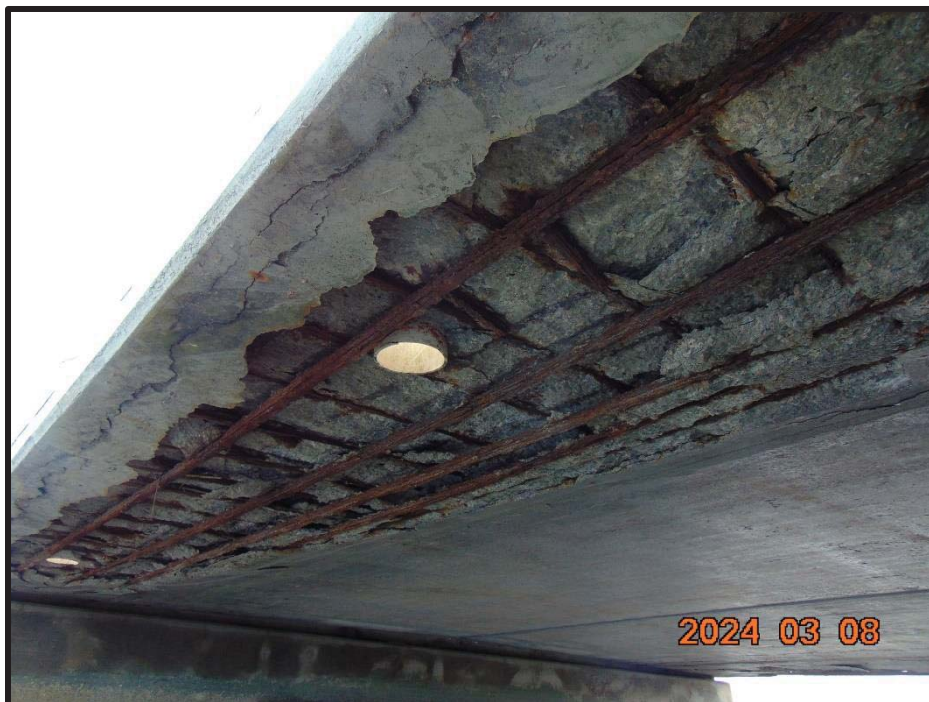
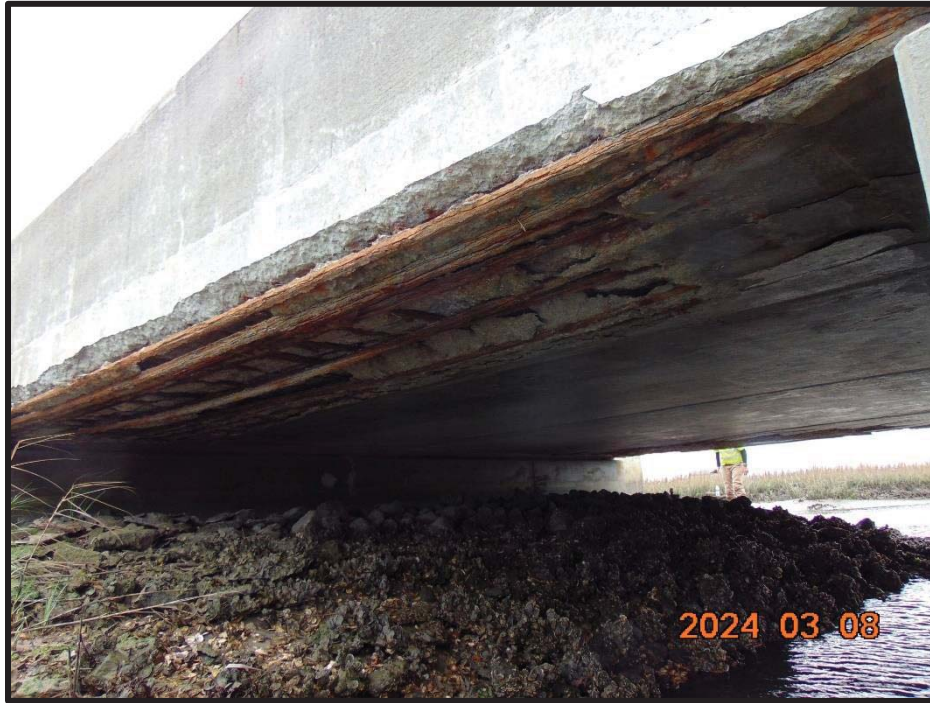
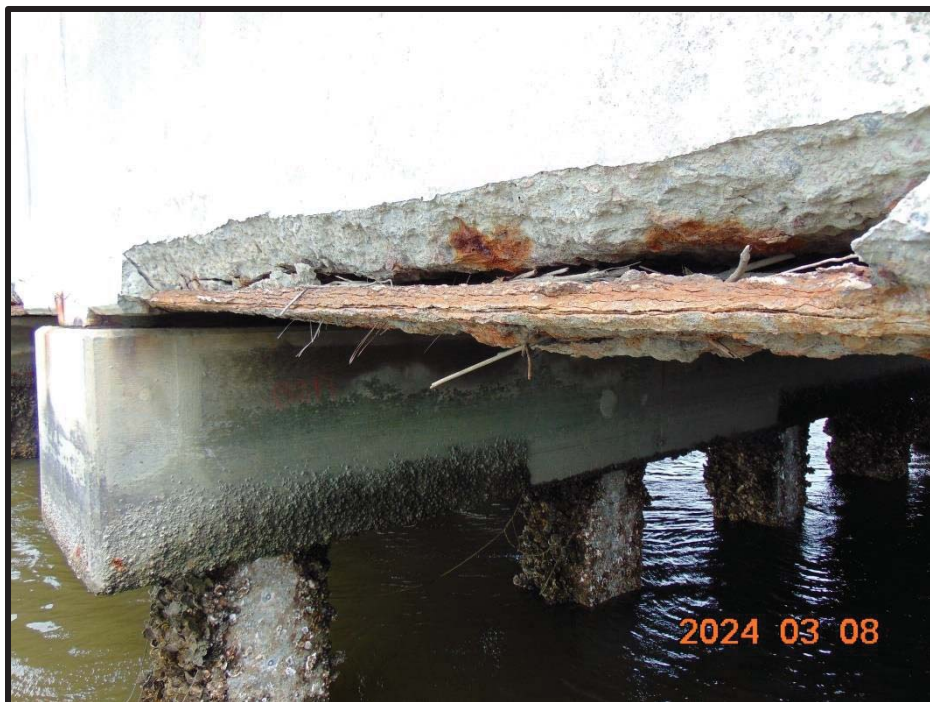
Photo 26: Spalling w/ Exposed Rebar Noted Throughout the Bridge Deck
