Asbestos & Lead Paint Inspection Report

S-23-41 Bridge over Middle Saluda River

December 20, 2023 | Report Number: 7323P180

Re: Asbestos & Lead Paint Inspection Report
SCDOT Bridge Package 19
S-23-41 over Middle Saluda River
Bridge Asset No. 04125
Greenville County, South Carolina
Terracon Project No. 7323P180
SCDOT Project No. P041159
Survey Conducted: November 8, 2023

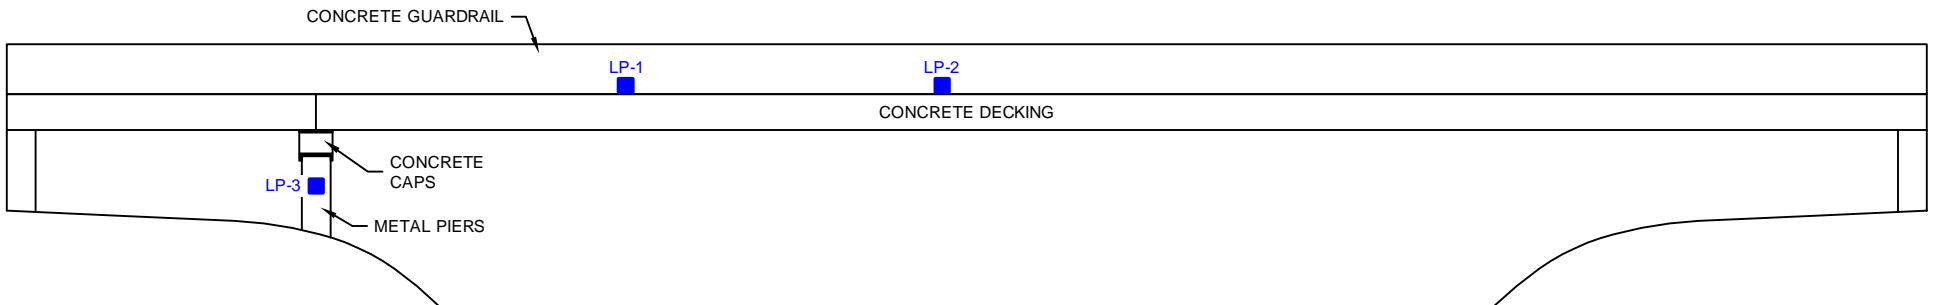
SAMPLE LOCATION PLAN

Lead was not detected above the detection limits in any of the paint chip samples collected. A summary of the lead paint laboratory results is presented in Table 1. The analytical report is included in Appendix B.

- No further considerations are required regarding lead paint. Debris may be disposed as demolition debris.

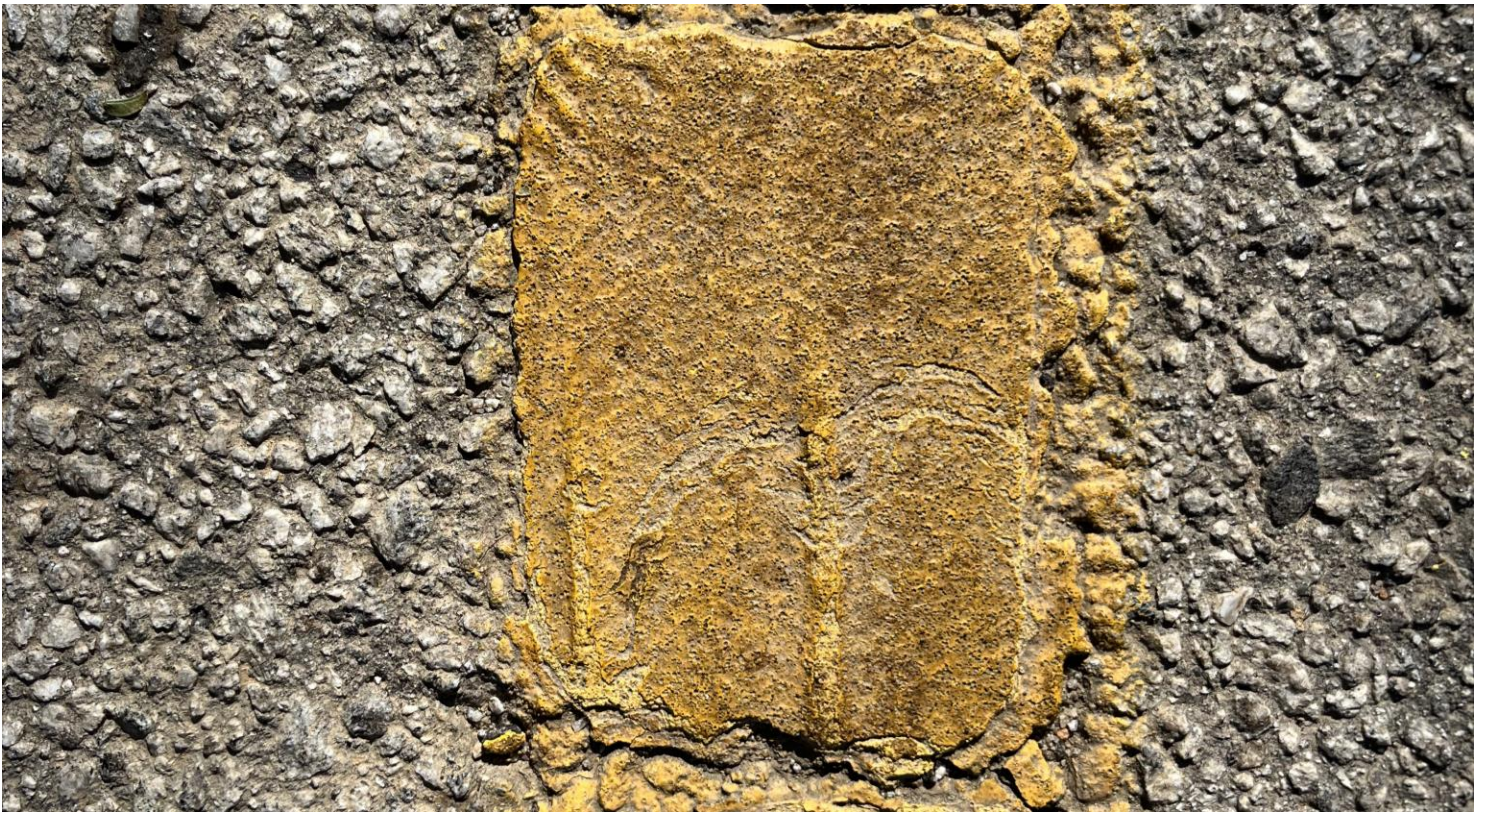
PHOTO # 3 View of LP-1 yellow stripe paint.

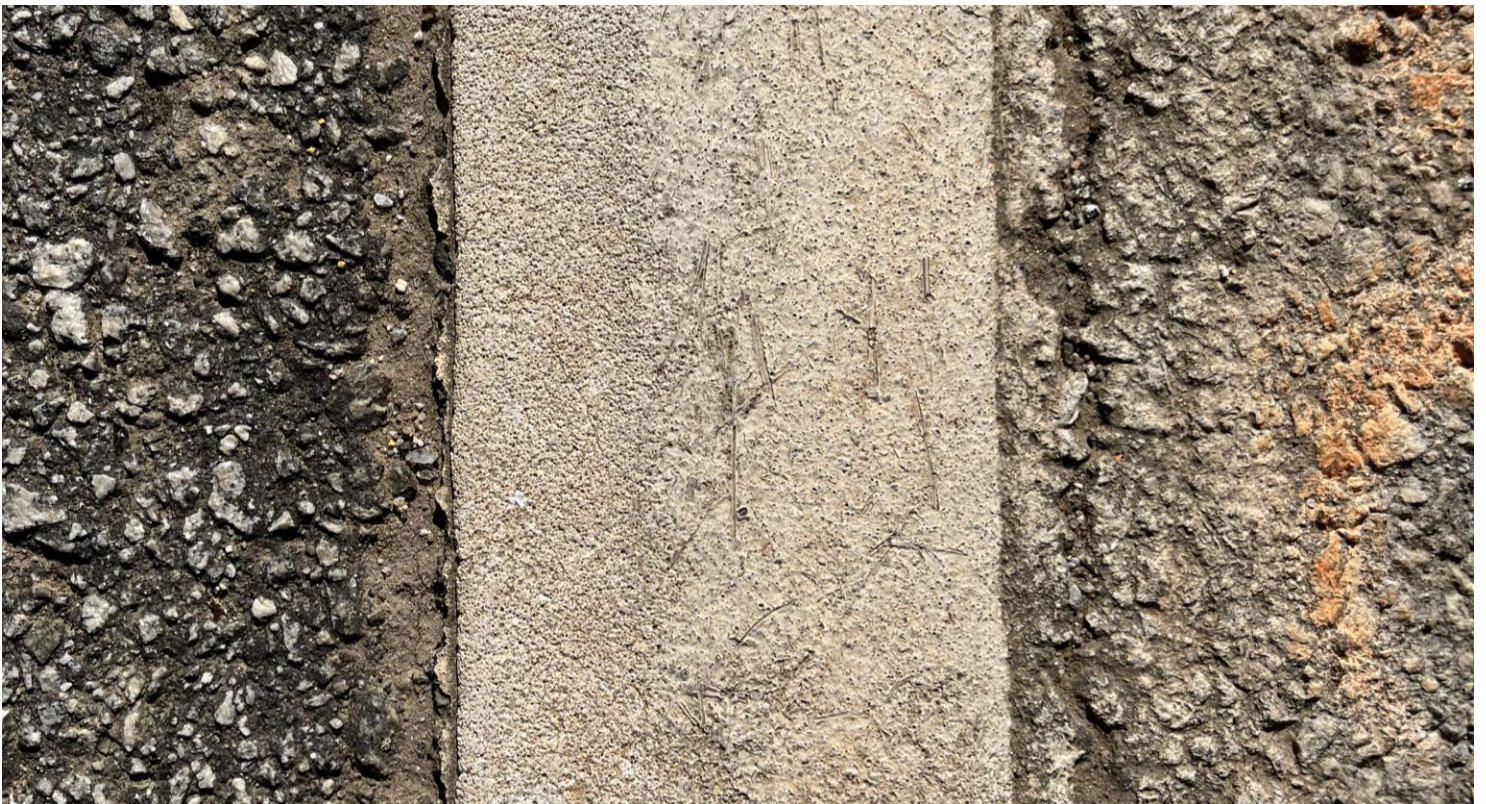
PHOTO # 4 View of LP-2 white stripe paint.

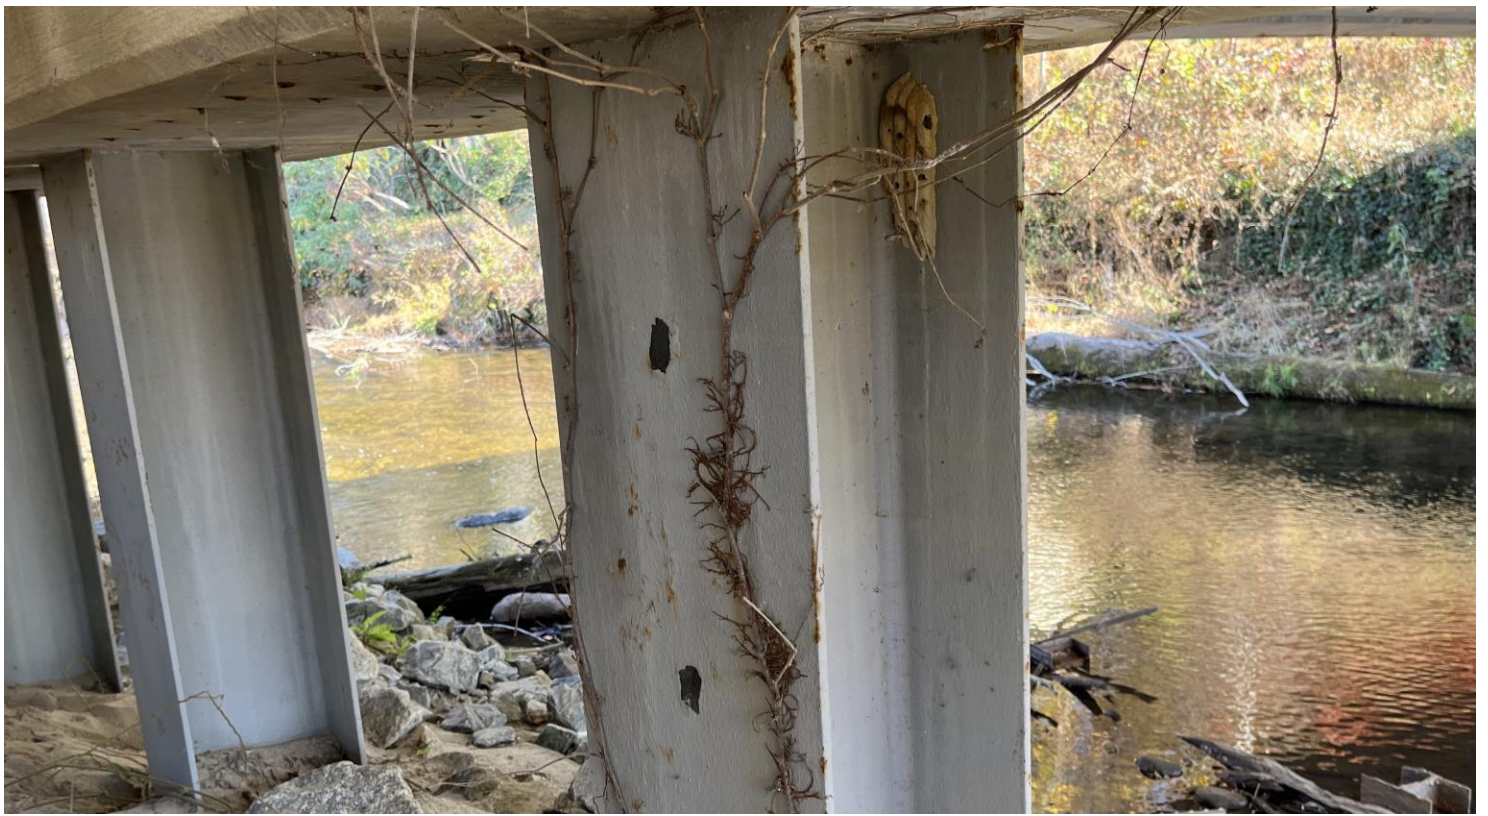
PHOTO # 5 View of LP-3 Grey pier paint.
