Asbestos & Lead Paint Inspection Report

S-23-40 Bridge over Saluda Overflow

June 27, 2024 | Report Number: 7323P180 SCDOT Project No. P043137

Re: Asbestos & Lead Paint Inspection Report
Bridge Package 19
Bridge Asset No. 02541
Greenville County, South Carolina
Terracon Project No. 7323P180
SCDOT Project ID: P043137
Survey Conducted: June 17, 2024

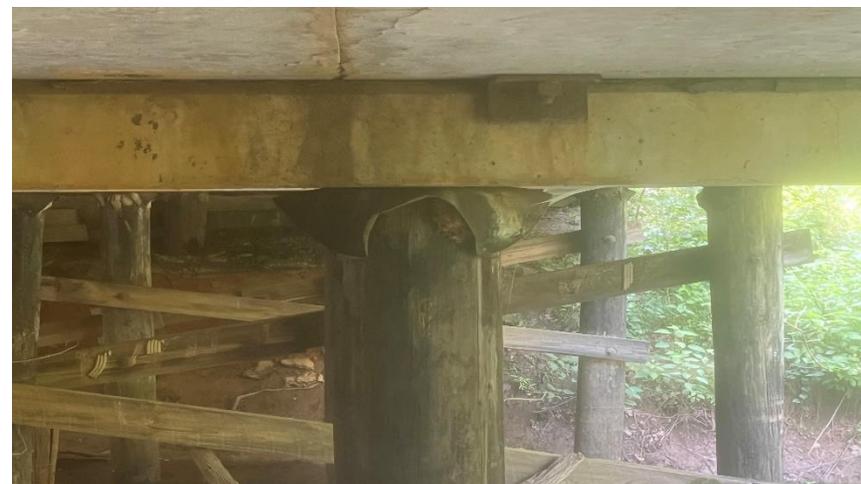
HA	Approx. Quantity*	Samples Collected	Description	Material Location	Lab Result	Category	Condition
1	50 SF	3	Shingle Vibration Dampener	Between Piers and Pier Caps	NAD	Misc.	NF, Good
2	400 SF	3	Tar and Felt Vibration Dampener	Between Pier Caps and Decking	NAD	Misc.	NF, Good

Photo 3: HA #1: Shingle Vibration Dampener.

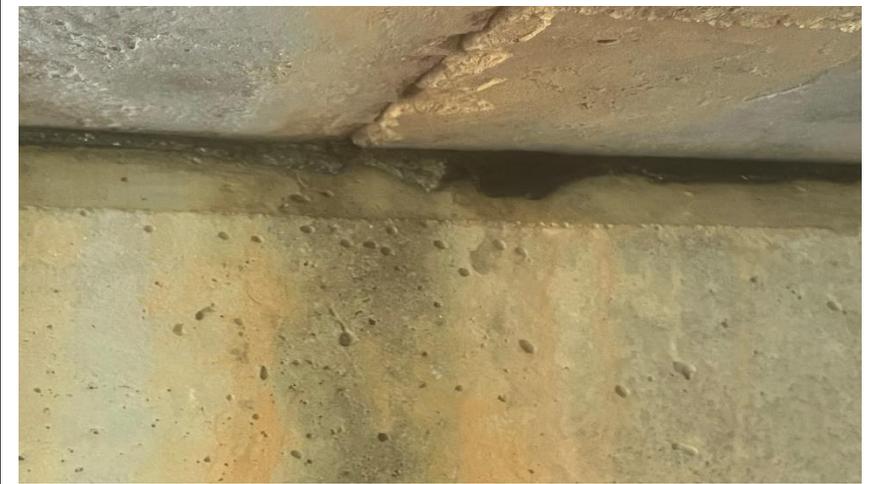
Photo 4: HA #2: Tar and Felt Vibration Dampener.

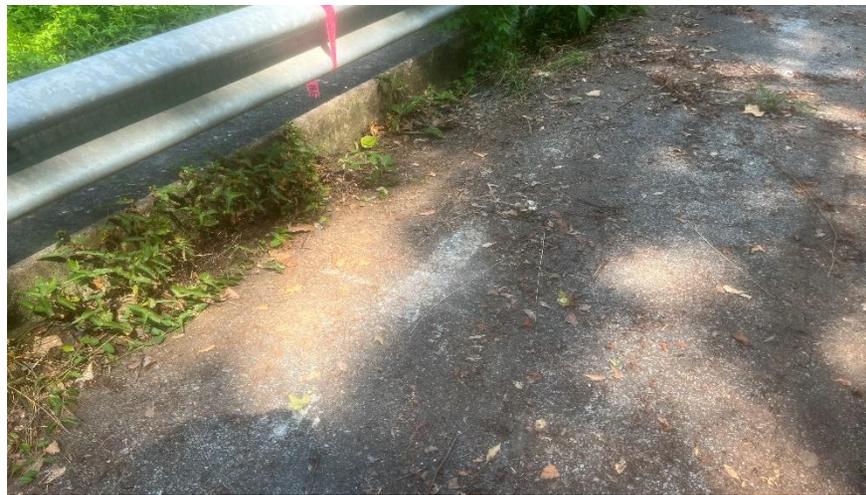
Sample Number	Description	Location	Lab Result
LP-1	White Paint	Shoulder Lines	0.0081%
LP-2	Yellow Paint	Median Lines	<0.0080%
LP-3	Gray Paint	Pier	<0.0080%
LP-4	Orange Paint	Metal Brackets	56%

Photo 5: LP-1: White Paint on shoulder line.

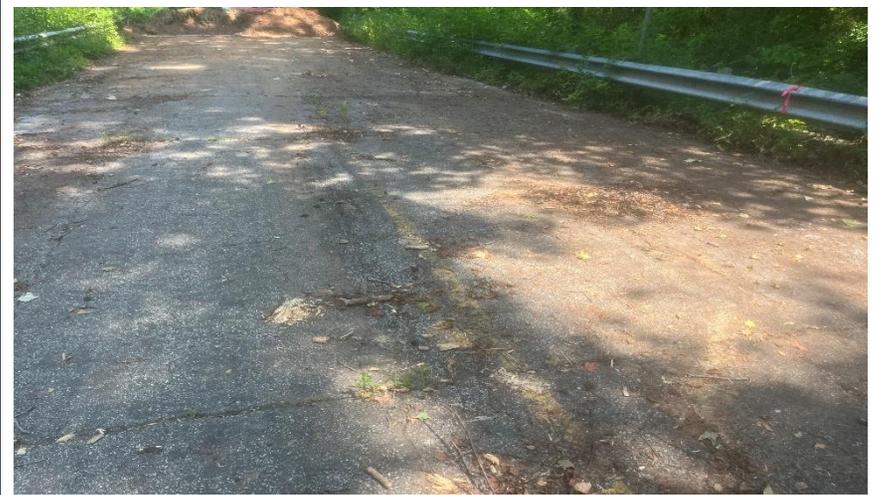
Photo 6: LP-2 Yellow Paint on median line.

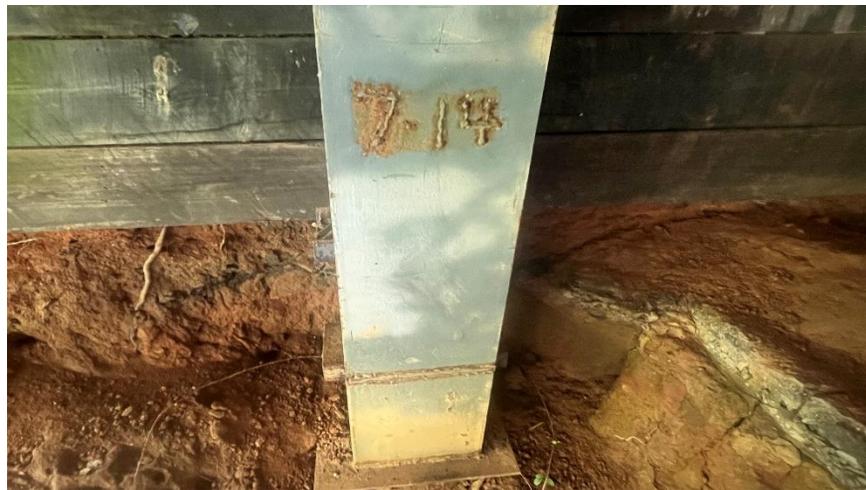
Photo 7: LP-3 Gray Paint on pier.

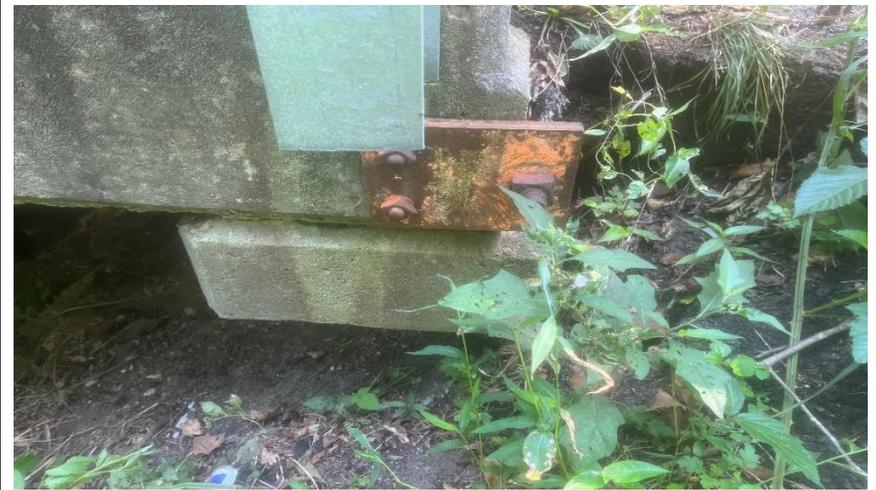
- LP-4 Orange on Metal Bracket (56% by weight)

Photo 8: LP-4 Orange Paint on metal bracket.

- **Dispose of lead painted debris in a Class II Landfill.** - SCDHEC regulations require that lead-painted demolition debris be disposed in a permitted Class II landfill. Landfills should be contacted to determine their specific disposal requirements. Metal components painted with lead-based paint may be recycled however the recycler should be contacted to determine their specific requirements.

- **Inform contractors and workers of presence of lead in paints** - Occupational Safety and Health Administration Lead Regulations apply to actions initiated on lead containing materials. This regulation applies to lead concentrations greater than the analytical limit of detection. This regulation provides exposure levels on airborne lead and does not reference the concentration of lead in paint or other lead-containing materials. Workers performing work on surfaces which have any lead concentration should be notified to comply with OSHA requirements. The full OSHA lead standard should be referenced for compliance.
