Asbestos & Lead Paint Inspection Report

S-23-40 Bridge over South Saluda River

December 20, 2023 | Report Number: 7323P180

Re: Asbestos & Lead Paint Inspection Report
Bridge Package 19
Bridge Asset No. 02540
Greenville County, South Carolina
Terracon Project No. 7323P180
SCDOT Project ID: P041160
Survey Conducted: November 16, 2023

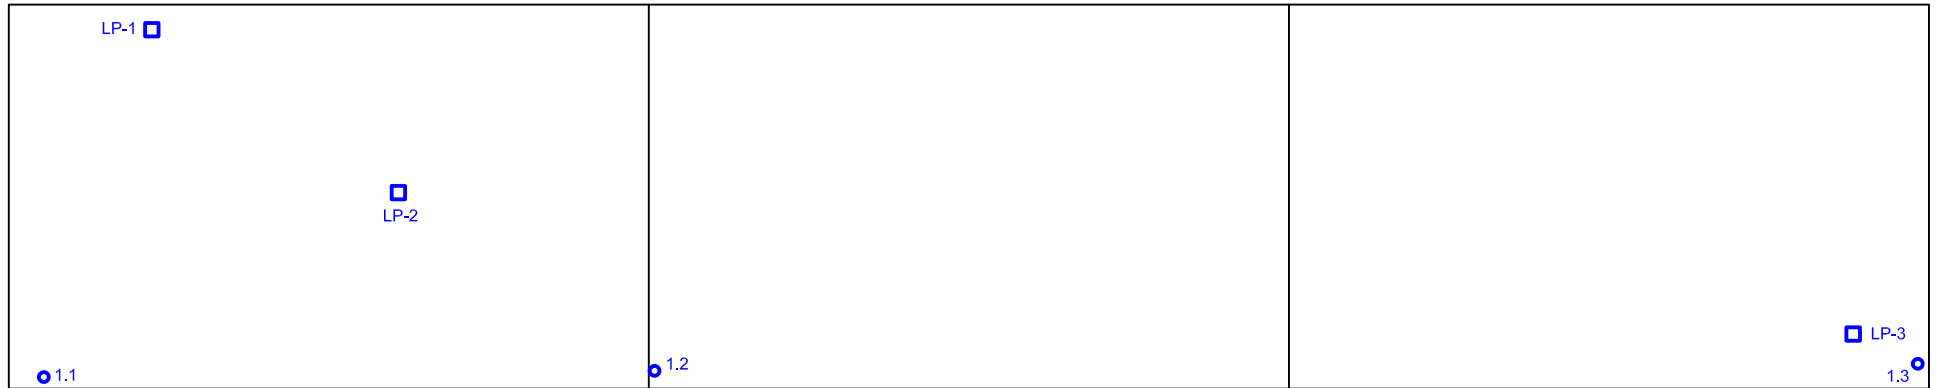
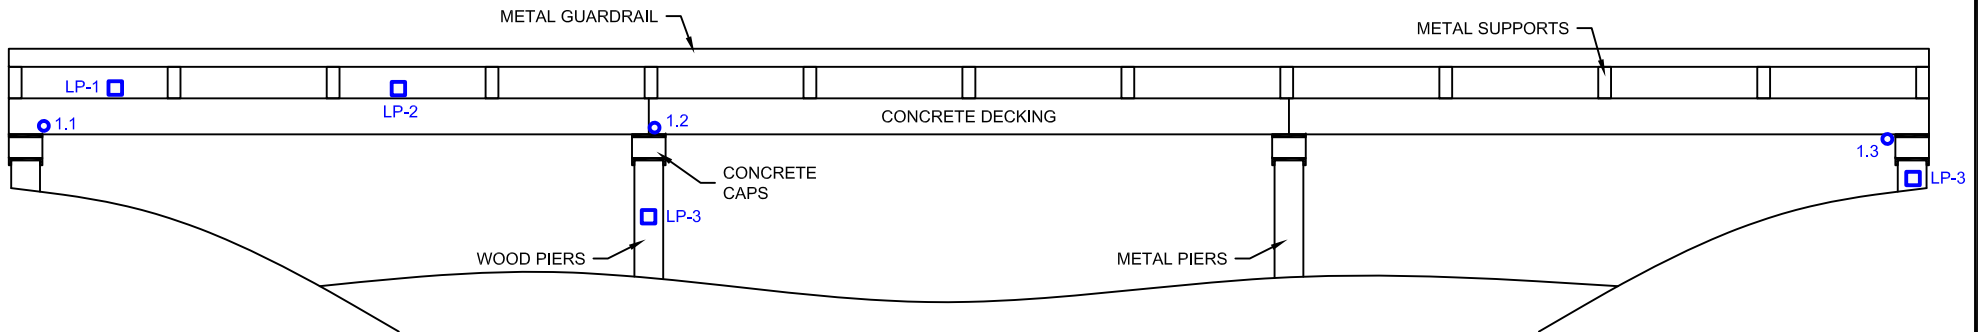
SAMPLE LOCATION PLAN

See Figure 2 for sample locations

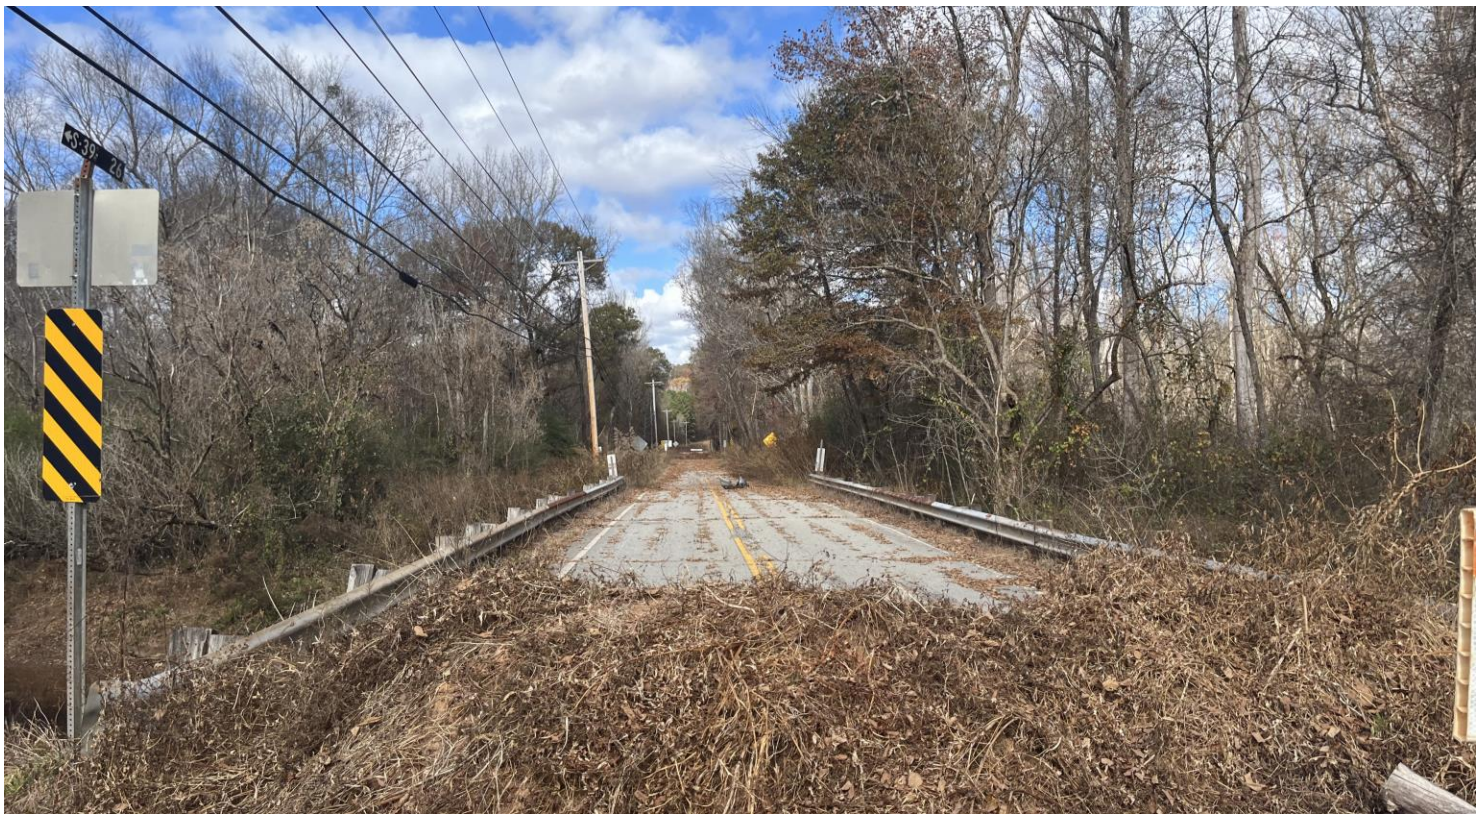
PHOTO # 1 View of the bridge facing to the north with LP-1 yellow stripe paint in view.

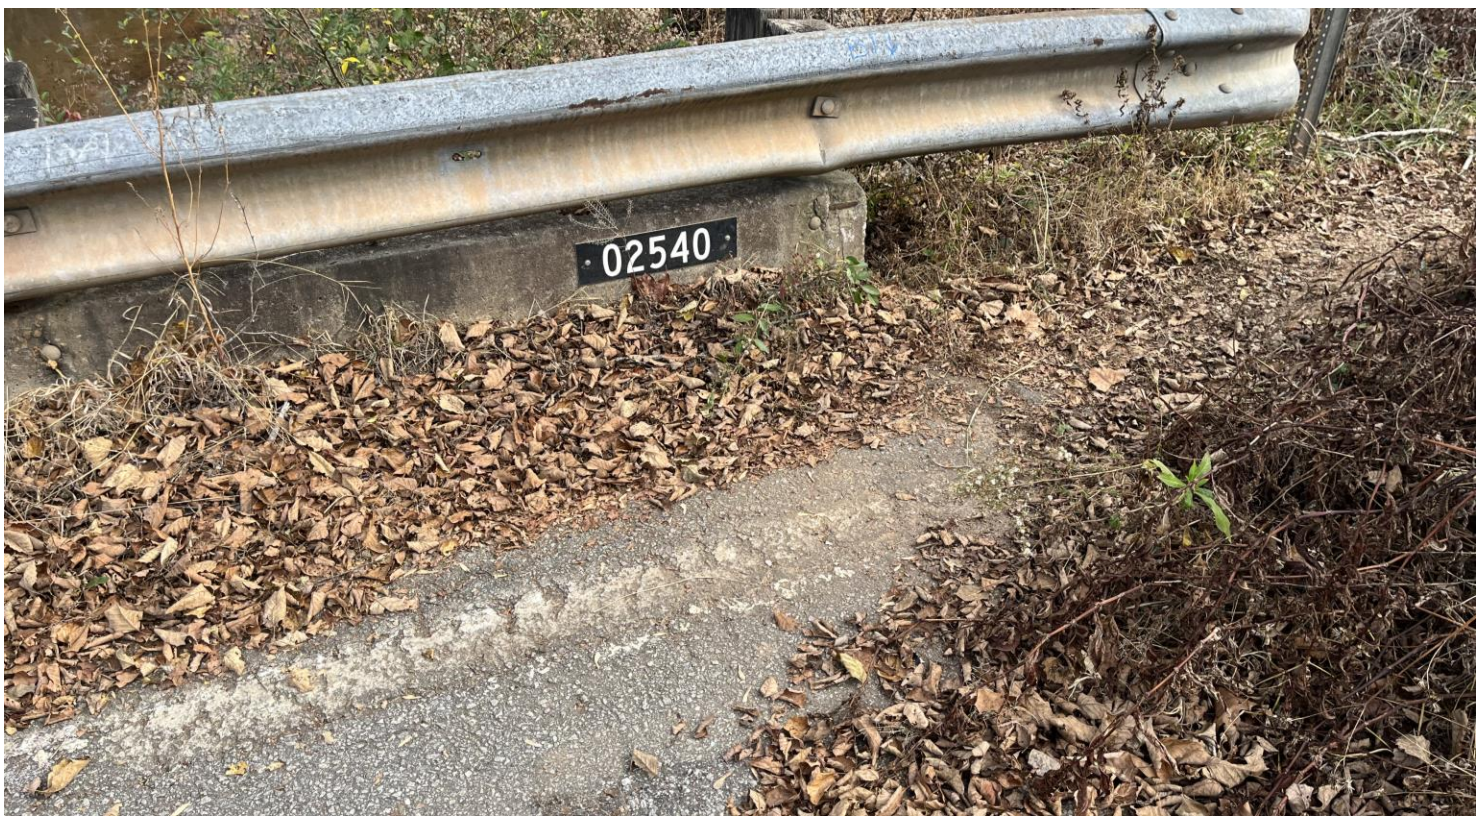
PHOTO # 3 View of bridge asset number and LP-2 White stripe paint

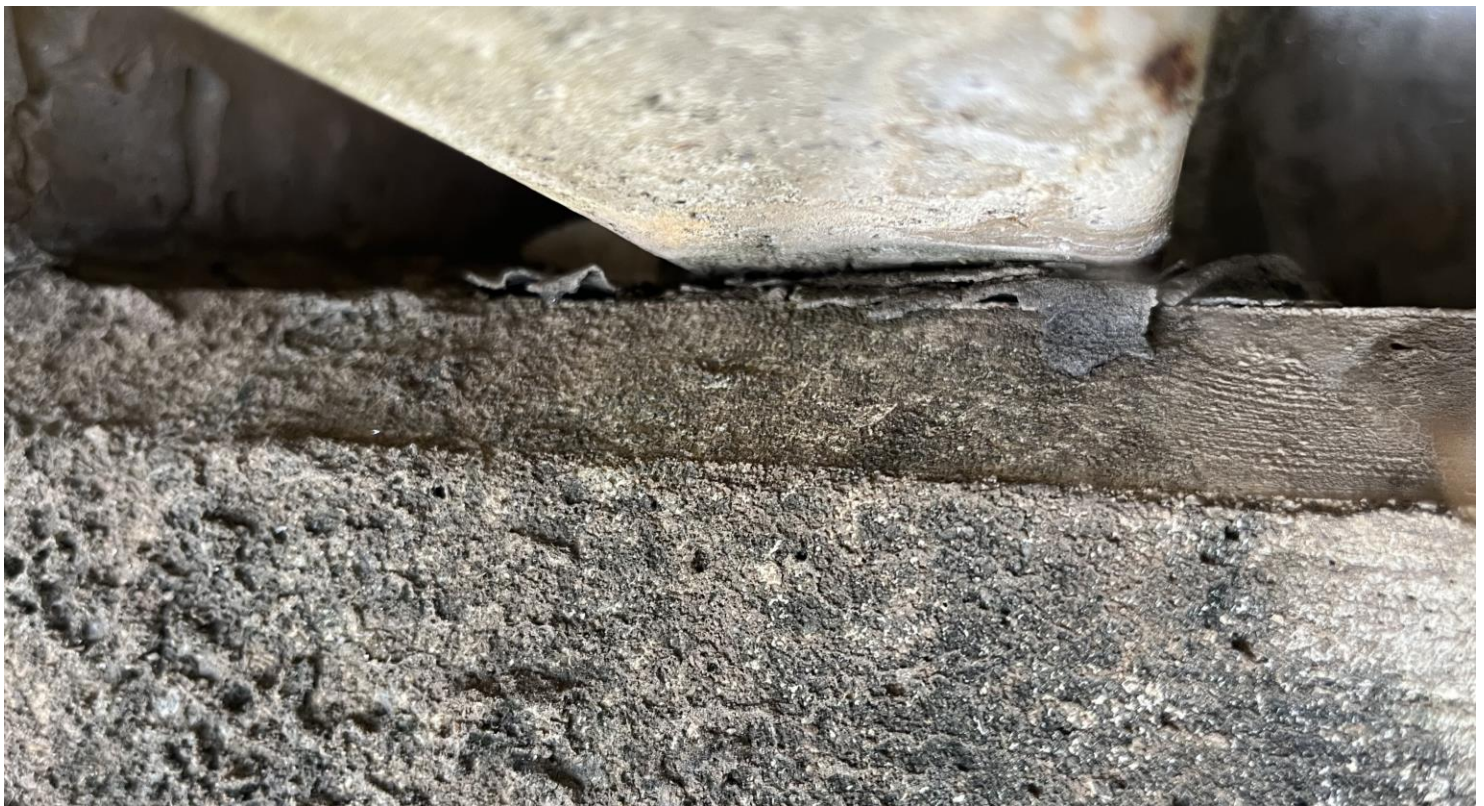
HA	Approx. Quantity* (ft ²)	Samples Collected	Description	Material Location	Lab Result	Category	Condition
1	150	3	Thin felt vibration barrier	Between piers and pier caps, Between pier caps and decking	NAD	Misc.	F, Good

Homogeneous Material 1 is a NOB material. Negative PLM results were confirmed with TEM analysis.

PHOTO # 4 View of HA #1 thin felt vibration dampener.

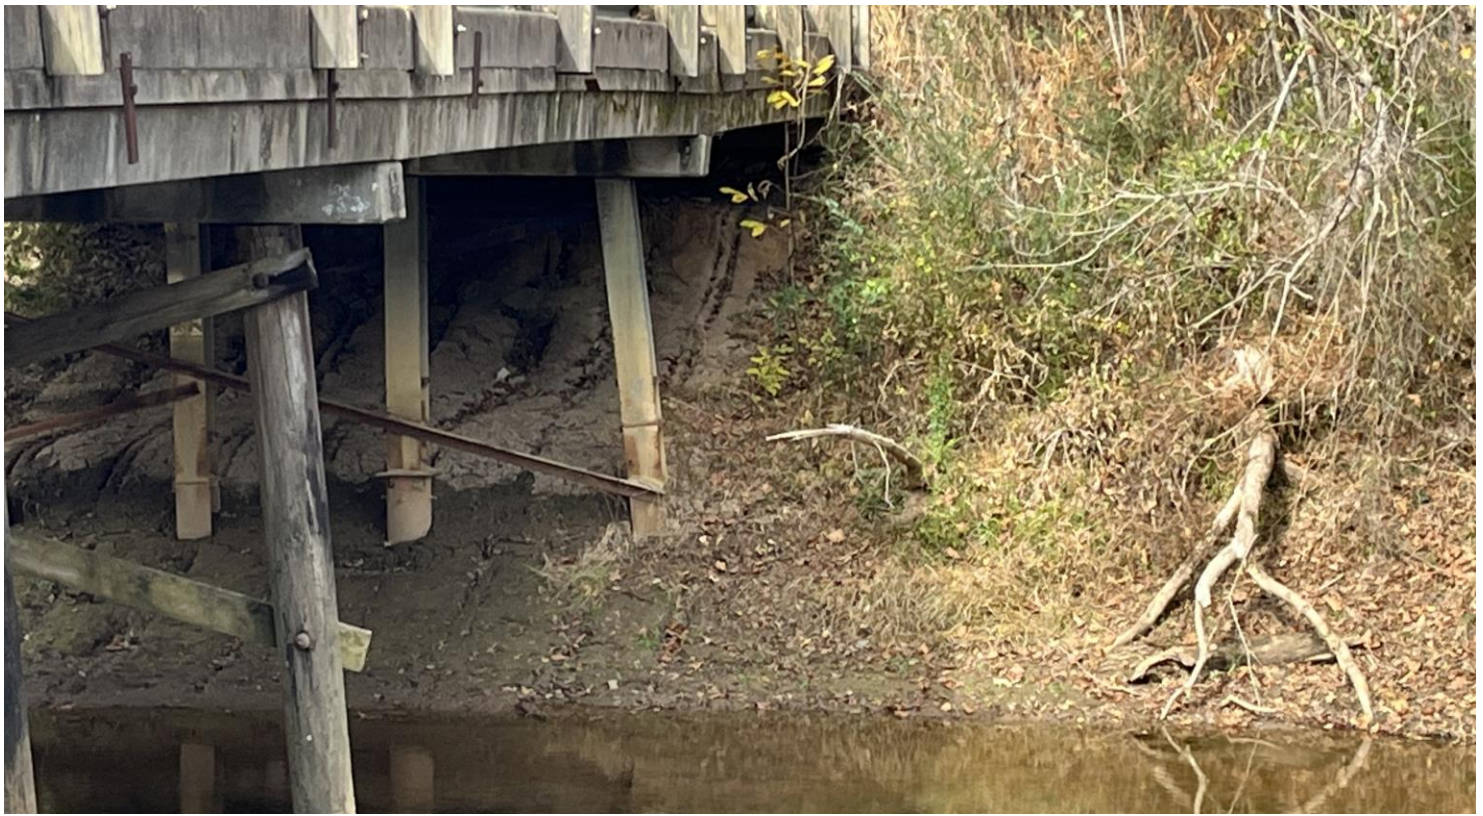
PHOTO # 5 View of LP-3 grey pier paint.
