# Asbestos & Lead Paint Inspection Report

S-39-26 Bridge over Tributary to Saluda River

June 27, 2024 | Report Number: 7323P180 SCDOT Project No. P043138

Re: Asbestos & Lead Paint Inspection Report  
SCDOT Bridge Package 19  
S-39-26 over Tributary to Saluda River  
Asset No. 05605  
Pickens County, South Carolina  
Terracon Project No. 7323P180  
SCDOT Project No. P043138  
Survey Conducted: June 17, 2024

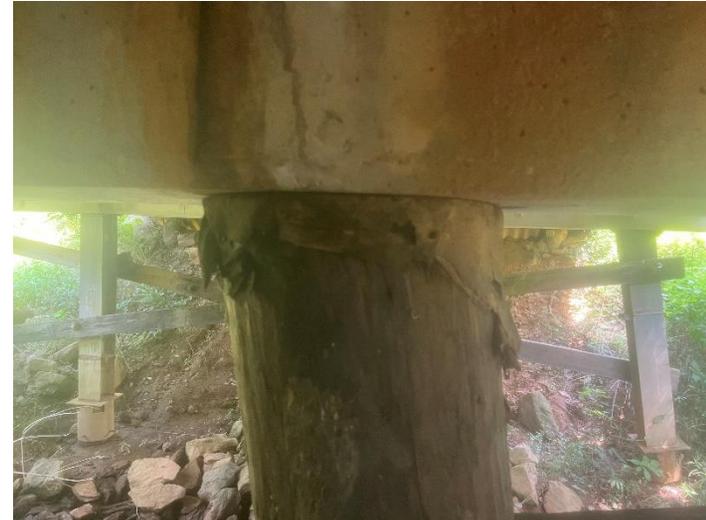
**Photo 2:** HA #1: Felt Vibration Dampener

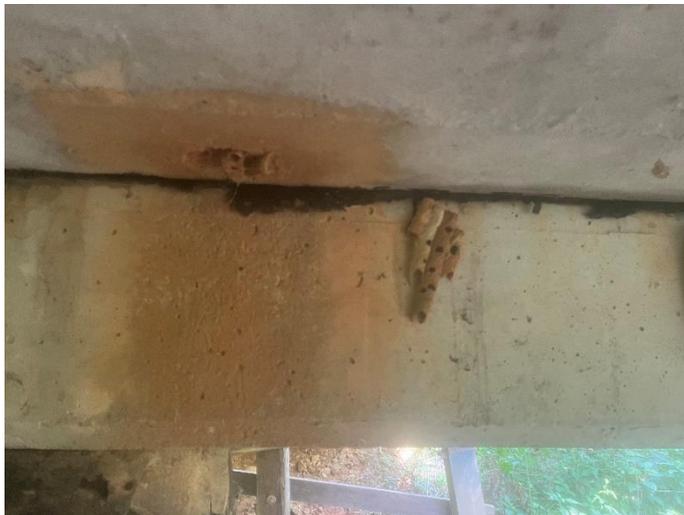
**Photo 3:** HA #2: Tar and Felt Vibration Dampener

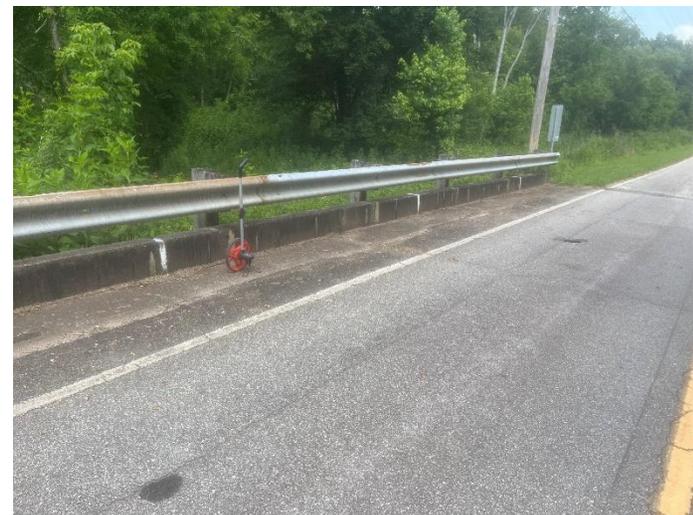
**Photo 4:** LP-1: White Road Paint

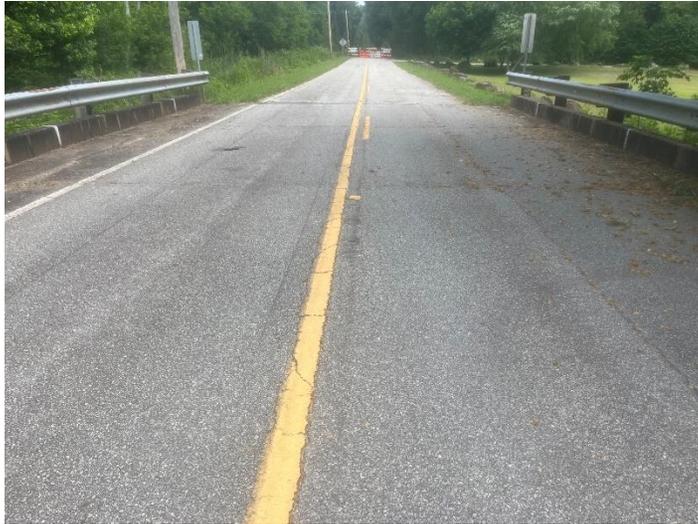
**Photo 5:** LP-2: Yellow Road Paint

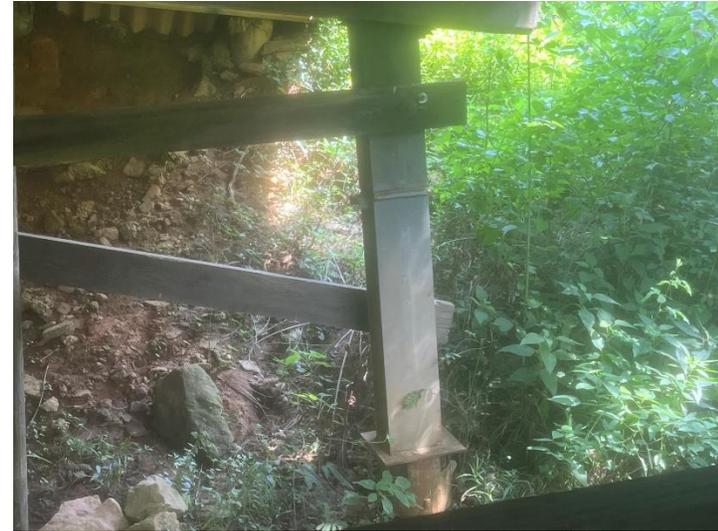
- LP-3 Gray on Steel Pier (0.62% by weight)
- LP-4 Orange on Metal Bracket (49% by weight)

**Photo 6:** LP-3: Gray Pier Paint

- **Dispose of lead painted debris in a Class II Landfill.** - SCDHEC regulations require that lead-painted demolition debris be disposed in a permitted Class II landfill. Landfills should be contacted to determine their specific disposal requirements. Metal components painted with lead-based paint may be recycled however the recycler should be contacted to determine their specific requirements.

- **Inform contractors and workers of presence of lead in paints** - Occupational Safety and Health Administration Lead Regulations apply to actions initiated on lead containing materials. This regulation applies to lead concentrations greater than the analytical limit of detection. This regulation provides exposure levels on airborne lead and does not reference the concentration of lead in paint or other lead-containing materials. Workers performing work on surfaces which have any lead concentration should be notified to comply with OSHA requirements. The full OSHA lead standard should be referenced for compliance.

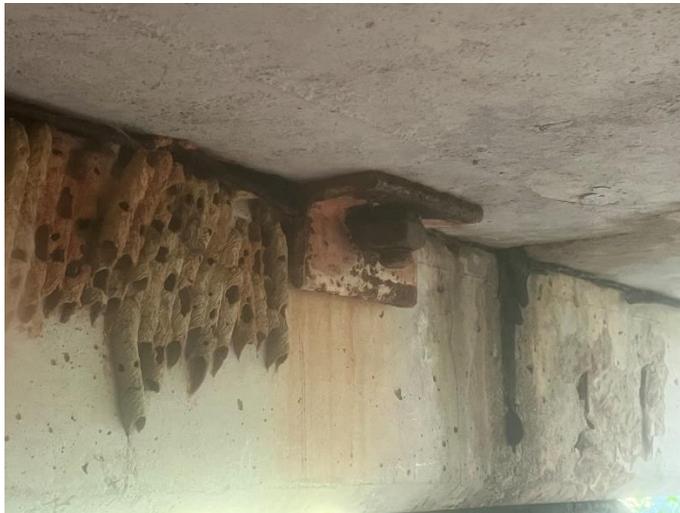
**Photo 7:** LP-4: Orange Bracket Paint
