Asbestos & Lead Paint Inspection Report

S-23-94 Bridge over Suber Tributary

December 20, 2023 | Report Number: 7323P180

Re: Asbestos & Lead Paint Inspection Report
SCDOT Bridge Package 19
S-23-94 over Suber Tributary
Bridge No. 237009400300
Greenville County, South Carolina
Terracon Project No. 7323P180
SCDOT Project No. P041163
Survey Conducted: December 5, 2023

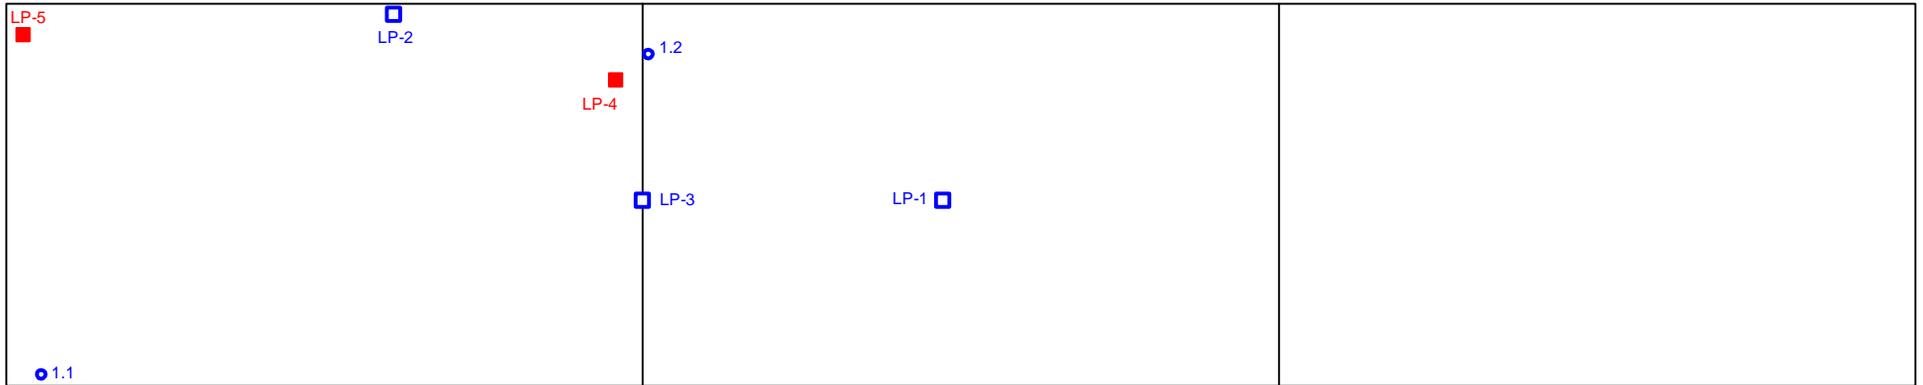
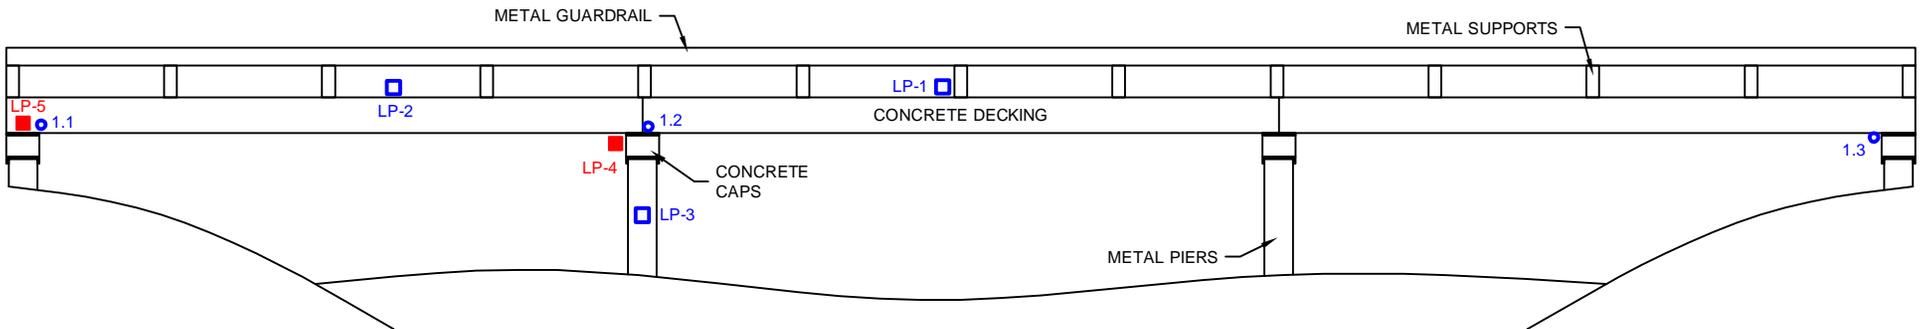
See Figure 2 for sample locations

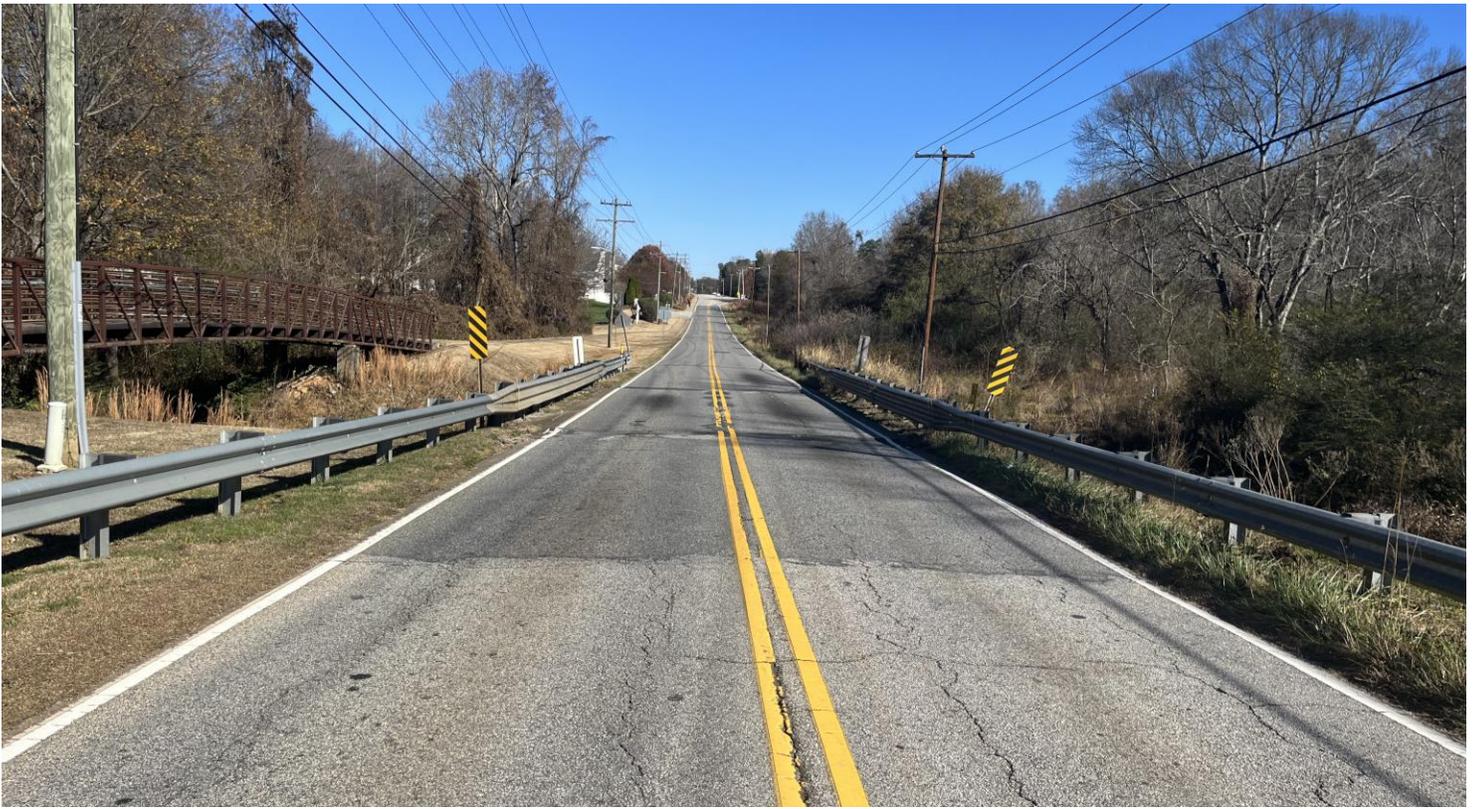
PHOTO # 1 View of the bridge facing to the north with LP-1 Yellow paint and LP-2 White paint in view.

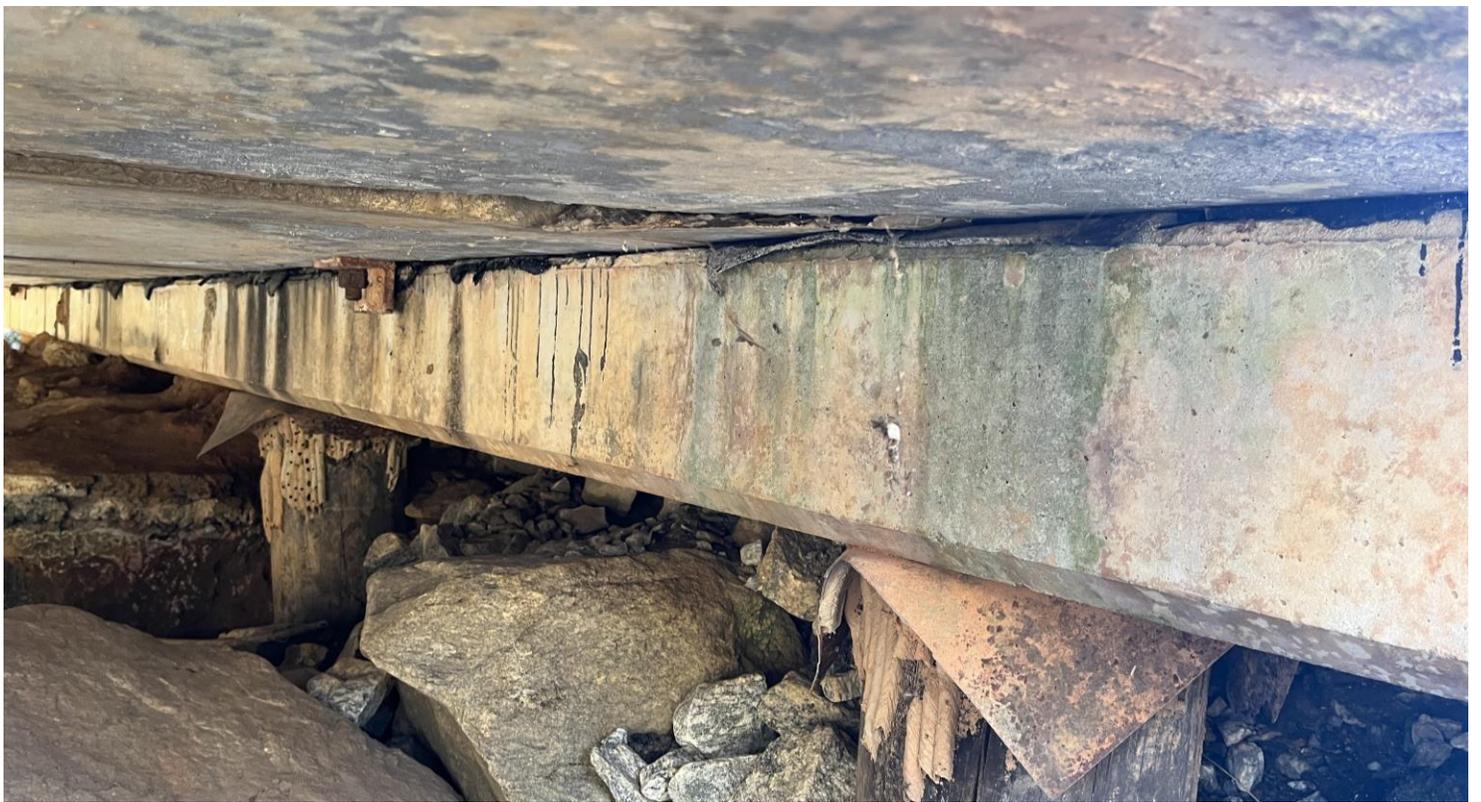
HA	Approx. Quantity* (ft ²)	Samples Collected	Description	Material Location	Lab Result	Category	Condition
1	85	3	Thick tar and shingle vibration dampener	Between pier caps and decking	NAD	Misc	NF, Good

PHOTO # 4 View of HA #1 Thick tar and shingle vibration dampener.

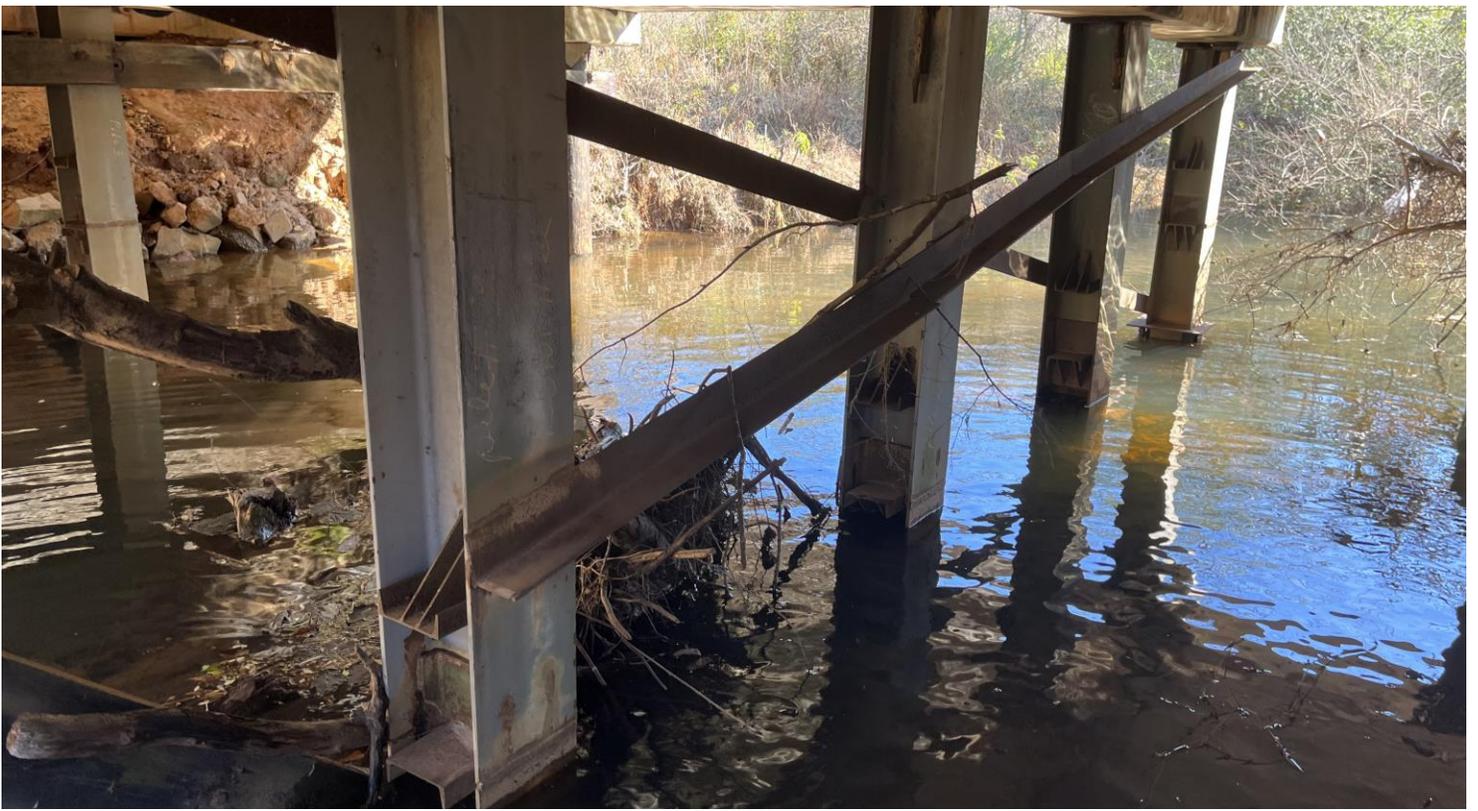
PHOTO # 5 View of LP-3 Grey paint on piers.

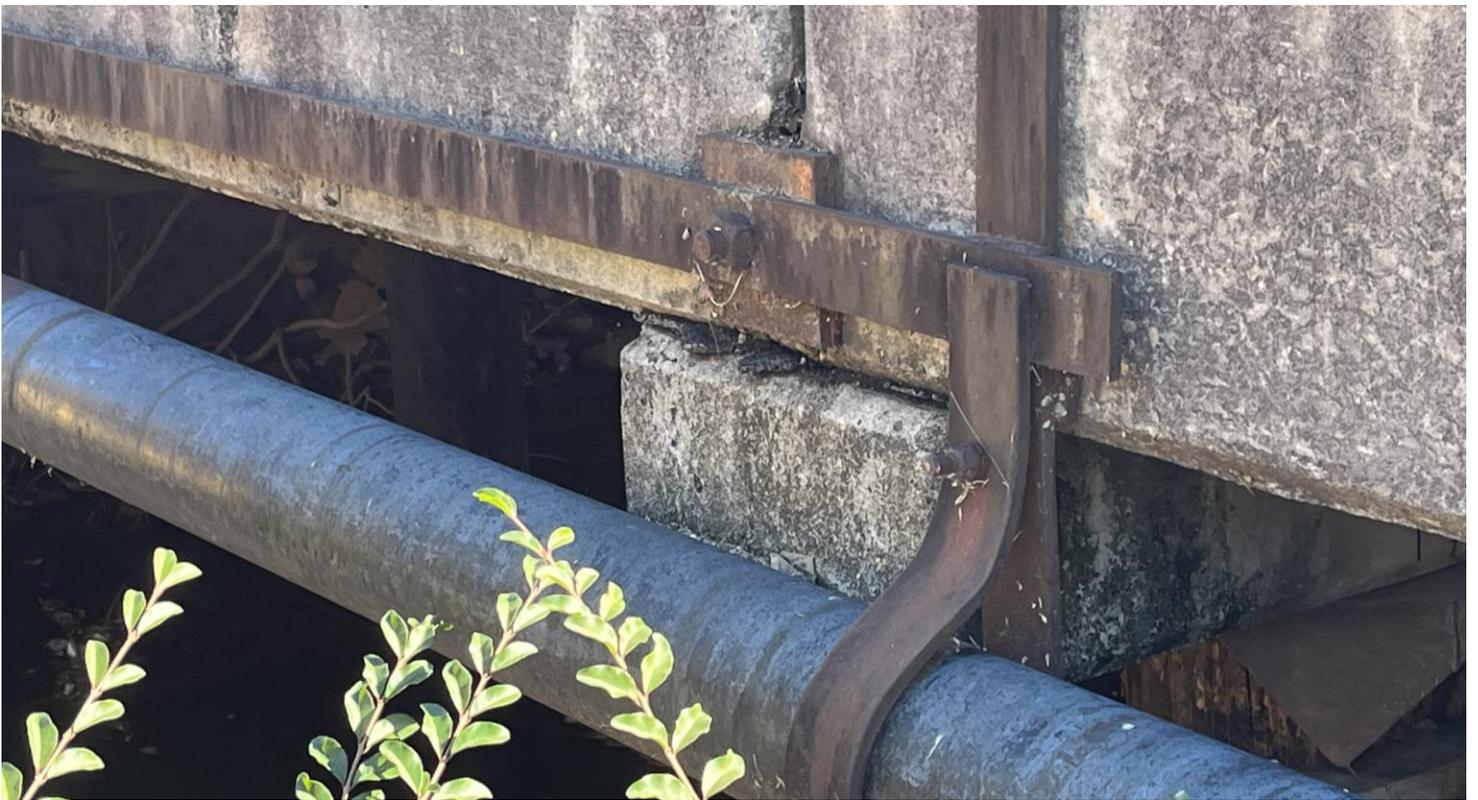
- Orange Bracket paint (45% by weight)
- Black pipe paint (0.054%)

PHOTO # 6 View of LP-4 Orange bracket and LP-5 Black pipe.

- **Dispose of lead painted debris in a Class II Landfill.** - SCDHEC regulations require that lead-painted demolition debris be disposed in a permitted Class II landfill. Landfills should be contacted to determine their specific disposal requirements. Metal components painted with lead-based paint may be recycled however the recycler should be contacted to determine their specific requirements.

- **Inform contractors and workers of presence of lead in paints** - Occupational Safety and Health Administration Lead Regulations apply to actions initiated on lead containing materials. This regulation applies to lead concentrations greater than the analytical limit of detection. This regulation provides exposure levels on airborne lead and does not reference the concentration of lead in paint or other lead-containing materials. Workers performing work on surfaces which have any lead concentration should be notified to comply with OSHA requirements. The full OSHA lead standard should be referenced for compliance.
