Asbestos & Lead Paint Inspection Report

S-23-102 Bridge over Armstrong Creek

December 20, 2023 | Report Number: 7323P180

Re: Asbestos & Lead Paint Inspection Report
SCDOT Bridge Package 19
S-23-102 over Armstrong Creek
Bridge Asset No. 03308
Greenville County, South Carolina
Terracon Project No. 7323P180
SCDOT Project No. P041161
Survey Conducted: November 30, 2023

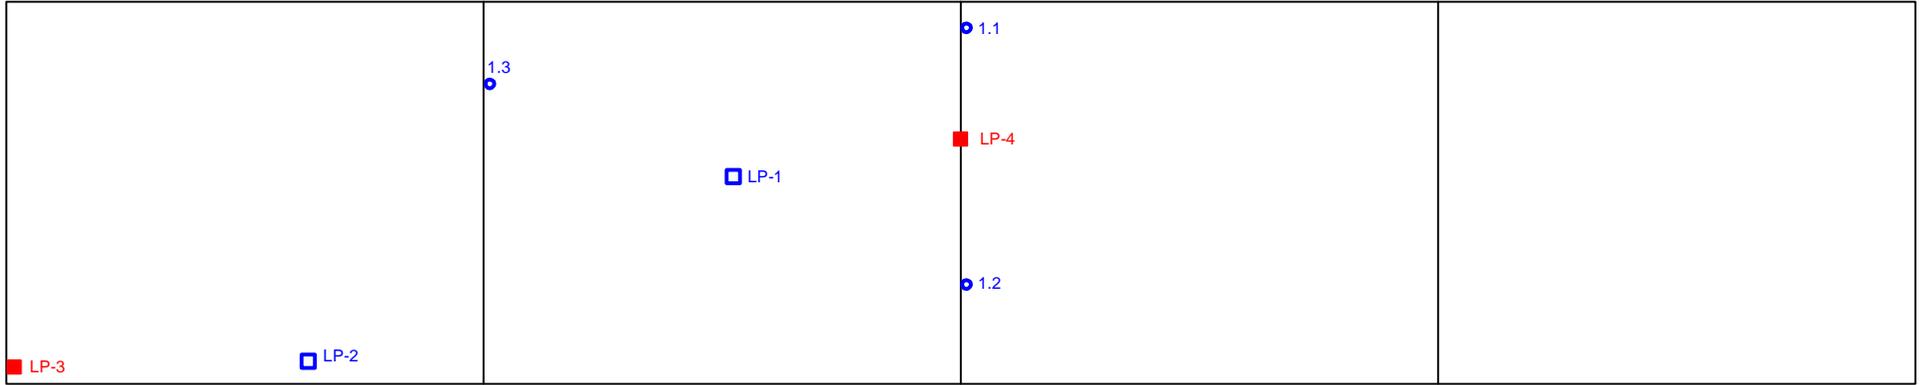
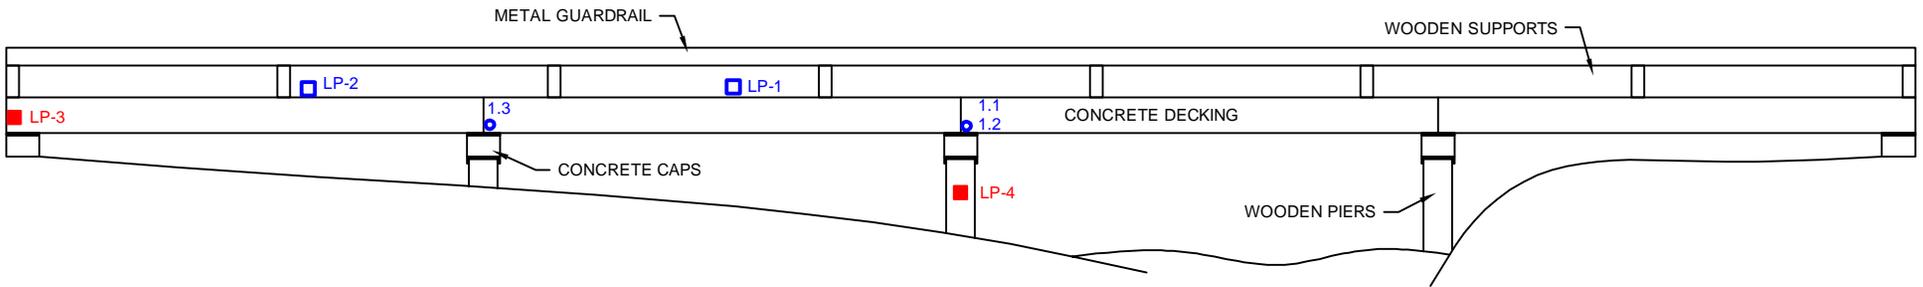
PLAN VIEW

See Figure 2 for sample locations

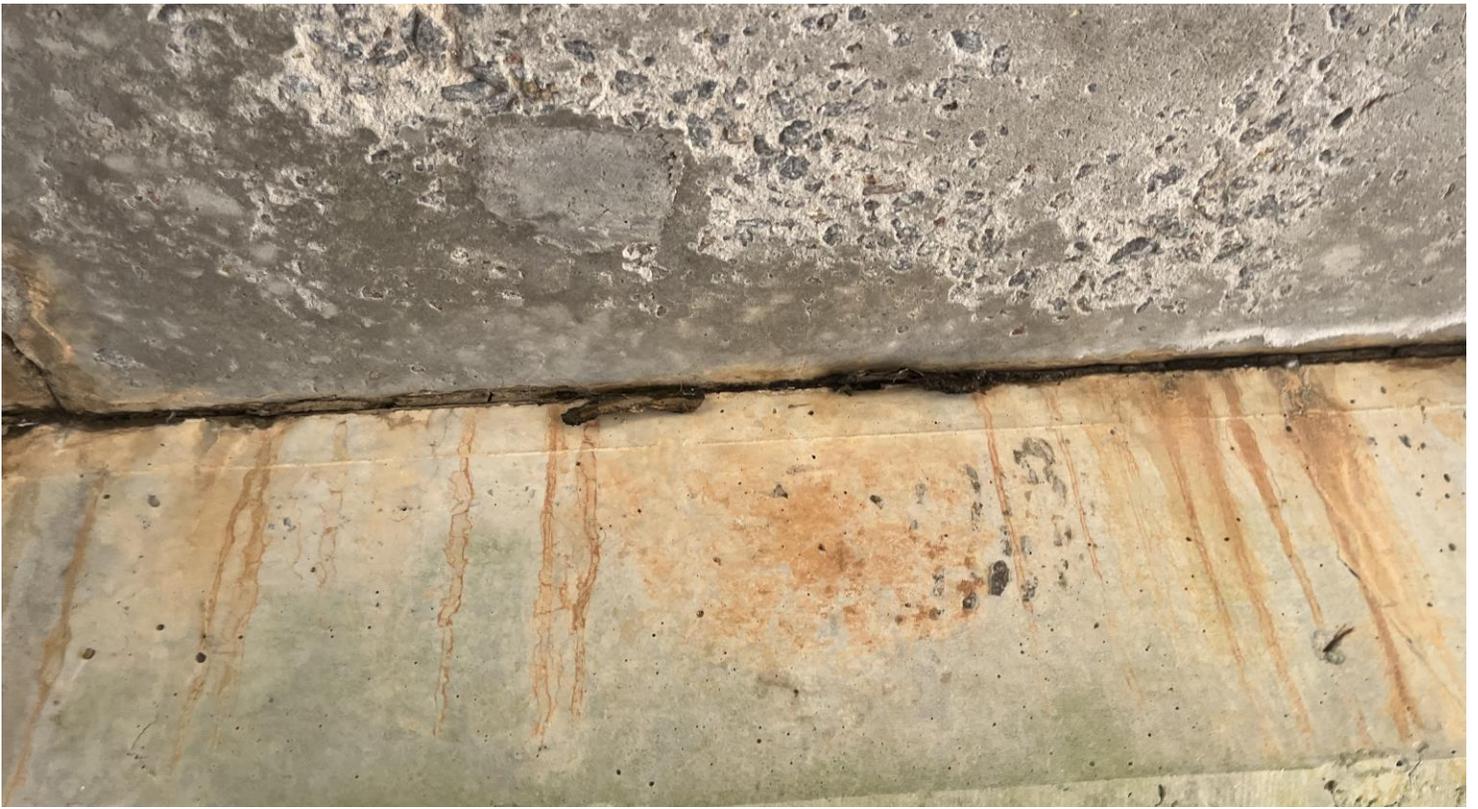
HA	Approx. Quantity* (ft ²)	Samples Collected	Description	Material Location	Lab Result	Category	Condition
1	75	3	Thick tar and felt vibration dampener	Between pier caps and decking	NAD	Misc.	NF, Good

PHOTO # 5 View of HA #1 Thick tar and felt vibration dampener.

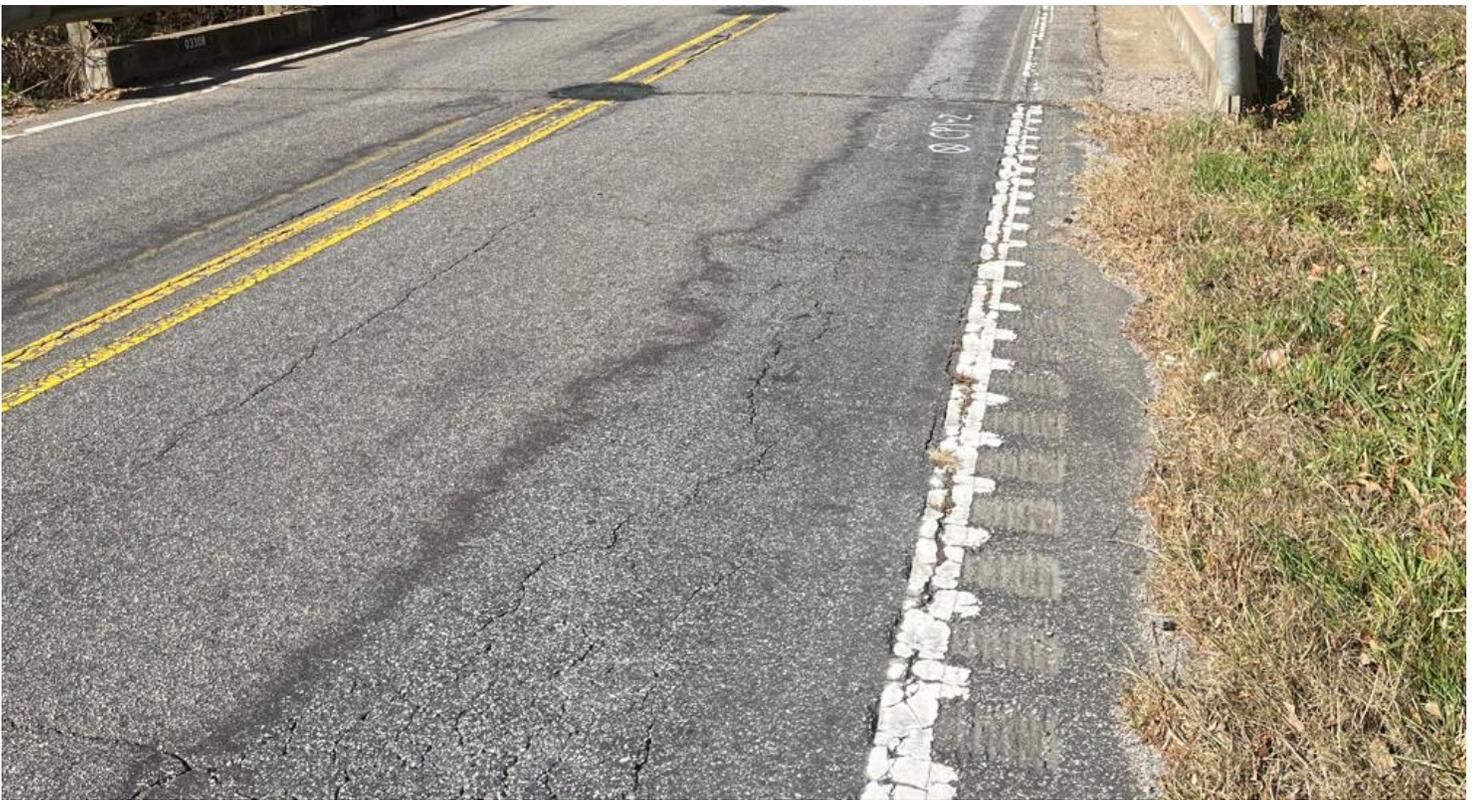
PHOTO # 6 View of LP-1 White stripe paint LP-2 Yellow stripe paint.

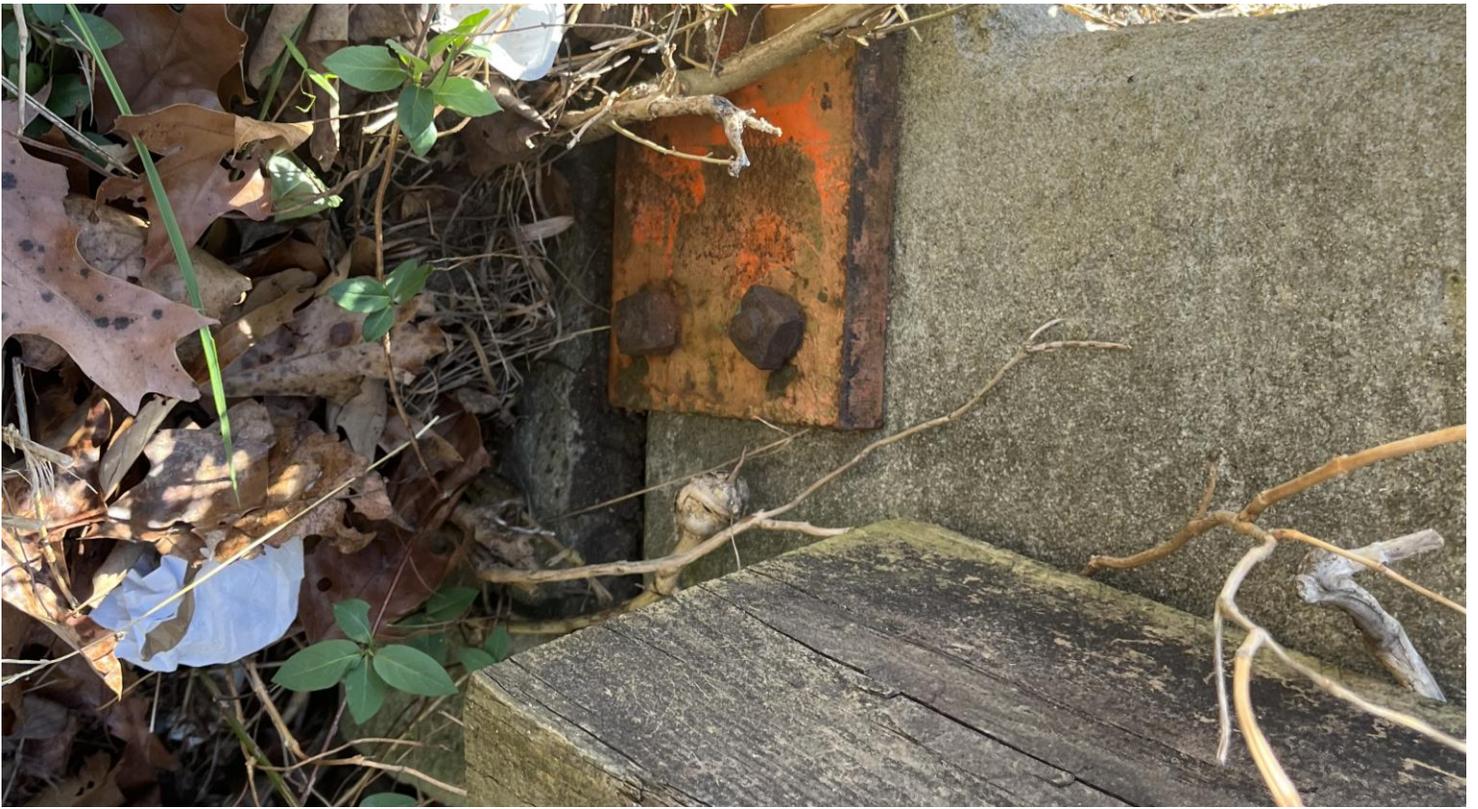
- Orange paint on tension bracket plates (37% by weight).
- Gray paint on steel beams (0.013% by weight).

PHOTO # 7 View of LP-3 orange bracket paint.

- **Dispose of lead painted debris in a Class II Landfill.** - SCDHEC regulations require that lead-painted demolition debris be disposed in a permitted Class II landfill. Landfills should be contacted to determine their specific disposal requirements. Metal components painted with lead-based paint may be recycled however the recycler should be contacted to determine their specific requirements.

- **Inform contractors and workers of presence of lead in paints** - Occupational Safety and Health Administration Lead Regulations apply to actions initiated on lead containing materials. This regulation applies to lead concentrations greater than the analytical limit of detection. This regulation provides exposure levels on airborne lead and does not reference the concentration of lead in paint or other lead-containing materials. Workers performing work on surfaces which have any lead concentration should be notified to comply with OSHA requirements. The full OSHA lead standard should be referenced for compliance.

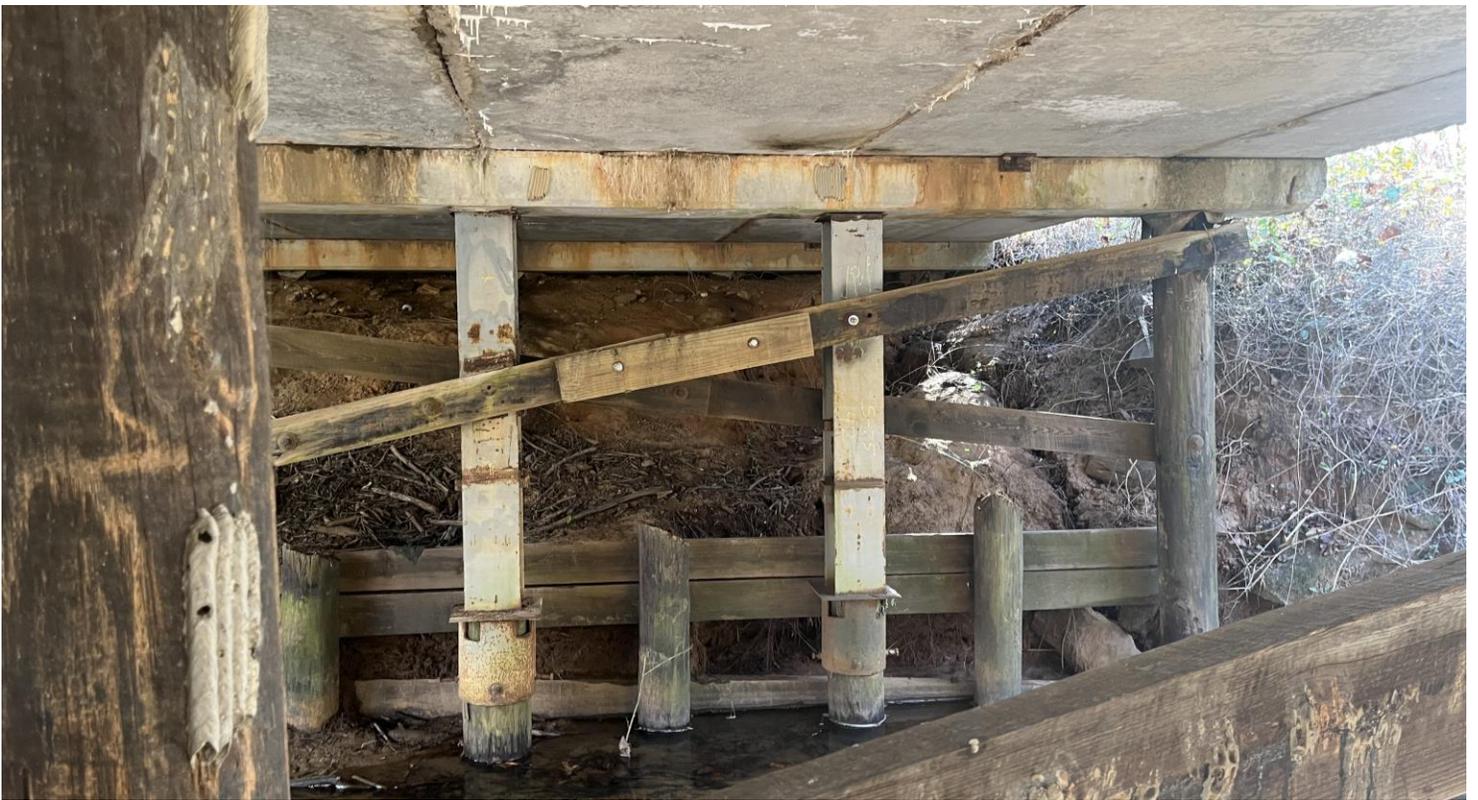
PHOTO # 8 View of LP-4 grey pier paint.
