LEAD-BASED PAINT INVESTIGATION REPORT

US 278 OVER BEAVERDAM BRANCH
BRIDGE ASSETTS #01190 AND #01191
JASPER COUNTY, SOUTH CAROLINA

October 18, 2024

FME Project No.: G7100.006

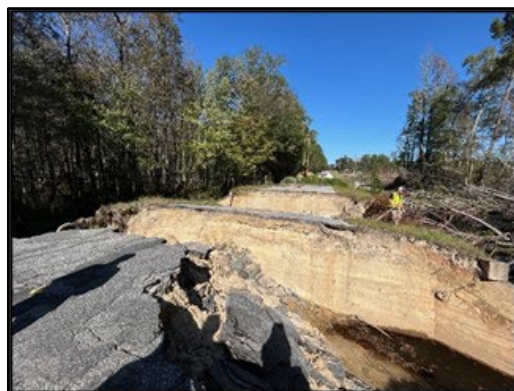
Photo 1: US 278 over Beaverdam Branch in Jasper County, South Carolina

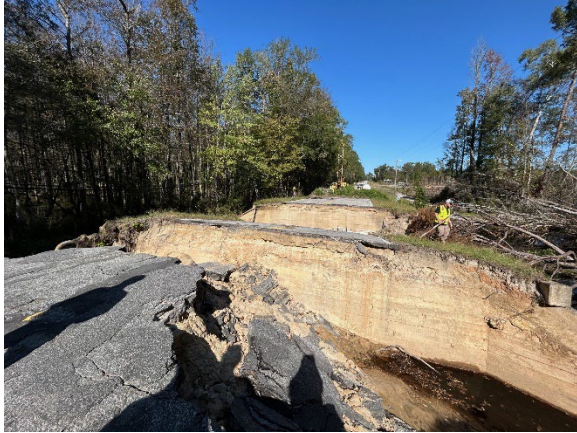
Photo 1. Top View of Bridge.

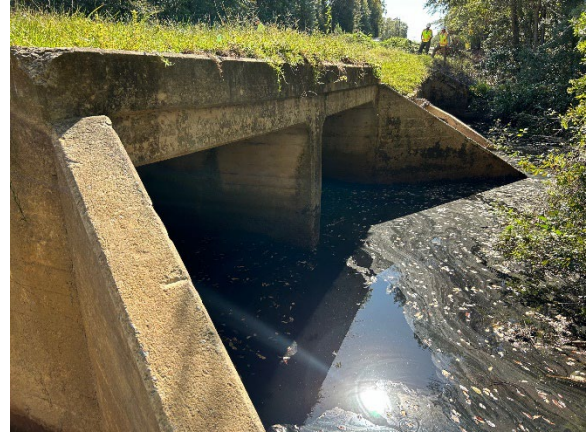
Photo 2. Southwest Corner View of Bridge.

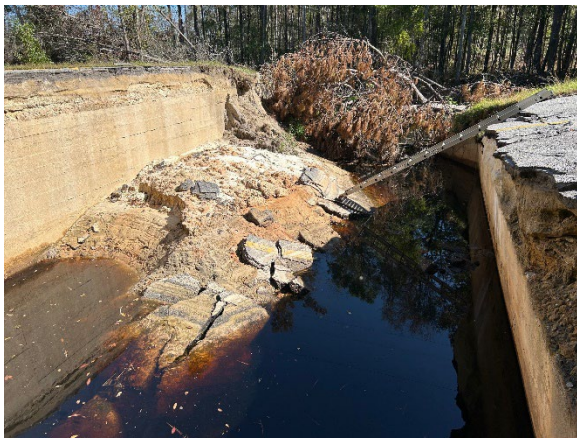
The existing Bridges ($\approx 72.0' \text{ L} \times 46.0' \text{ W}$, culvert edge to edge) are located on US 278 over Beaverdam Branch in Jasper County, South Carolina. The construction date of the Bridges are unknown. The existing Bridges consists of two (2) double barrel poured-in-place (PIP) concrete box culverts and associated concrete wing walls on the horizontal alignment of US 278. The culverts were originally backfilled with soil between them and had an asphalt overlay but were both washed out and uncovered during hurricane Helene. A metal utility line was attached to the northeast side of the Bridges that

Photo 3. Washout Between the Culverts.
