ASBESTOS CONTAINING MATERIAL INVESTIGATION REPORT

S-38-39 (CANNON BRIDGE RD.) BRIDGE OVER
COOPER SWAMP
BRIDGE #3870003900400
ORANGEBURG COUNTY, SOUTH CAROLINA

January 14, 2024

F&ME Project No.: G7100.009

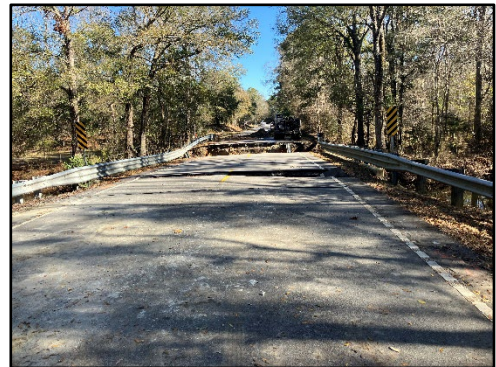
Photo 1: S-38-39 (Cannon Bridge Rd.) Bridge over Cooper Swamp in Orangeburg County, South Carolina.

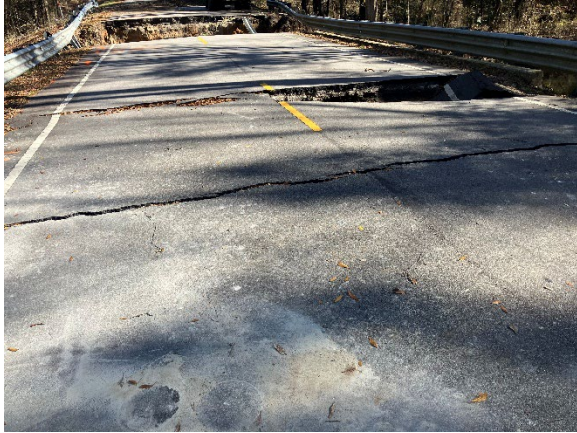
Photo 1. Top View of Bridge Deck.

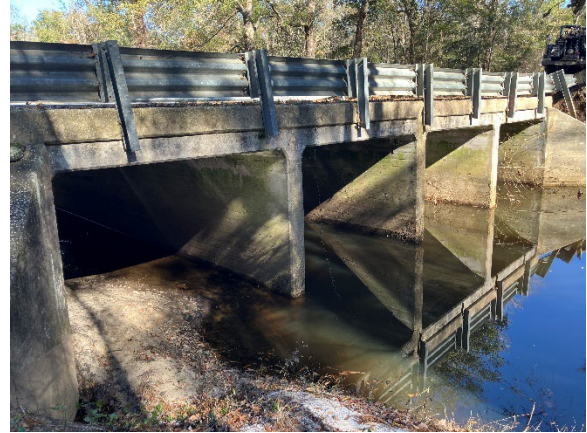
Photo 2. Southwestern Corner View of Bridge.

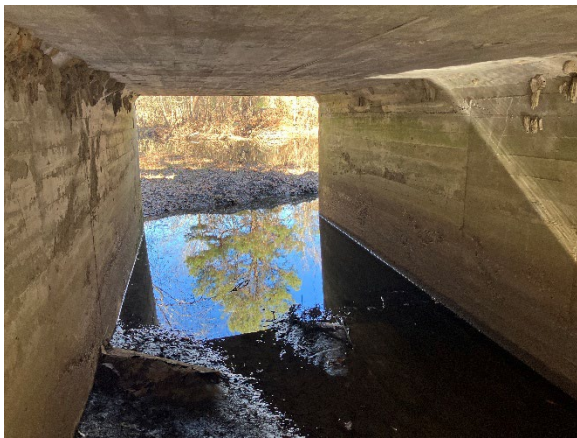
Photo 3. Underside View of Bridge.

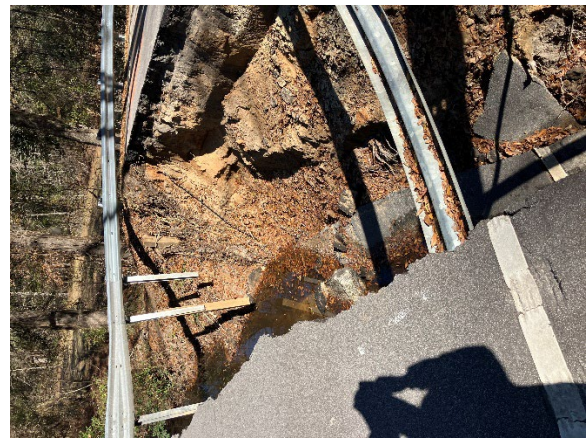
The Bridge was recently damaged during Hurricane Helene. The soil on the eastern side approach to the Bridge was washed out during Hurricane Helene. During the investigation, accessible bridge components (i.e., expansion joints, etc.) were visually inspected for suspect ACM. Examples of possible suspect materials include bond break bearing pads, expansion joint material, and drainage scuppers. No suspect materials were observed/visible on the Bridge. Refer to the included Appendix B, General Bridge Plan. Also, refer to Appendix D, Site Photographs, for more details.

Photo 4. Eastern Side of Bridge Wash Out.

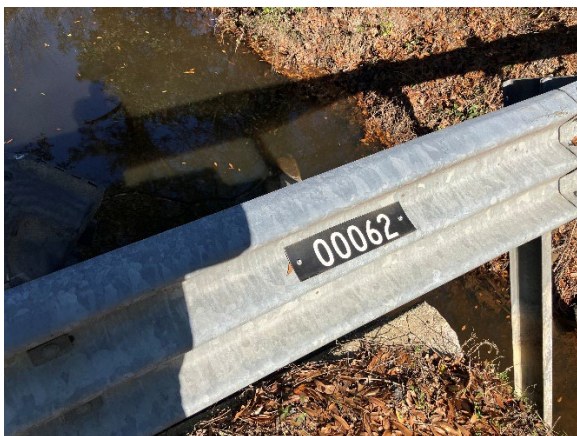
Photo 5. Bridge Asset # Attached to Galvanized Metal Guardrail.
