LEAD-BASED PAINT INVESTIGATION REPORT

S-38-634 (DEER TRAIL RD.) BRIDGE OVER COOPER SWAMP
ORANGEBURG COUNTY, SOUTH CAROLINA
PROJECT ID# PO44270

January 22, 2025

FME Project No.: G7100.009

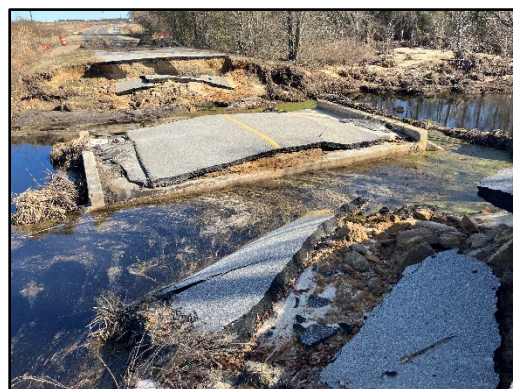
Photo 1: S-38-634 (Deer Trail Rd.) Bridge over Cooper Swamp in Orangeburg County, South Carolina.

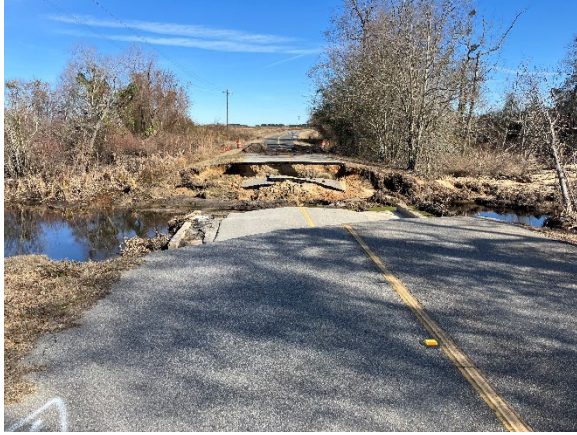
Photo 1. Western View of the Top of the Bridge.

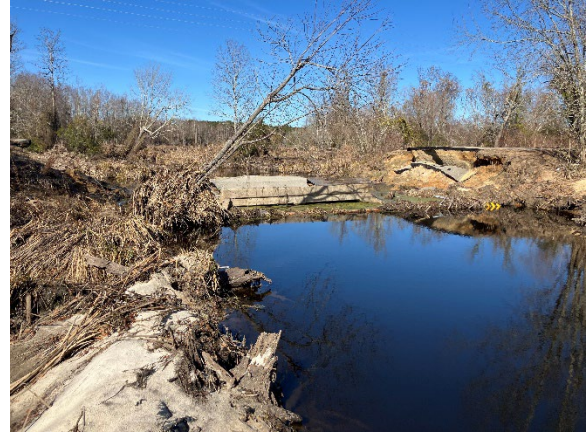
Photo 2. Southeastern View of Bridge.

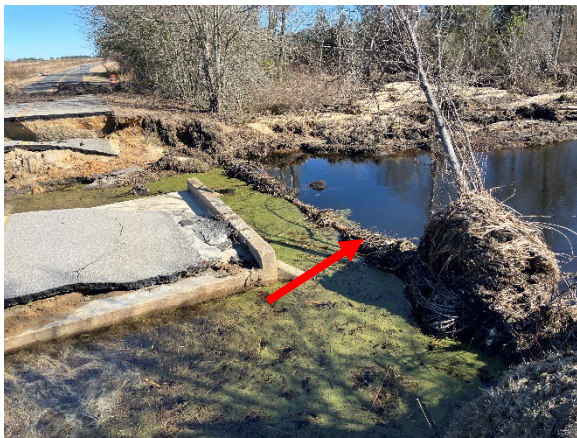
Photo 3. Exposed Utility Pipe on the Southern Side of Bridge.

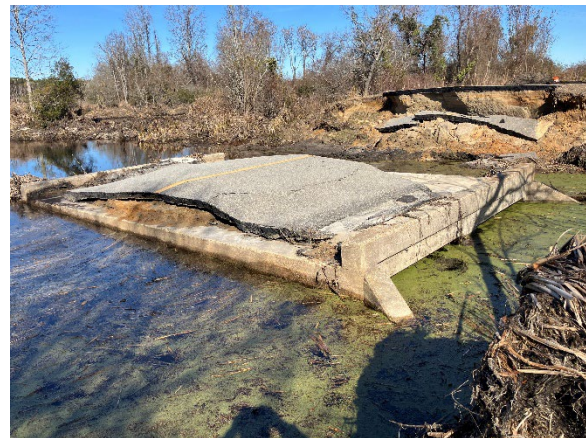
Photo 4. Southwestern View of Bridge.

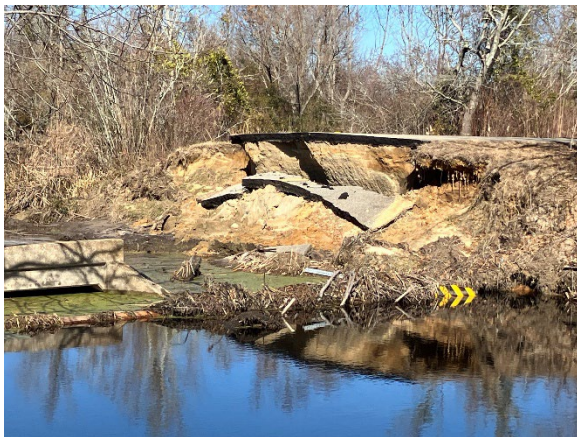
The Bridge was recently damaged during Hurricane Helene in September 2024. The soils on the approach to both sides of the Bridge were washed out during recent flooding. FME's LBP Investigation sampling protocol consisted of randomly selecting Bridge components and scanning them with a Sci-Aps X-Ray Fluorescence (XRF) Portable Analyzer (Model # X550 Pb, Serial #03033). However, no accessible painted or coated bridge components were identified to scan with the XRF analyzer for lead. Refer to Appendix C, Site Photos, for typical views of the Bridge. Appendix D includes the inspector's EPA lead-based paint inspector certification.

Photo 5. View of the Washout on the East Side of Bridge.

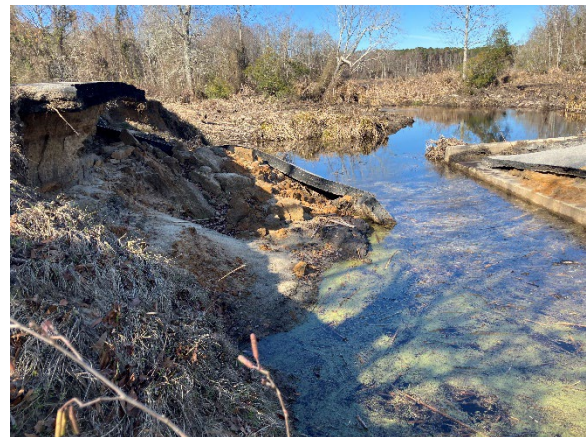
Photo 6. View of Washout on the West side of the Bridge.
