ASBESTOS CONTAINING MATERIAL INVESTIGATION REPORT

S-38-1210 (BUFFALO POND RD.) BRIDGE OVER TAMPA CREEK
ORANGEBURG COUNTY, SOUTH CAROLINA
PROJECT ID# P044271

F&ME Project No.: G7100.009

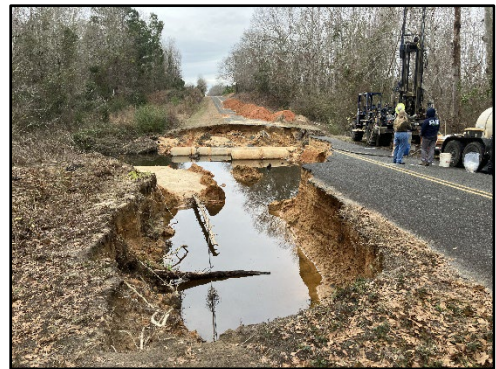
Photo 1: S-38-1210 Bridge over Tampa Creek in Orangeburg County, South Carolina.

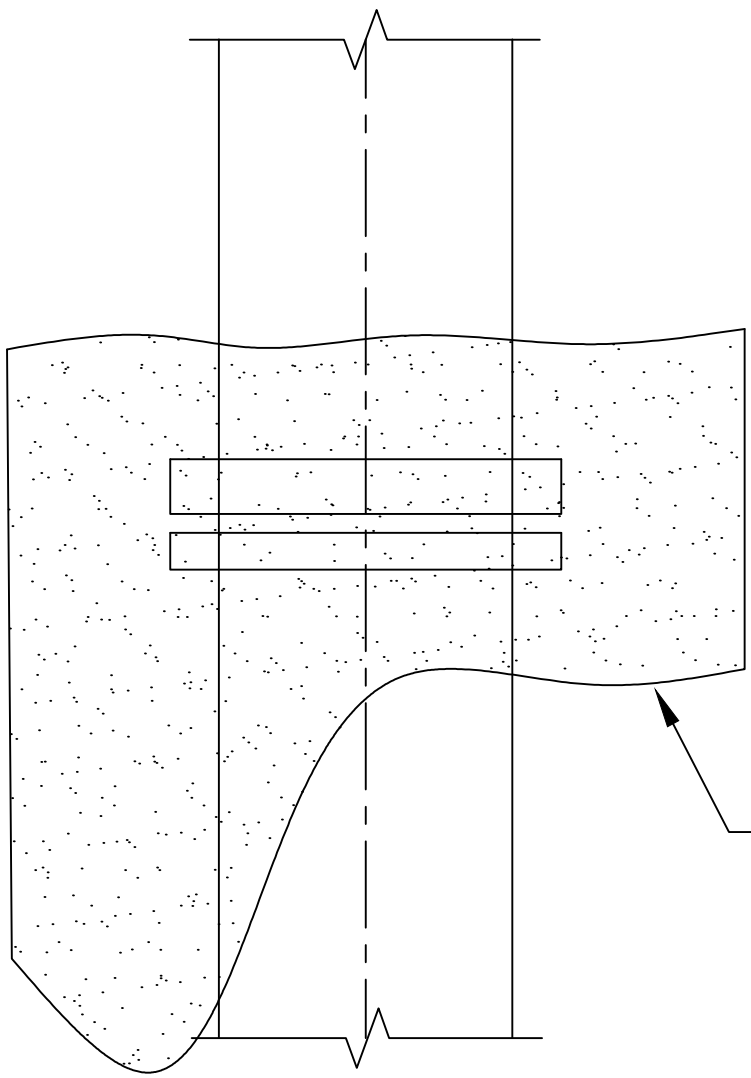
2

Estimated Washed Out
Portion of Bridge
