ASBESTOS CONTAINING MATERIAL INVESTIGATION REPORT

S-24-166 (TILLMAN TERRITORY RD.) RBO
TRIBUTARY TO HENLEYS CREEK
GREENWOOD COUNTY, SOUTH CAROLINA
PROJECT ID P043994

November 1, 2024

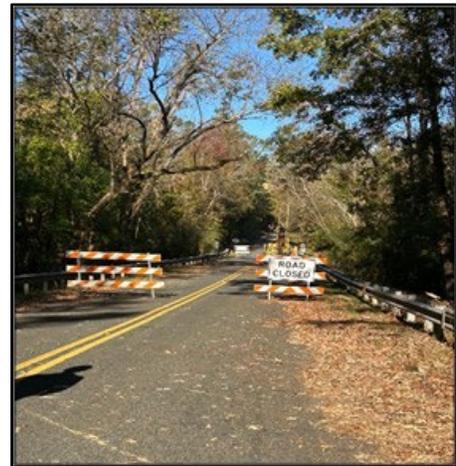
Photo 1: S-24-166 over a tributary to Henleys Creek in Greenwood County, South Carolina

Observations indicate that the Bridge has undergone a repair at an unknown date. A single timber pile on the southwest side of the Bridge has had a steel sleeve added to provide additional support. Refer to Appendix A, Site Vicinity Map, for the location of the Bridge. Appendix B, General Bridge Plan, for a layout of the Bridge.

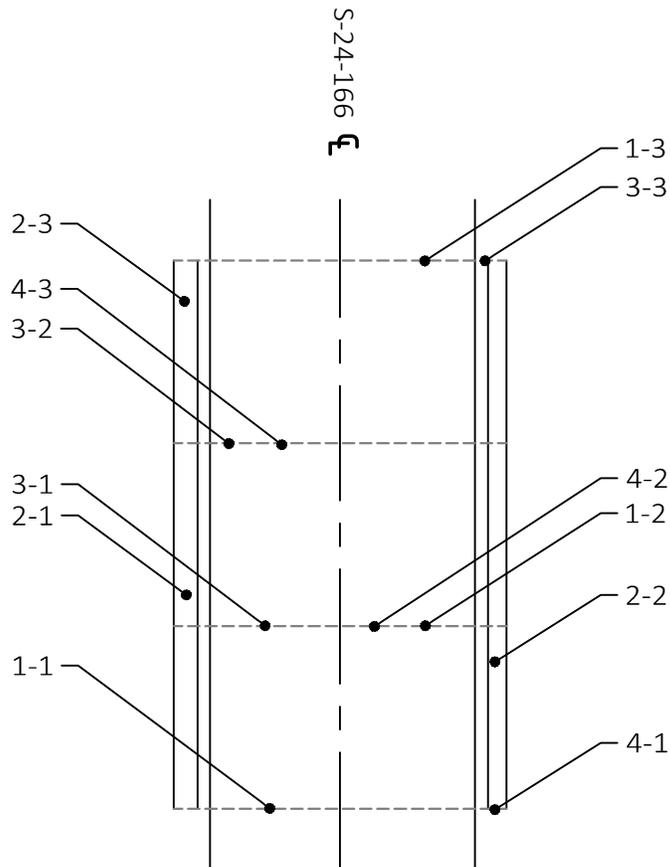
2

Sample ID	Description
1-1	Crack Sealant
1-2	Crack Sealant
1-3	Crack Sealant
2-1	Guardrail Coating
2-2	Guardrail Coating
2-3	Guardrail Coating
3-1	Wood Coating
3-2	Wood Coating
3-3	Wood Coating
4-1	Timber Pile Cap Felt
4-2	Timber Pile Cap Felt
4-3	Timber Pile Cap Felt
