LEAD-BASED PAINT INVESTIGATION REPORT

S-24-166 RBO TRIBUTARY TO HENLEYS CREEK
GREENWOOD COUNTY, SOUTH CAROLINA
PROJECT ID P043994

FME Project No.: G7100.007

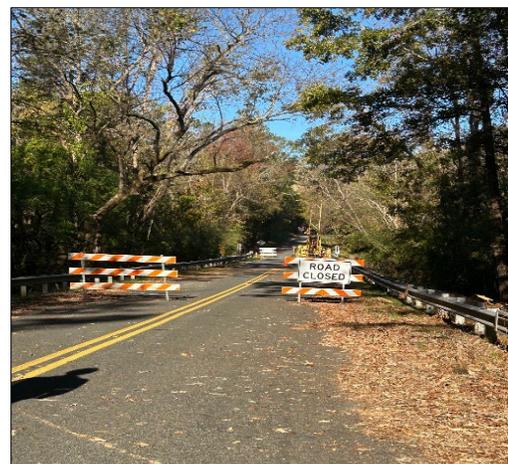
Photo 1 – S-24-166 RBO Tributary to Henleys Creek, Greenwood County.

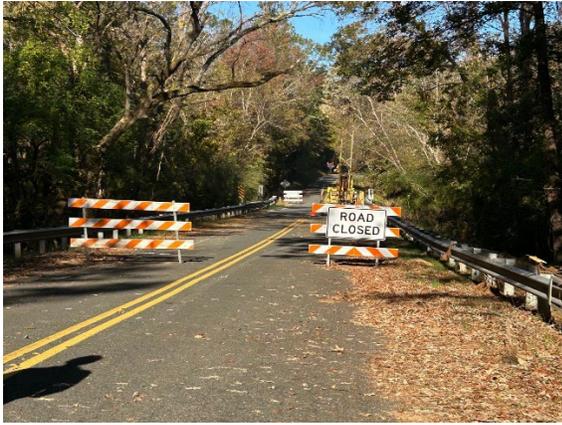
Photo 1. Top View of Bridge.

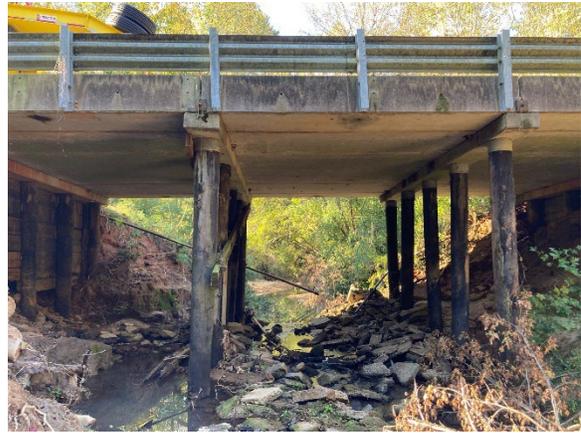
Photo 2. Northeast Side View of Bridge.

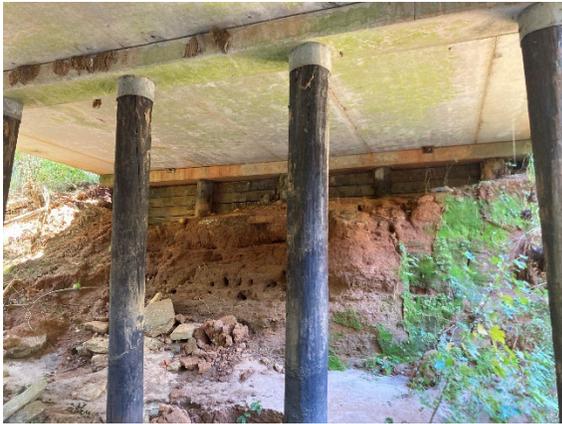
Photo 3. Underside View of Bridge.

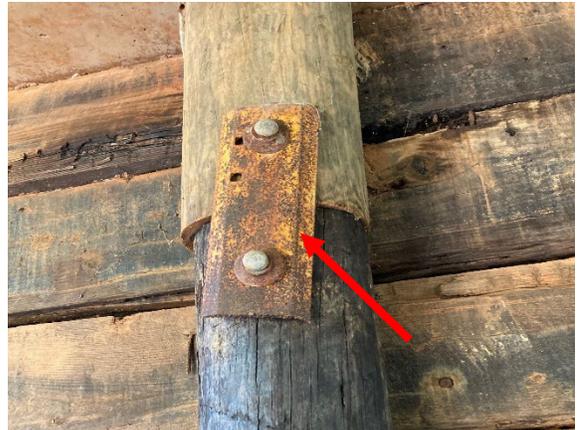
- **Silver Bent Cap Brackets**
- **Yellow Metal Brace on Timber Pile**

Photo 4. LBP on Yellow Metal Brace.

Therefore, OSHA regulations and procedures should be followed when impacting these components. If possible, they should be removed in whole and disposed of properly. Also, SCDES disposal requirements for lead containing materials should also be followed.

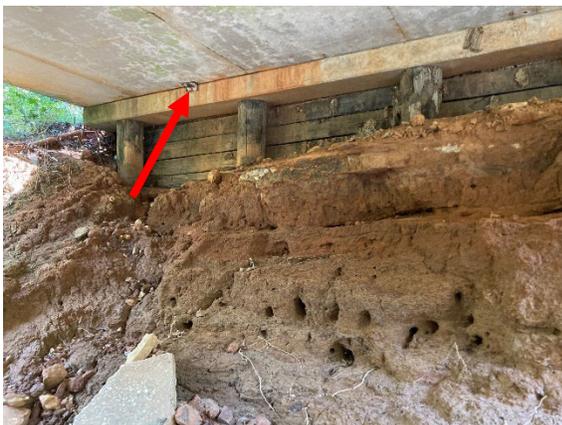
Photo 5. LBP on Silver L-Bracket.

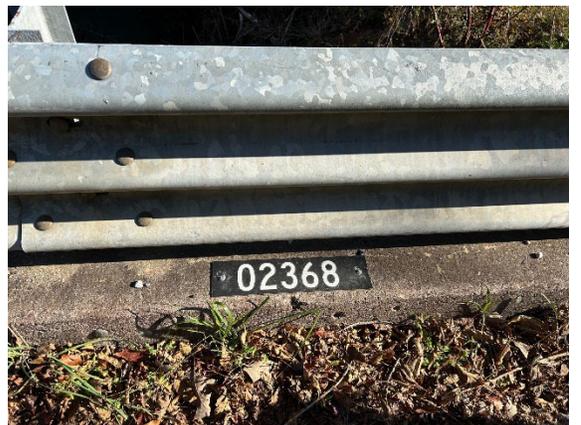
Photo 6 SCDOT Bridge Asset # Placard Attached to Concrete Curb of Bridge.
