SCDOT BRIDGE INSPECTION FORM

(008) BRIDGE ID: 4010012620072	(005) ROUTE: RICHLAND I-126
(420) ASSET NO: 7935	(006) CROSSING: I-126
(419) RAMP NO: 8970	(009) LOCATION: 3 MI N OF COLUMBIA
(026) FUNCTIONAL CLASS: 11	(016) LAT: 34d 1m 14.10s (017) LON: 81d 5m 39.44s

Bridge ID: 40-1-00126-2-00-72

18 Dec 2017

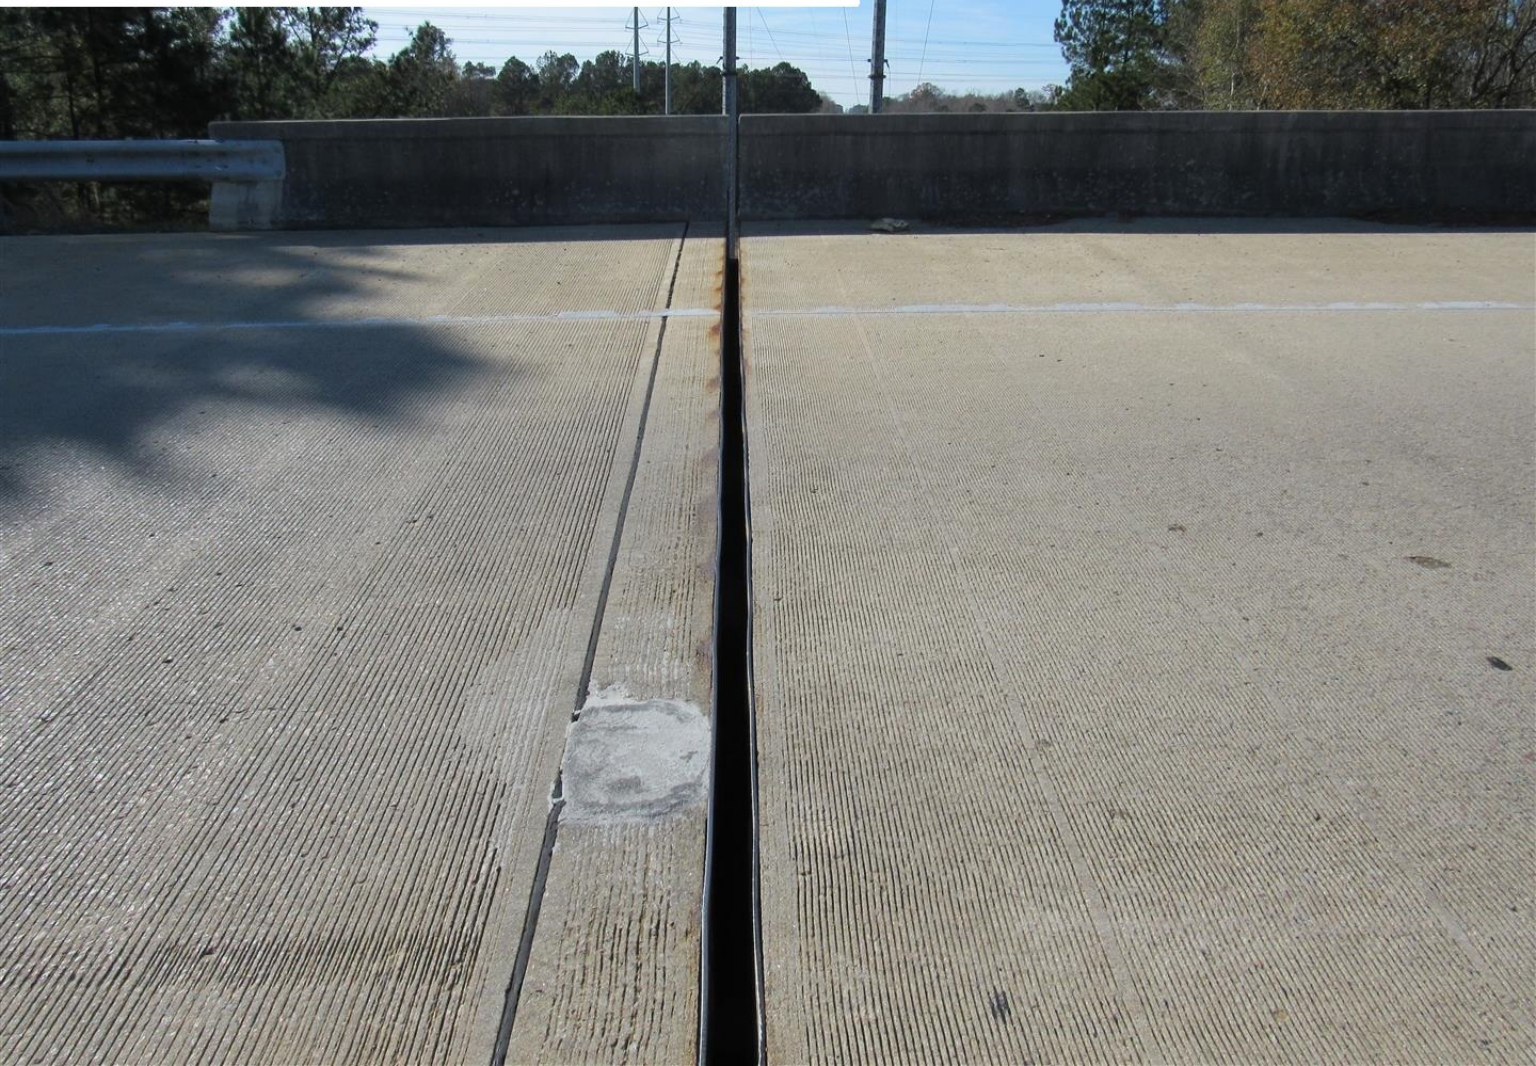
4010012620072 I-126 EBL X-I-126 18 Dec 2017
Expansion material missing at bent 4.

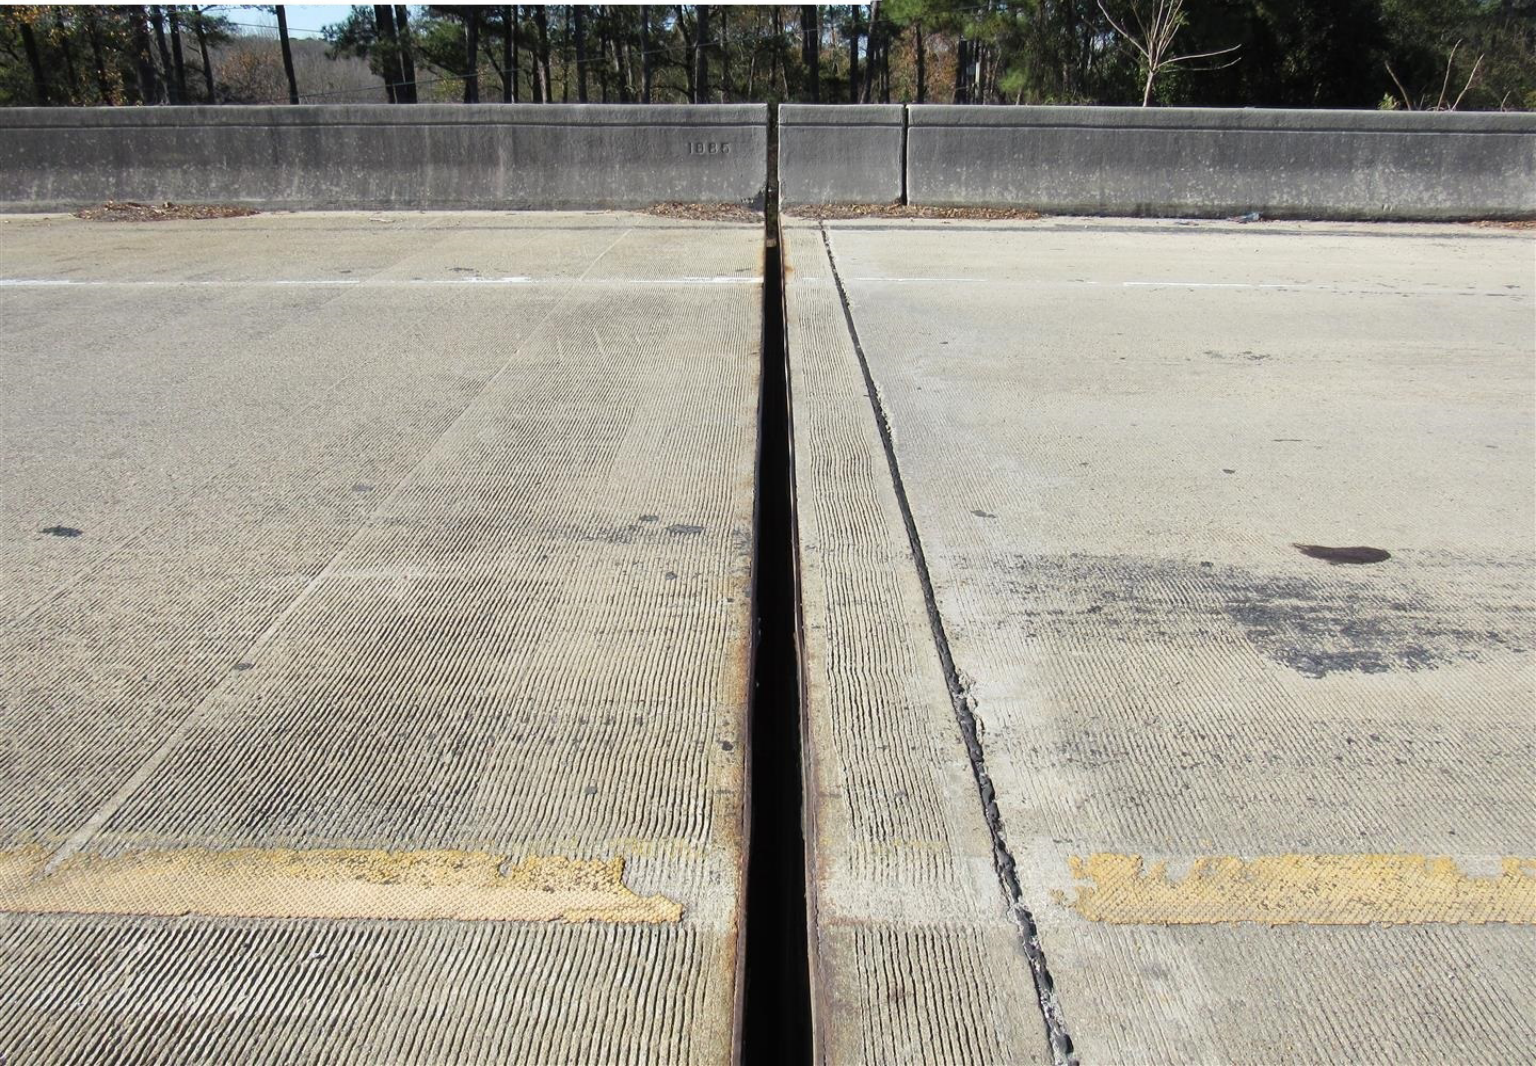
Expansion material missing at bents 1 and 6, (see photos).

4010012620072 I-126 EBL X-I-126 18 Dec 2017
Expansion material missing at bent 1.
