# Underwater Inspection Report

## I-126 RAMP

## Saluda River

Bridge ID No. 4010012620071

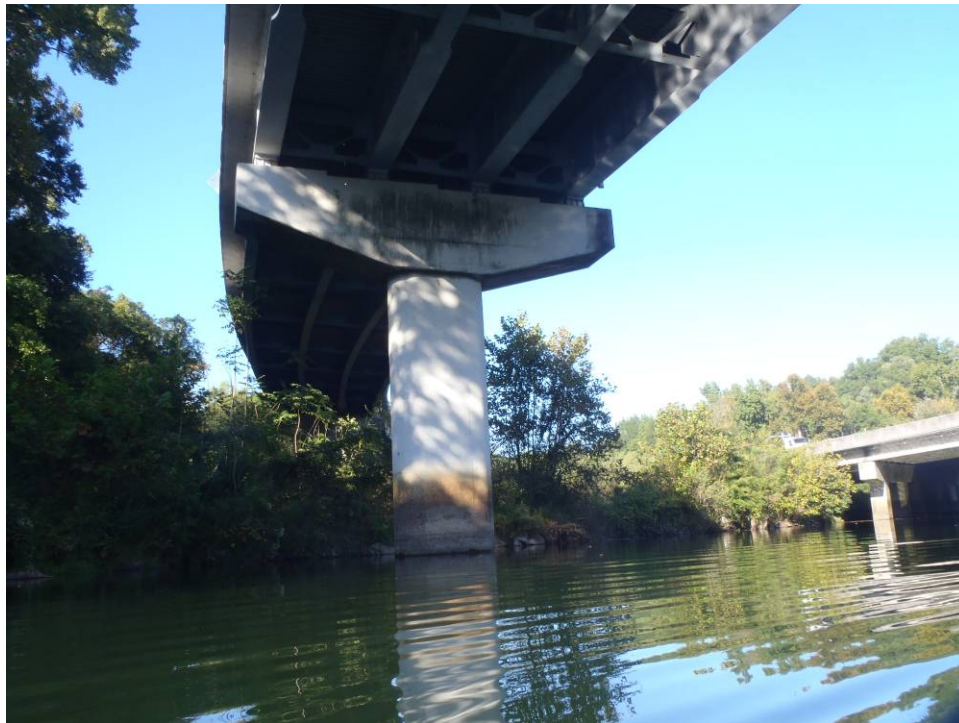
Photograph 2. View of Pier C, Typical of Piers A through C.

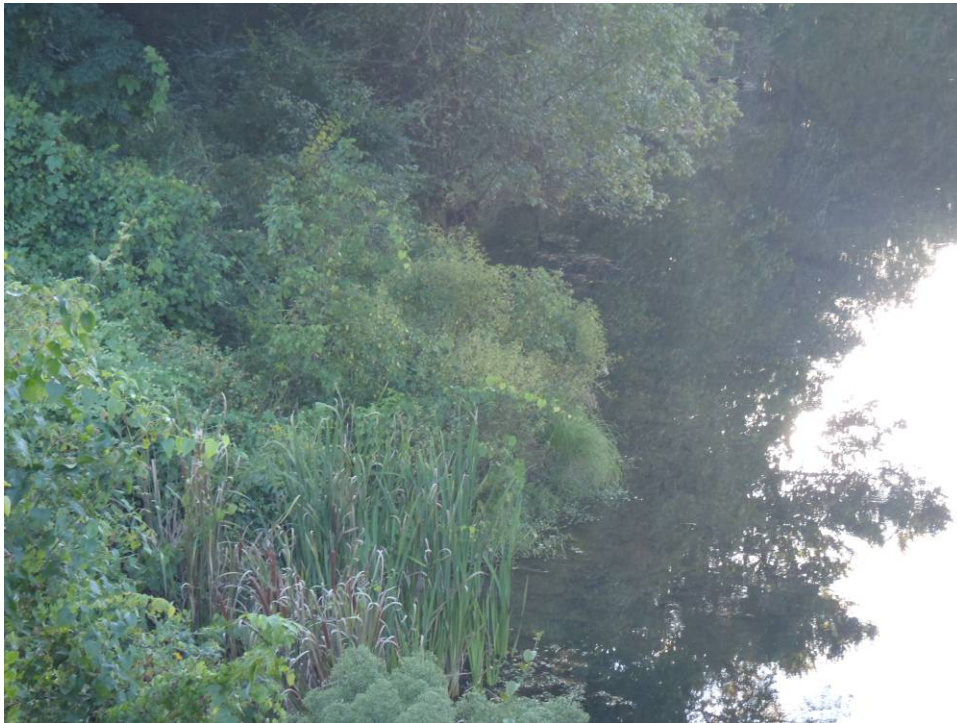
The banks along the Saluda River in the bridge vicinity are in stable condition. Embankment protection in the form of riprap and vegetation is present on the south and north banks. There is no sign of active erosion. Refer to Photographs 3 and 4 in Appendix B for a view of the south and north embankments, respectively. The channel bottom in the bridge vicinity primarily consists of rock.

**Photograph 3. South Embankment.**

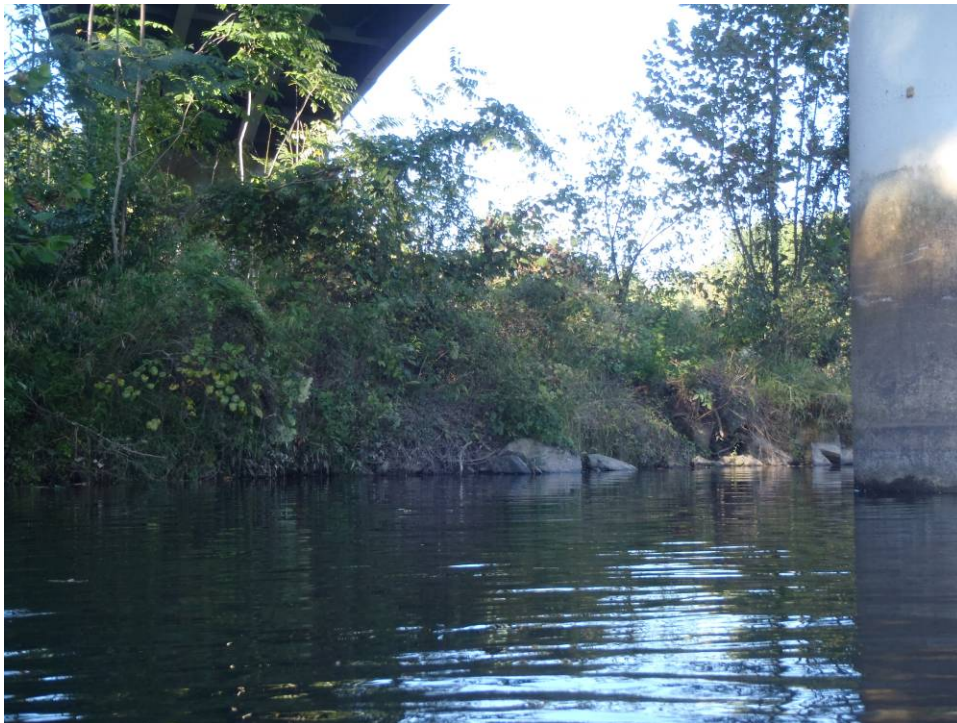
**Photograph 4. North Embankment.**

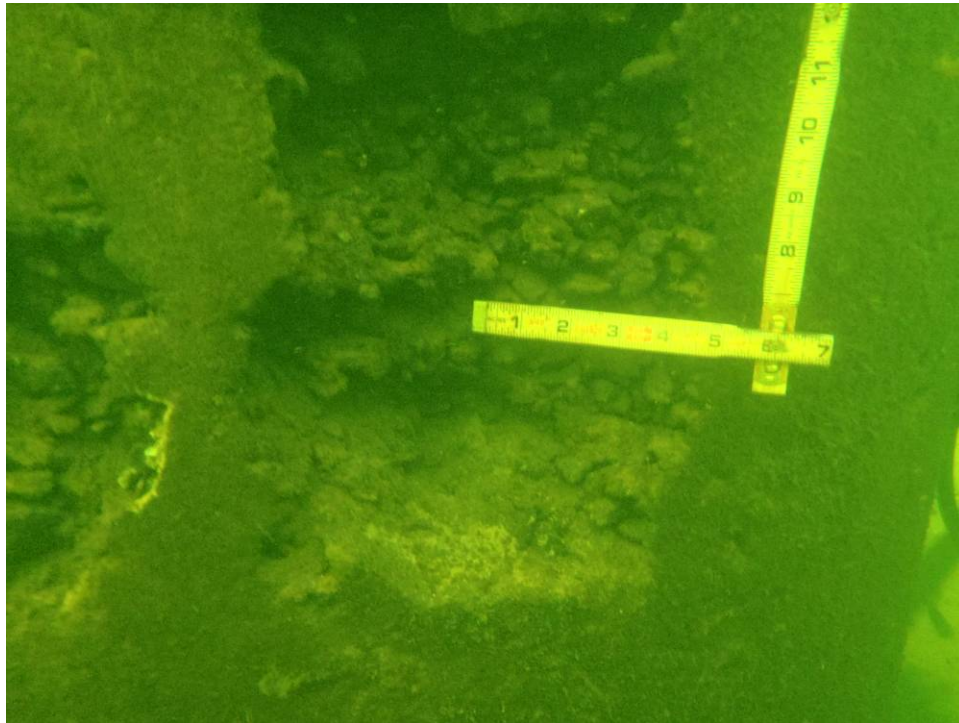
The SSUs located in water at the time of inspection included Piers A through C. All of the inspected SSUs have 1/4-in. penetration scaling from the channel bottom to 3 ft. above the waterline. There is moderate timber debris on the channel bottom around Pier B. There is a spall on the Pier B Column measuring 12 in. high by 16 in. wide and 3 in. deep with no exposed reinforcing located 11.5 ft. below the waterline on the downstream nose. Refer to Photograph 7 in Appendix B for a view of the spall. The footings of Piers A and B are exposed up to 2 1/2 ft. high. Refer to Table 2 in Appendix A for detailed measurements of the footing exposure. Refer to Figures 1 and 2 in Appendix A for detailed inspection notes and a plan view showing the existing conditions at each of the inspected piers.

Overall, the submerged components of the bridge SSUs are in **good** condition, except for Pier B which is in **satisfactory** condition. The light scaling observed is typical of in-service concrete of this age and does not currently affect the bridge. The spall observed on Pier B does not adversely affect the bridge. The exposed footings are likely an as-built condition and do not affect the structure.

**Photograph 7. Pier B, spall measuring 12 in. high by 16 in. wide by 3 in. of penetration located 11.5 ft. below the waterline on the downstream nose.**
