SCDOT BRIDGE INSPECTION FORM

(008) BRIDGE ID: 4070003100100			(005) ROUTE: RICHLAND S-31		
(420) ASSET NO: 7937			(006) CROSSING: I-26		
(419) RAMP NO:			(009) LOCATION: 3MI W COLA

Bridge Element Group Textual Data

Bridge ID: 40-7-00031-0-01-00

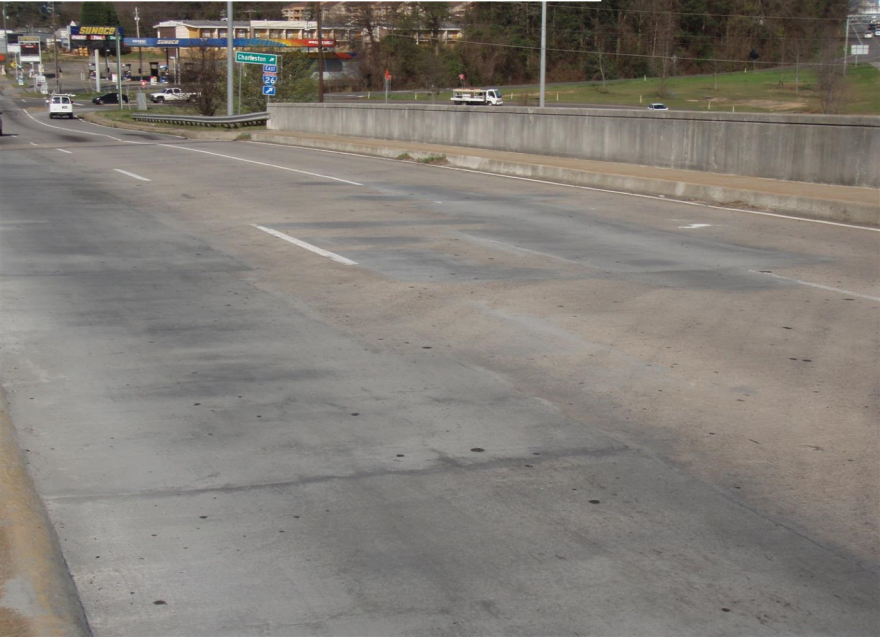
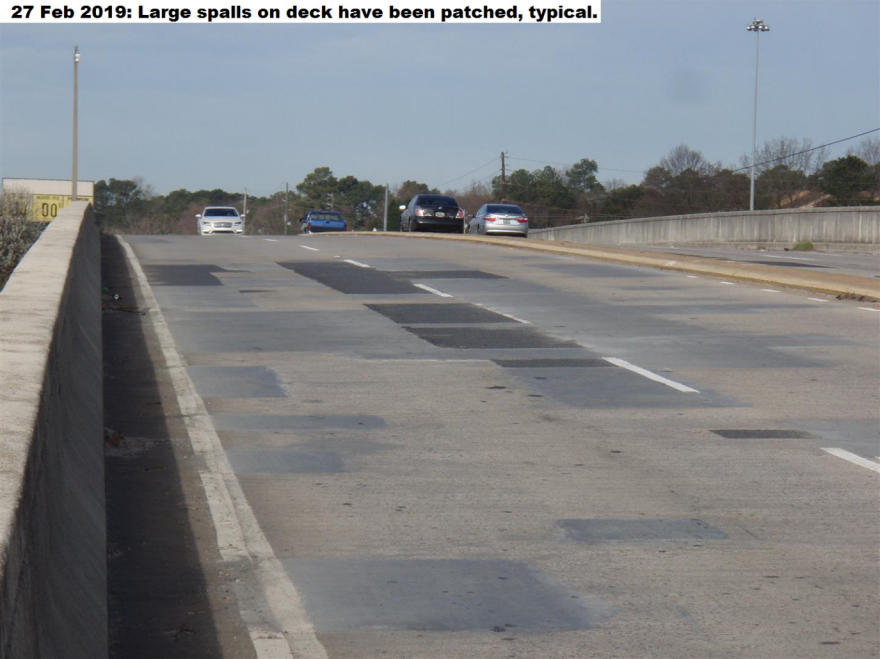
(6) Large spalls, that have been patched and hairline transverse and map cracking on deck with several transverse and diagonal cracks at .05"-.07" mid-span in WBL, (see photos). Transverse hairline cracks with efflorescence on underside of deck between beams 5 and 6 and at soffit. Deck chain drag performed, Jan 2017, 5,800 square feet of spalls and delamination, patched as of this inspection, Feb 2019, (see photo).

27 Feb 2019: Large spalls on deck have been patched, typical.

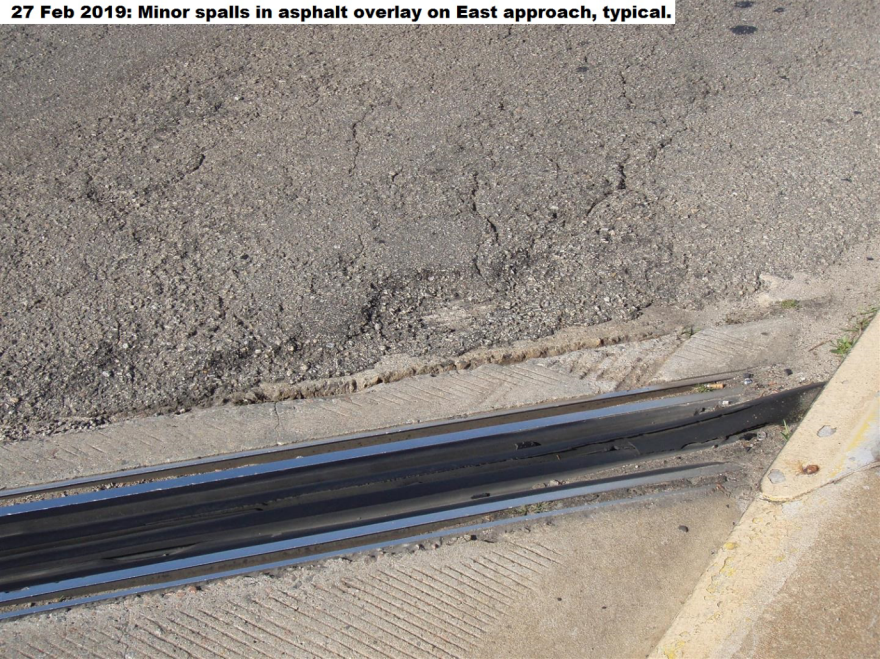
Hairline diagonal and map cracking in approach slab, West end. Approach slab East end covered with asphalt overlay with minor spalls, (see photo).

27 Feb 2019: Minor spalls in asphalt overlay on East approach, typical.

7937 - 70003100100-I-26				S		31	00		.18	N		
03/15/2005	805	D										N
(303) REPAIR STEEL PLATES IN MODULAR JOINTS, (SEE PHOTO).												
7937 - 70003100100-I-26				S		31	00		.18	N		
02/27/2019	504	D										N
PATCH SPALLS IN CONCRETE MEDIAN BARRIER ON DECK, (SEE PHOTO).												
7937 - 70003100100-I-26				S		31	00		.18	N		
02/27/2019	102	D										N
PATCH SPALLS IN ASPHALT OVERLAY ON WEST APPROACH, (SEE PHOTO).												
7937 - 70003100100-I-26				S		31	00		.18	N		
02/27/2019	805	D										N
(303) REPLACE EXPANSION MATERIAL IN MODULAR JOINTS, (SEE PHOTO).												
7937 - 70003100100-I-26				S		31	00		.18	N		
03/19/2003	807	D										N
(215) REPLACE WATER SEAL AT WINGWALL AND HEADWALL.												
7937 - 70003100100-I-26				S		31	00		.18	N		
02/11/2015	504	D										N
REPAIR CONCRETE MEDIAN BARRIER ON DECK, (SEE PHOTO).

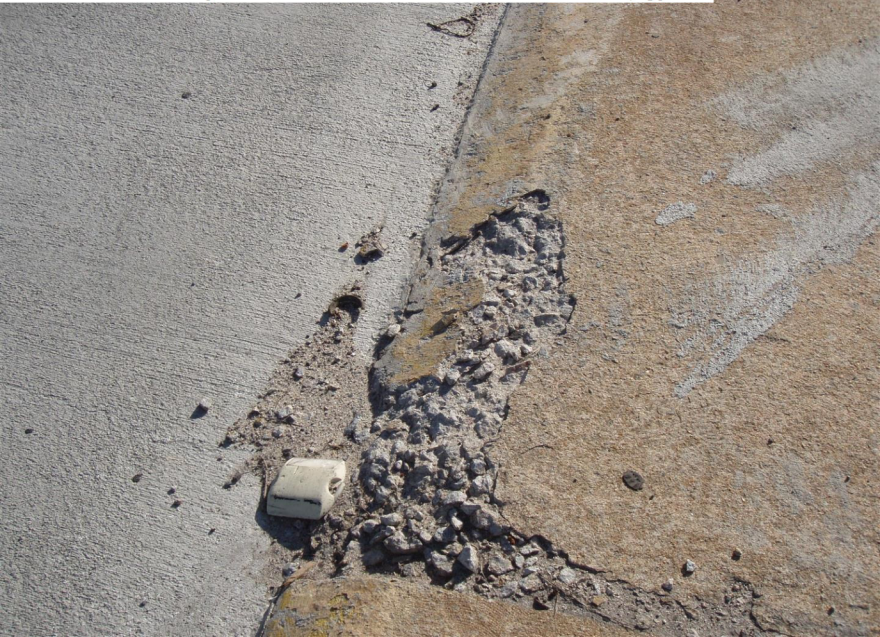
Bridge and approach rail in place. Hairline cracks with effloresce and minor spalls in concrete parapet walls. Minor damage to approach rail, East end, left side. Continuous concrete median barrier at bents 3, 4, and 5 and guardrail at bent 2 on I-26 EBL. Hairline cracks in continuous concrete median barrier on I-2. Raised median barrier in center of bridge between lanes on S-31, with minor spalls and upheaving at bent 1, (see photos).

27 Feb 2019: Minor spalls in raised median between lanes on S-31, typical.

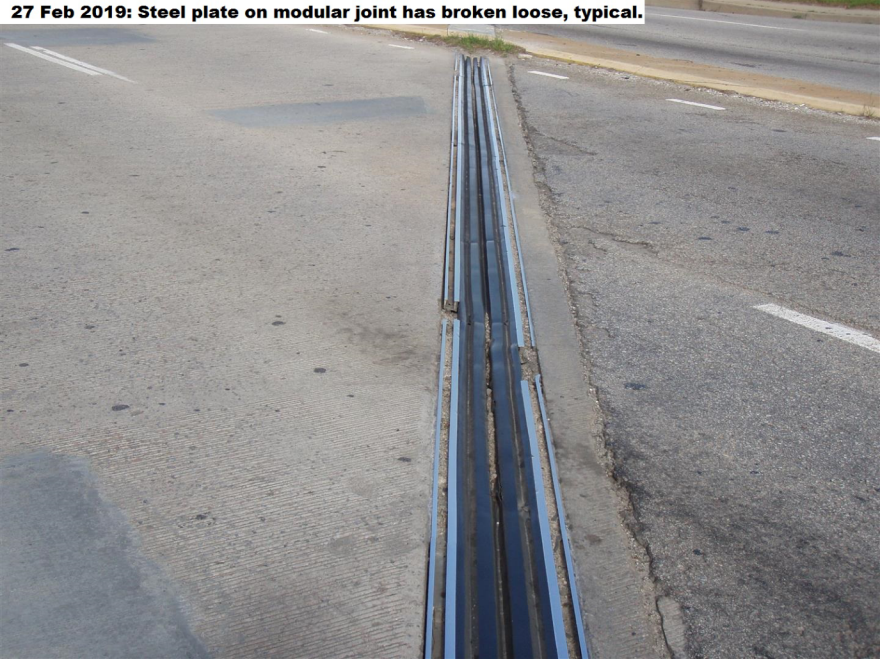
Steel plates on modular joints have broken loose, both ends, (see photo). Expansion material cracked, torn, and pulled loose, (see photo).

27 Feb 2019: Steel plate on modular joint has broken loose, typical.

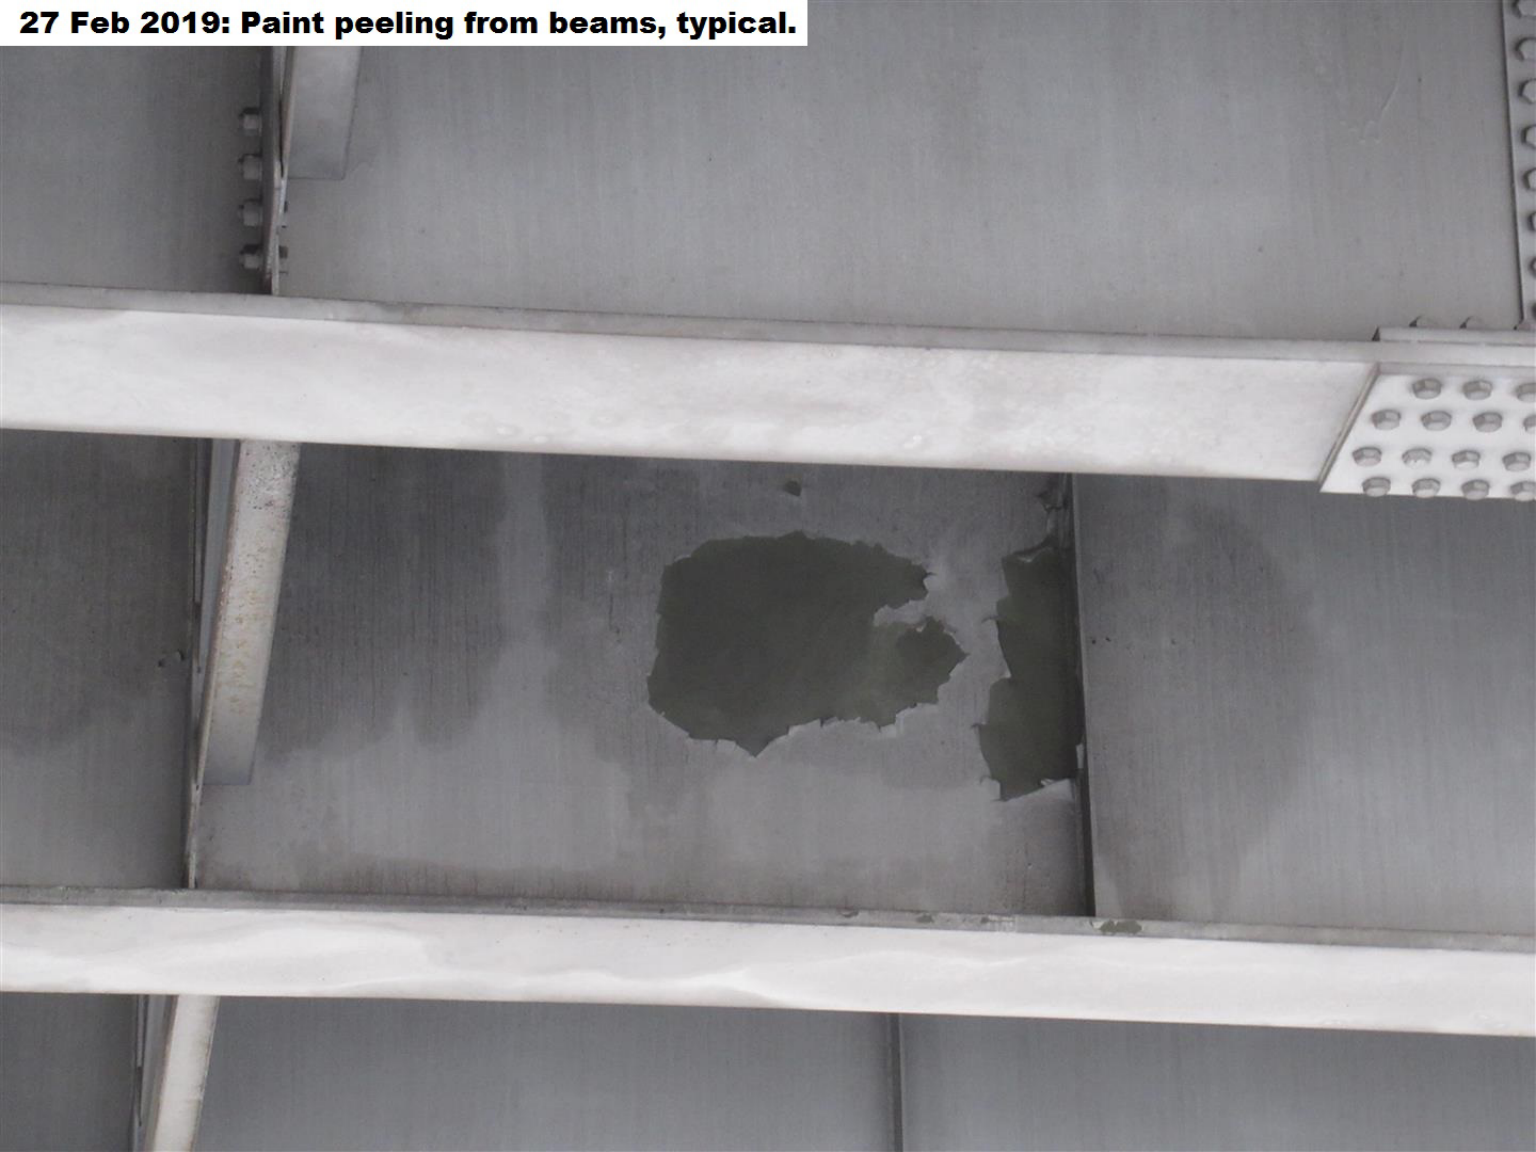
Paint is starting to peel from steel beams, diaphragms, and bearings, (see photos).

27 Feb 2019: Paint peeling from beams, typical.

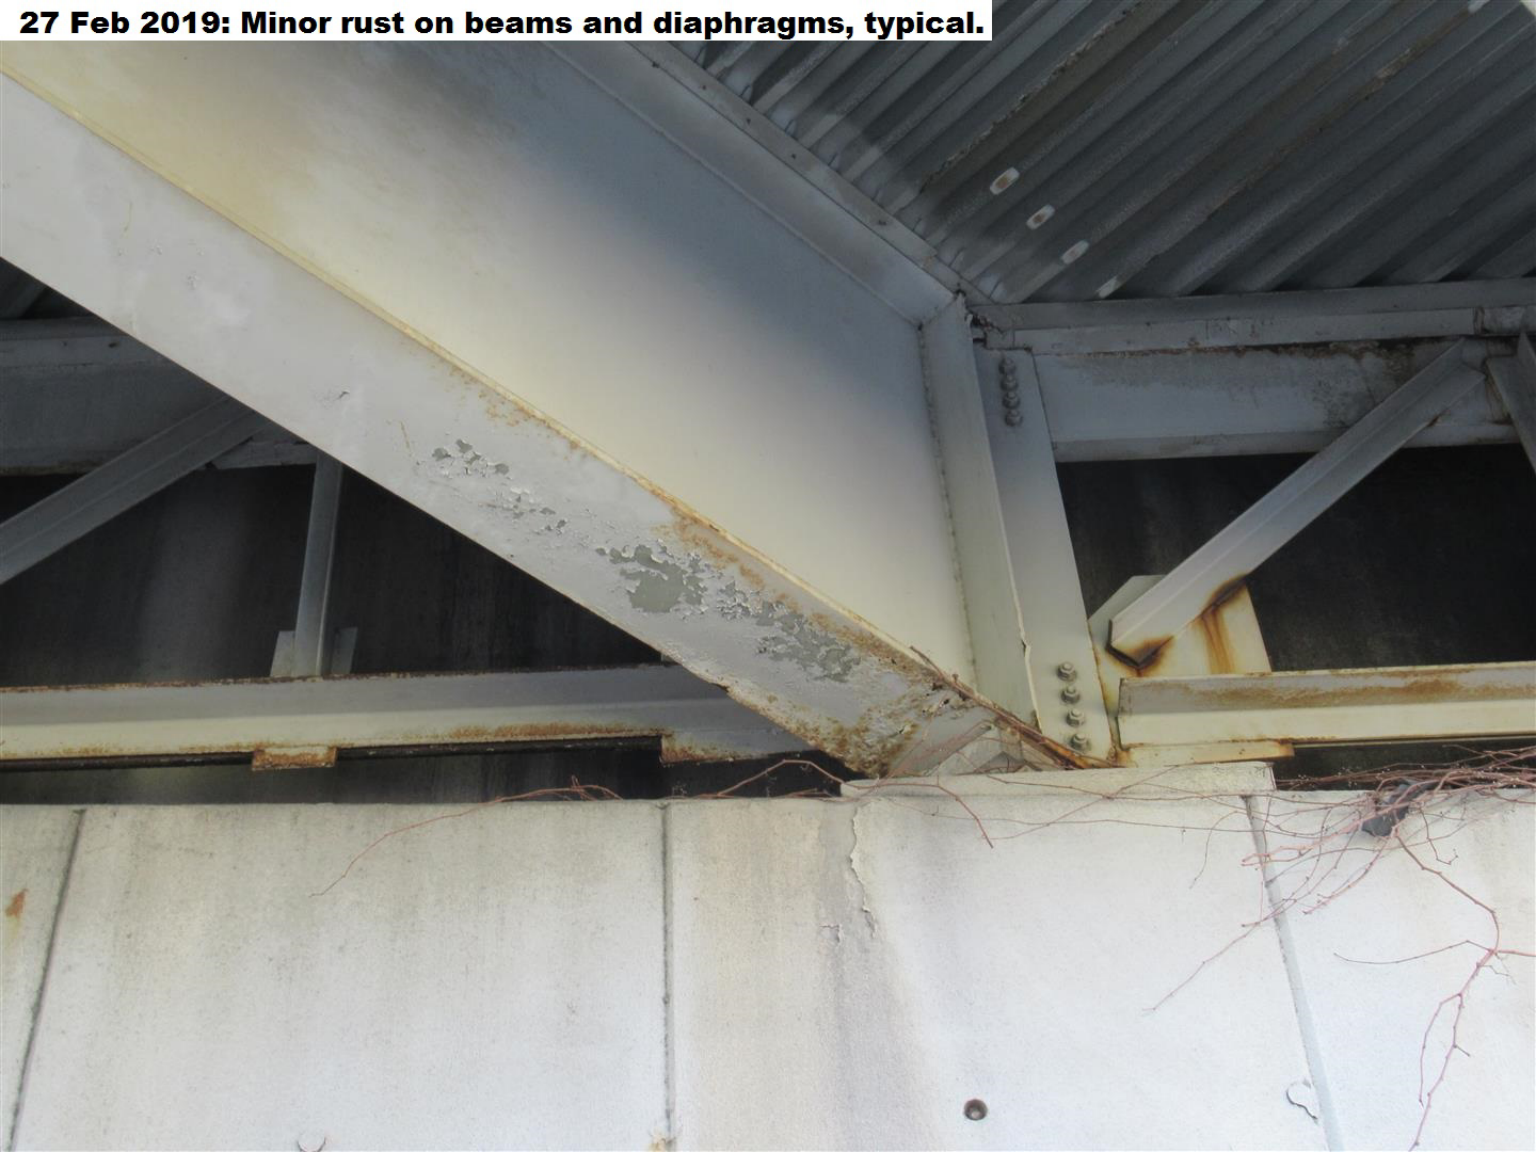
(7) Several loose splice plate bolts, (see sketch sheet). Minor rust on steel beams and diaphragms, (see photo).

27 Feb 2019: Minor rust on beams and diaphragms, typical.

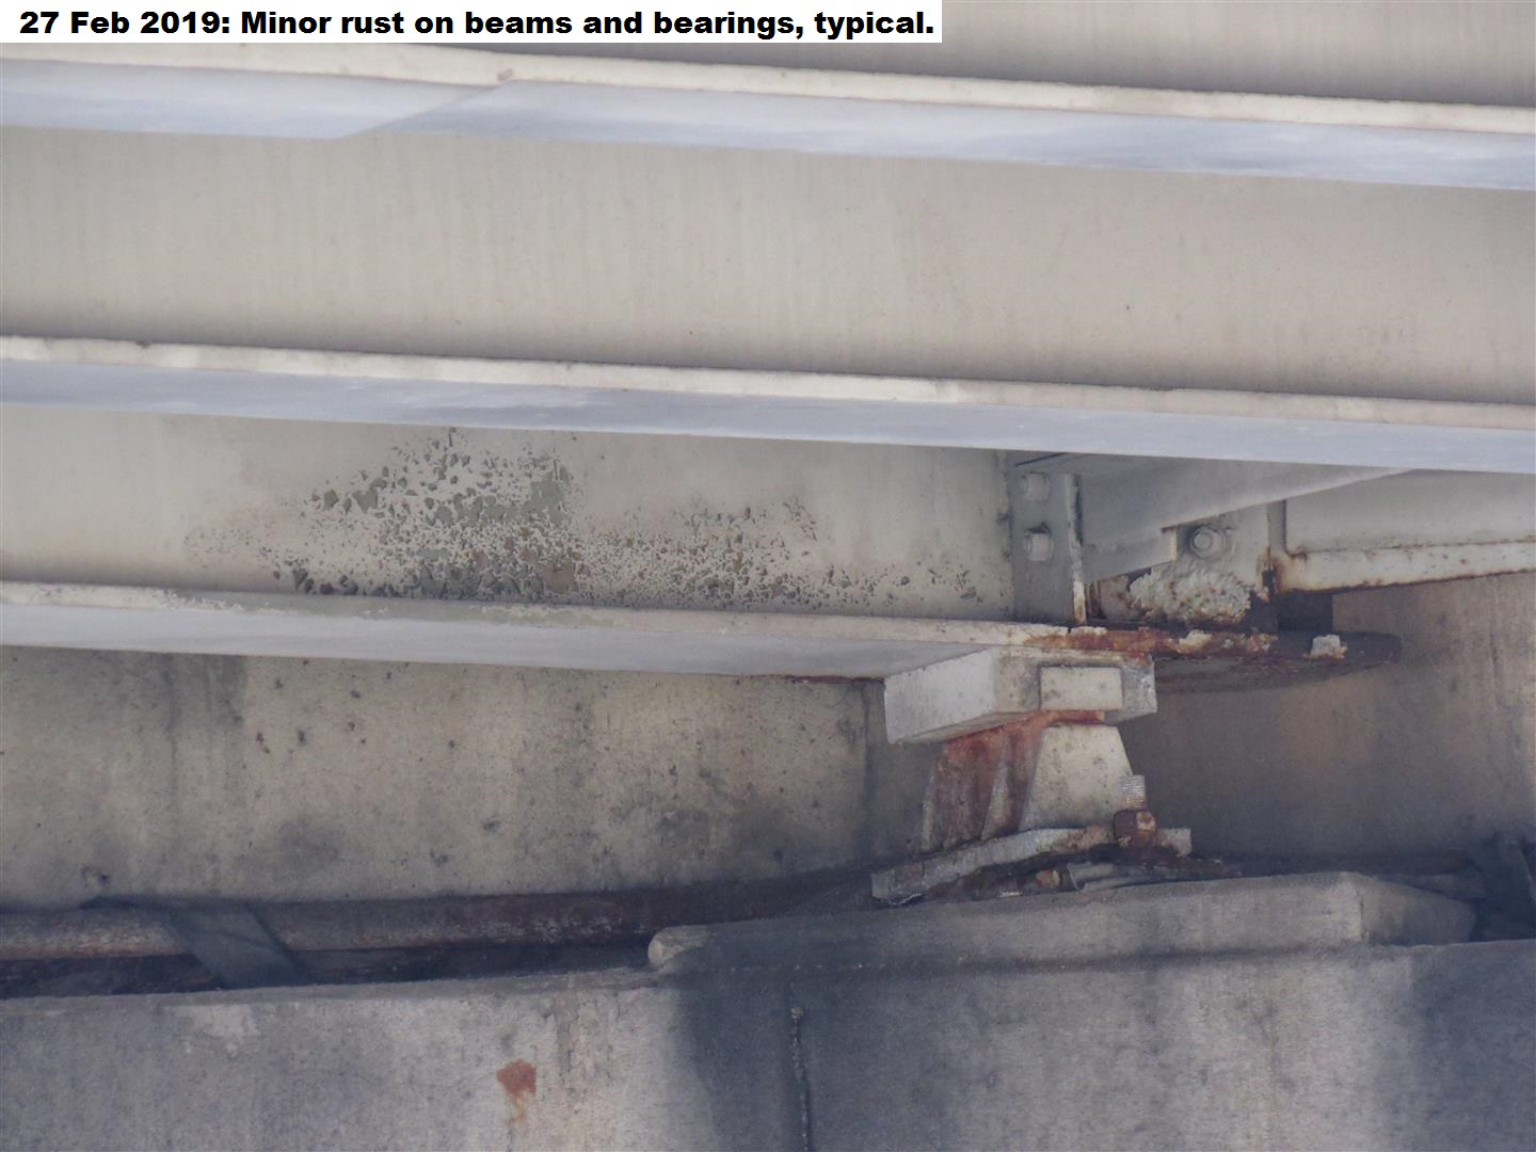
27 Feb 2019: Minor rust on beams and bearings, typical.

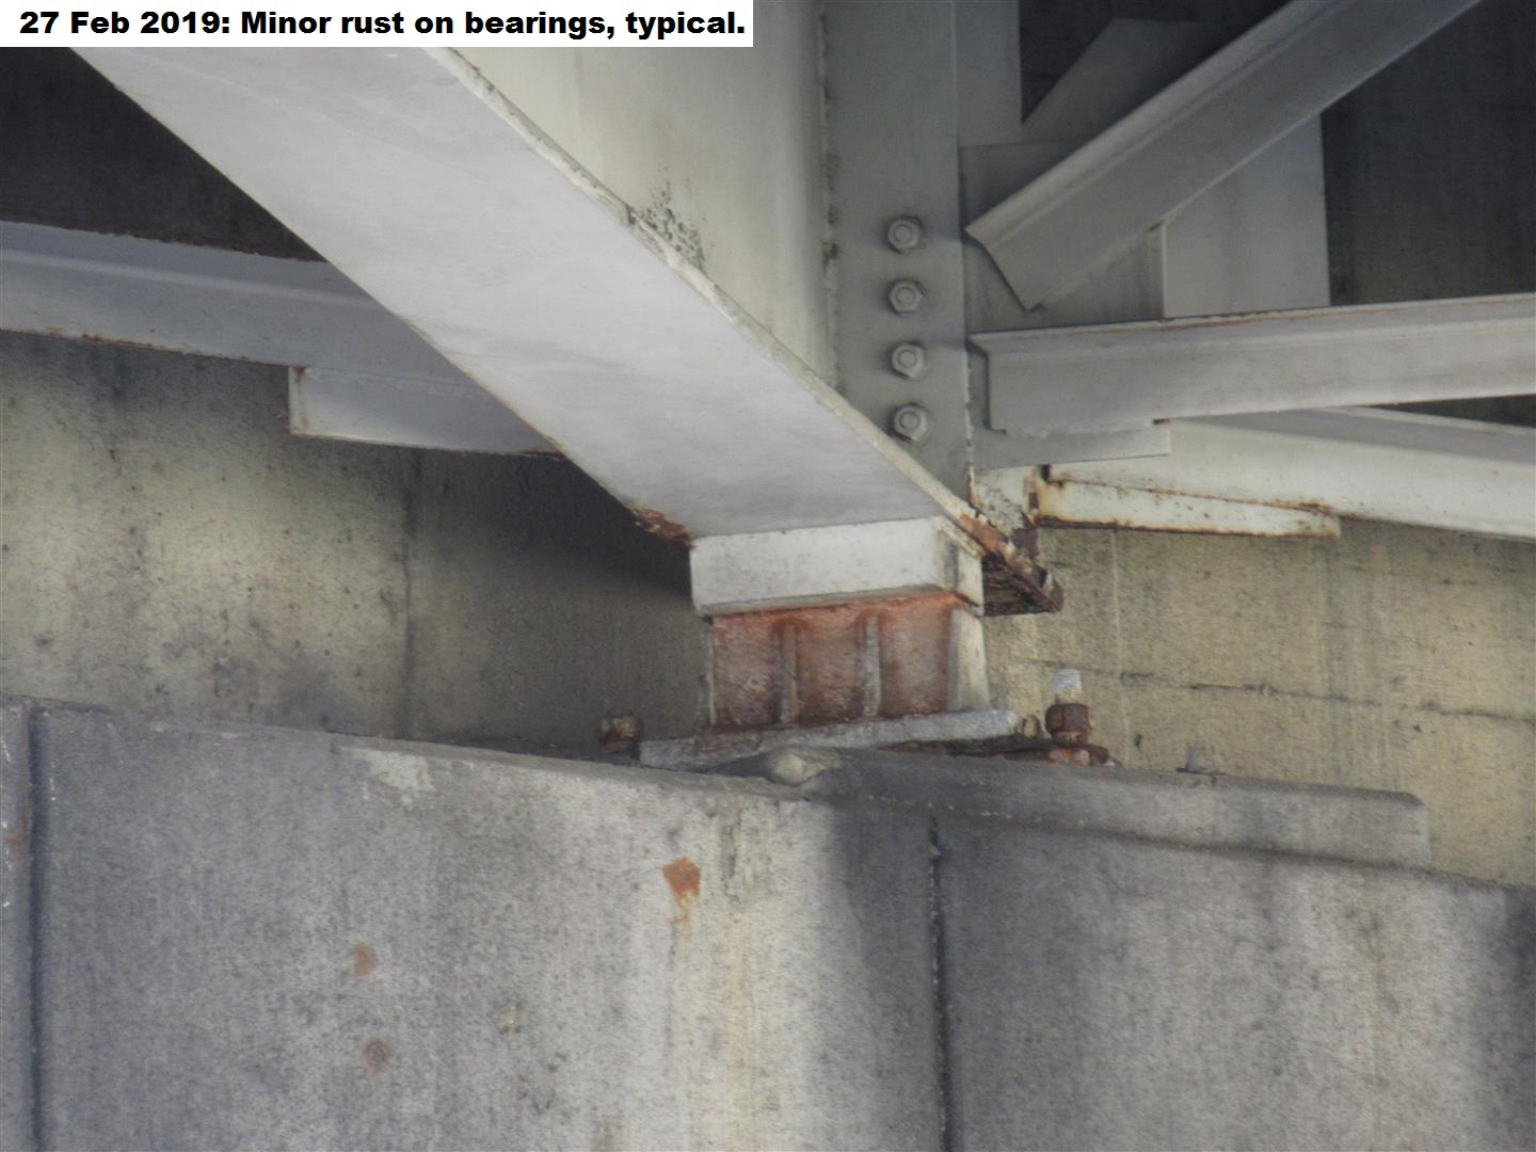
Several loose anchor bolt nuts, (see sketch sheet). Beam 9, bent 4 has a cracked weld in sole plate, left side, (see photo). Minor rust on bearings, (see photo).

27 Feb 2019: Minor rust on bearings, typical.

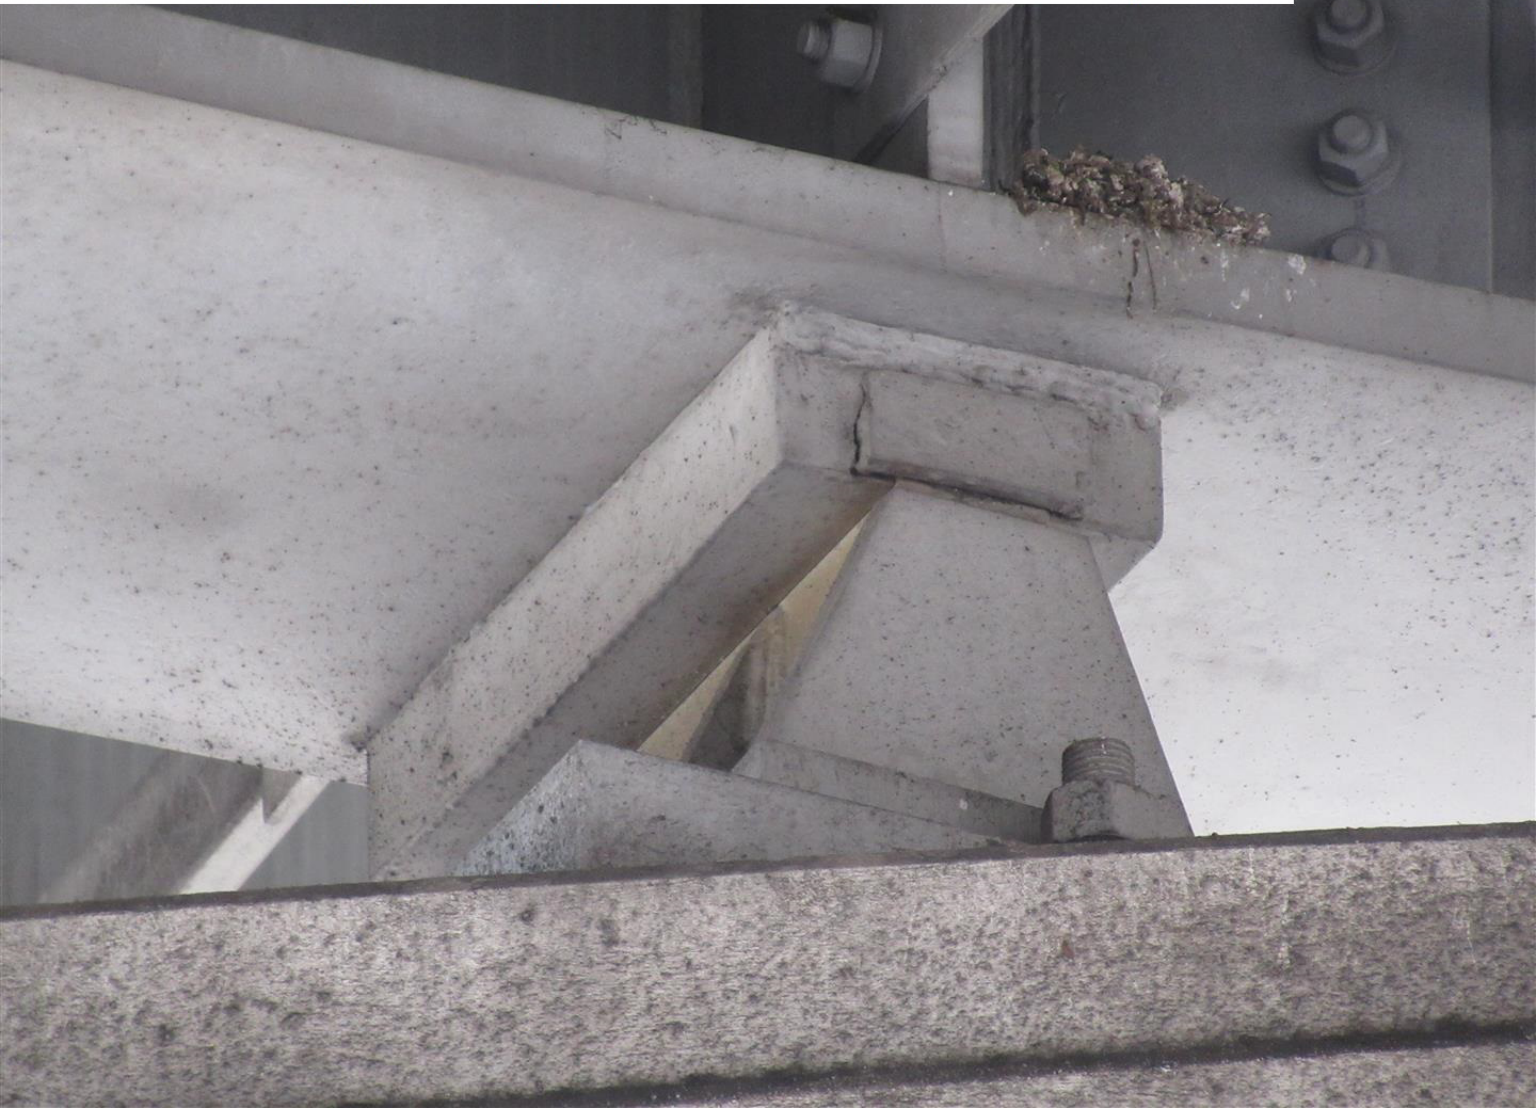
27 Feb 2019: Bearing at beam 9, bent 4 sole plate has broken welds, left side.

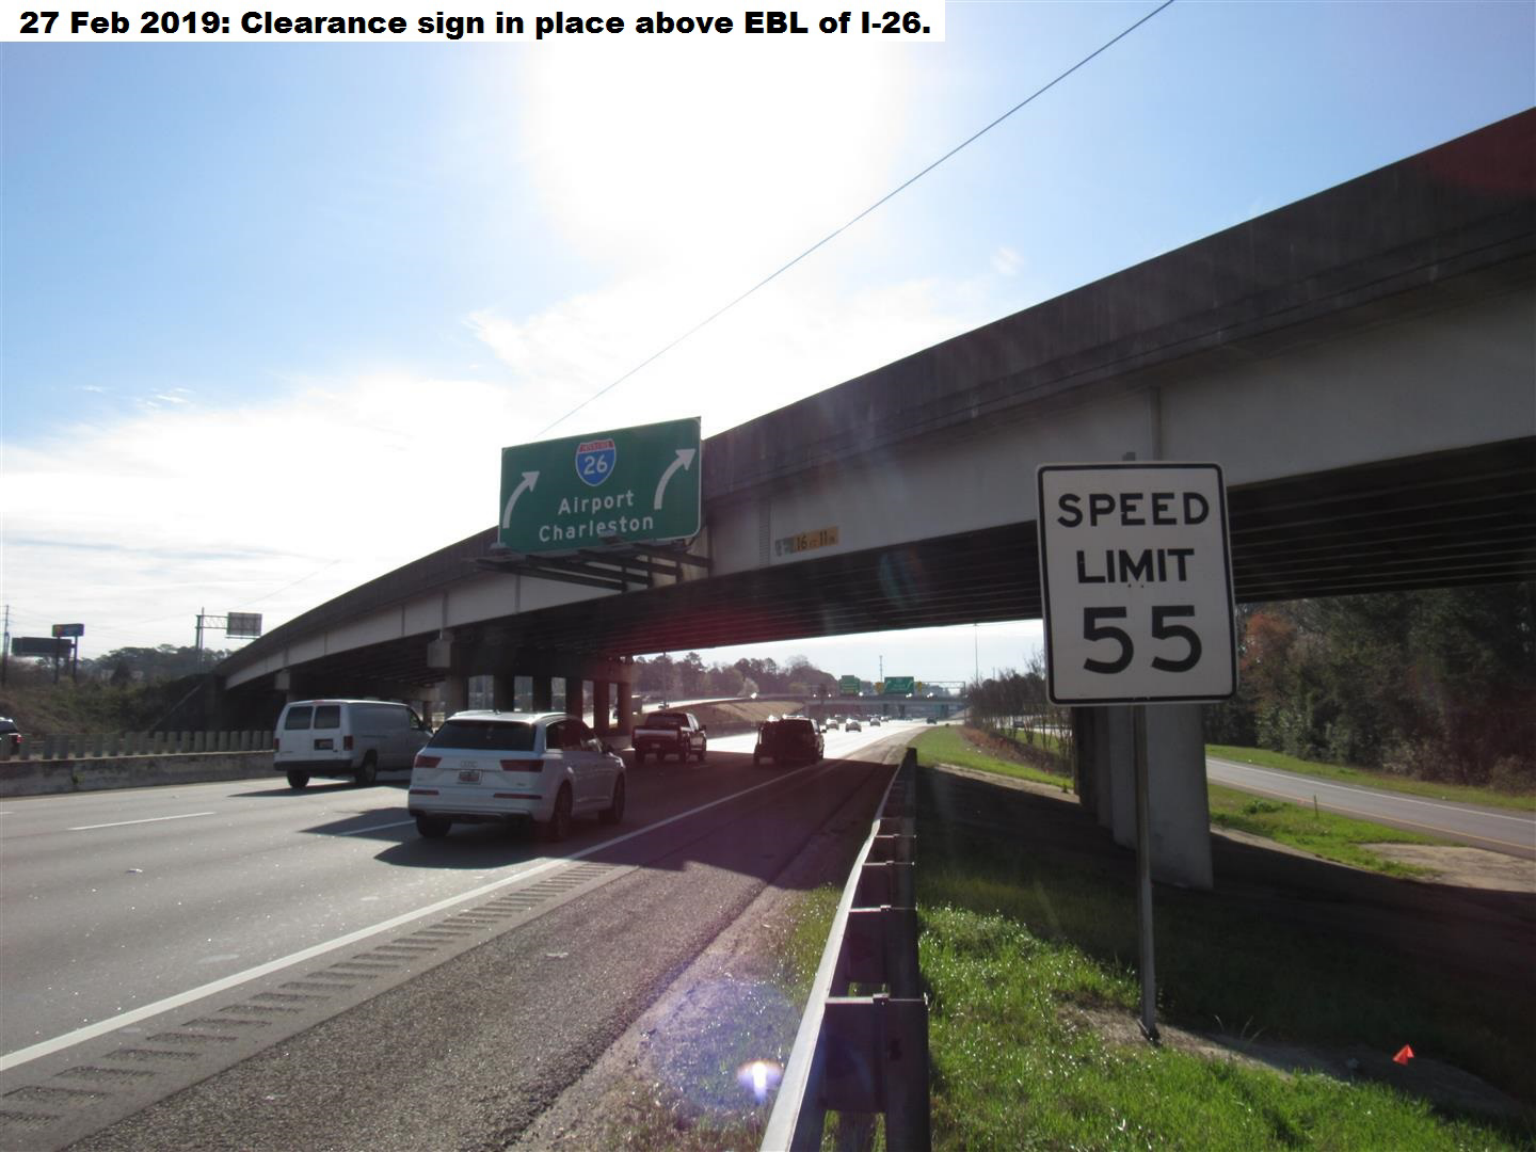
2ea bridge end signs in place on S-31. No bridge end signs on I-26. Clearance sign of 16'11" above EBL of I-26 in place. Directional sign in place above EBL of I-26.

27 Feb 2019: Clearance sign in place above EBL of I-26.
