## Carolina Crossroads - Video Inspection Summary - Phase 2 - 04/09/2021

# I-20/I-26/I-126 Corridor Improvement Project

Structure EC-4201

4' x 4' RCBC

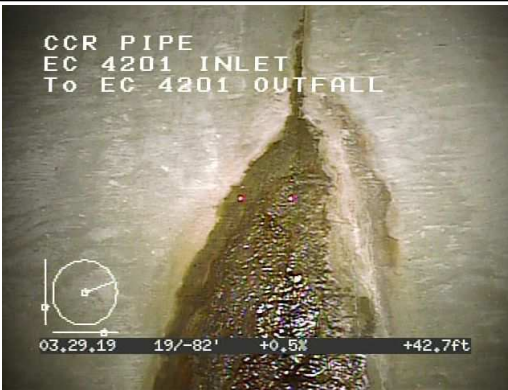
<p>CCR PIPE  EC 4201 INLET  To EC 4201 OUTFALL</p> <p>03.29.19 -176/-82' +0.5% +42.7ft</p>
42.7	<p style="text-align: center;"><b>Infil Weeper</b>  <b>Position: 3 To 5</b>  <b>Severity: None</b>  <b>Joint</b>  <b>Maint Weight: 2</b></p>	11:10

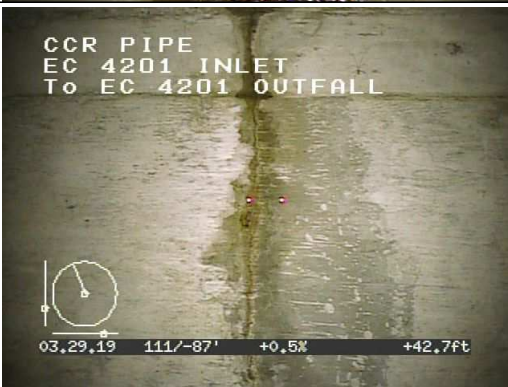
<p>CCR PIPE  EC 4201 INLET  To EC 4201 OUTFALL</p> <p>03.29.19 19/-82' +0.5% +42.7ft</p>
42.7	<p style="text-align: center;"><b>Infil Stain</b>  <b>Position: 10 To 1</b>  <b>Severity: None</b>  <b>Joint</b></p>	11:42

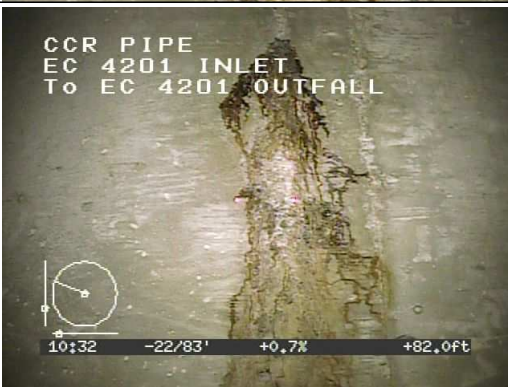
82.0	<b>Infil Weeper</b> <b>Position: 8 To 10</b> <b>Severity: None</b> <b>Maint Weight: 2</b>	20:54

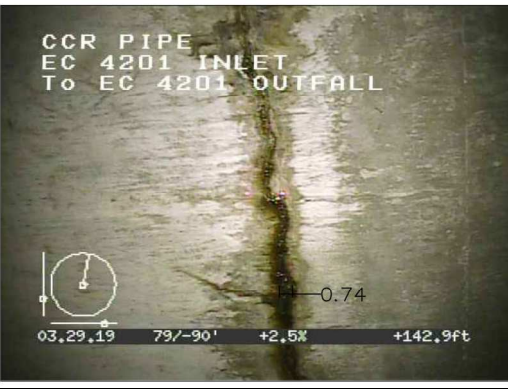
Distance	Fault Observation	Time	Picture
142.9	<p align="center"><b>Crack</b>  <b>Circumferential</b>  <b>Position: 10 To 2</b>  <b>Severity: None</b>  <b>Struct Weight: 1</b></p>	37:44

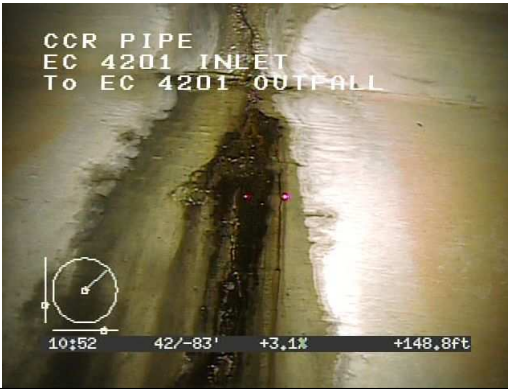
Distance	Fault Observation	Time	Picture
148.8	<p style="text-align: center;"><b>Infil Weeper</b>  <b>Position: 7 To 5</b>  <b>Severity: None</b>  <b>Maint Weight: 2</b></p>	40:11

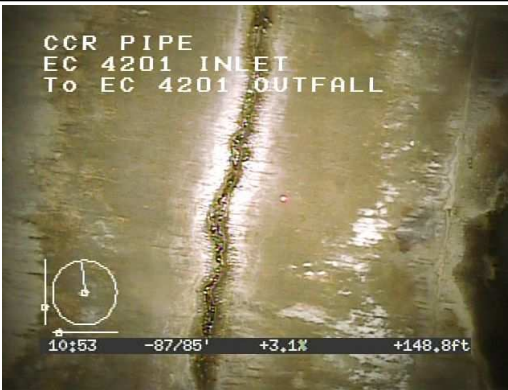
<p>CCR PIPE EC 4201 INLET To EC 4201 OUTFALL</p> <p>10:52 42+/-83' +3.1% +148.8ft</p>
148.8	<p style="text-align: center;"><b>Crack</b>  <b>Circumferential</b>  <b>Position: 11 To 1</b>  <b>Severity: None</b>  <b>Remarks: CRACK</b>  <b>WITH POSSIBLE</b>  <b>ROOTS</b>  <b>Struct Weight: 1</b></p>	41:06

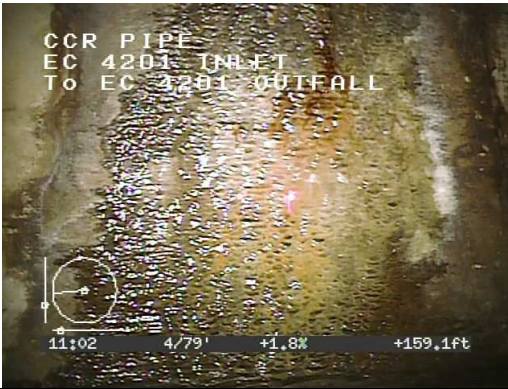
Distance	Fault Observation	Time	Picture
159.2	<p style="text-align: center;"><b>Infil Weeper</b>  <b>Position: 7 To 10</b>  <b>Severity: None</b>  <b>Maint Weight: 2</b></p>	49:57

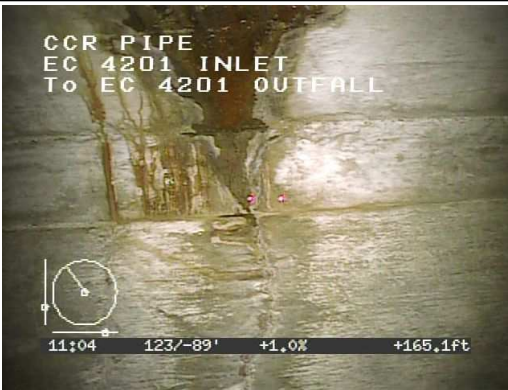
<p>CCR PIPE EC 4201 INLET TO EC 4201 OUTFALL</p> <p>11:02 4/79' +1.8% +159.1ft</p>
165.2	<p style="text-align: center;"><b>Crack</b>  <b>Circumferential</b>  <b>Position: 11 To 1</b>  <b>Severity: None</b>  <b>Struct Weight: 1</b></p>	51:03

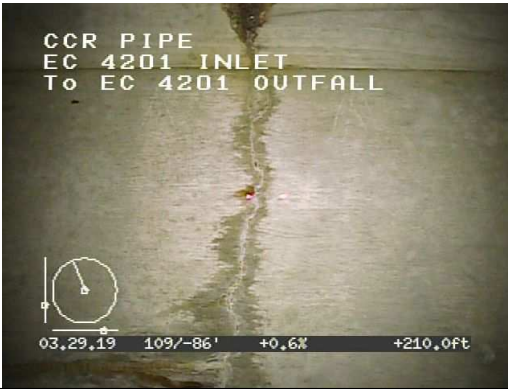
Distance	Fault Observation	Time	Picture
210.1	<p align="center"><b>Crack</b>  <b>Circumferential</b>  <b>Position: 11 To 1</b>  <b>Severity: None</b>  <b>Struct Weight: 1</b></p>	1:03:35

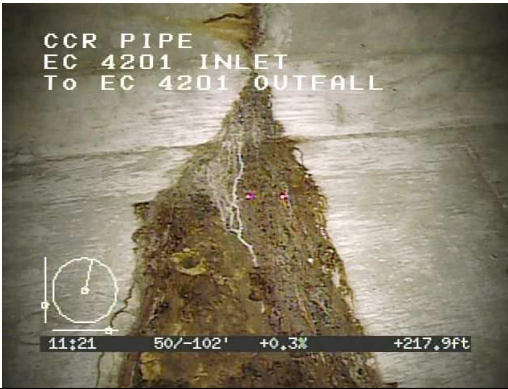
Distance	Fault Observation	Time	Picture
217.9	<b>Roots Fine Barrel</b> <b>Position: 7 To 1</b> <b>Severity: None</b> <b>Maint Weight: 2</b>	1:07:23

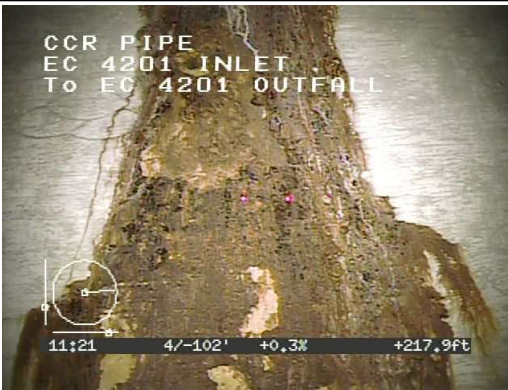
<p>CCR PIPE EC 4201 INLET To EC 4201 OUTFALL</p> <p>11:21 50/-102' +0.3% +217.9ft</p>
217.9	<b>Infil Stain</b> <b>Position: 7 To 5</b> <b>Severity: None</b>	1:07:52

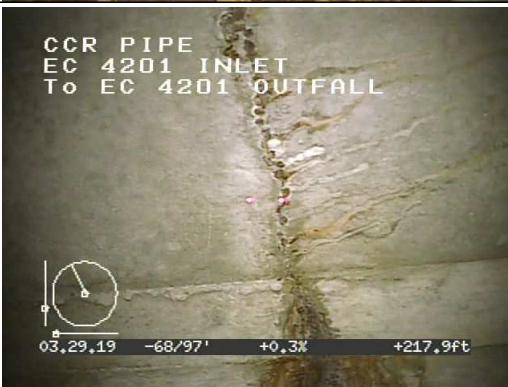
<p>CCR PIPE EC 4201 INLET To EC 4201 OUTFALL</p> <p>11:21 4/-102' +0.3% +217.9ft</p>
217.9	<b>Crack</b> <b>Circumferential</b> <b>Position: 11 To 1</b> <b>Severity: None</b> <b>Struct Weight: 1</b>	1:08:29

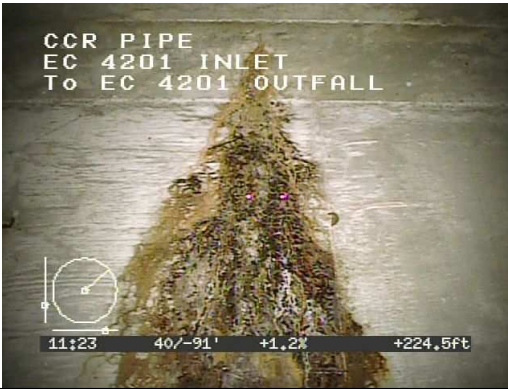
Distance	Fault Observation	Time	Picture
224.6	<b>Roots Fine Barrel</b> <b>Position: 1 To 5</b> <b>Severity: None</b> <b>Maint Weight: 2</b>	1:10:49

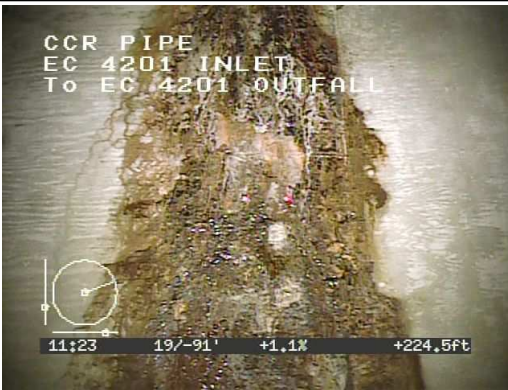
224.6	<b>Infil Stain</b> <b>Position: 1 To 5</b> <b>Severity: None</b>	1:09:43

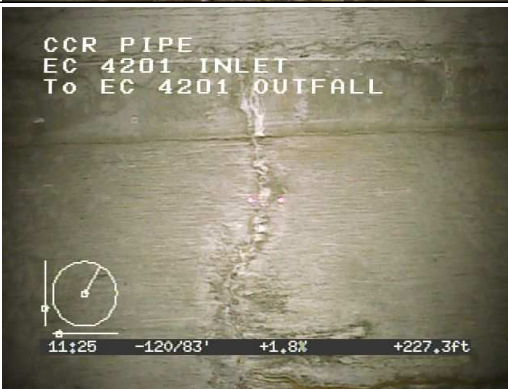
227.4	<b>Crack</b> <b>Circumferential</b> <b>Position: 11 To 1</b> <b>Severity: None</b> <b>Struct Weight: 1</b>	1:12:41

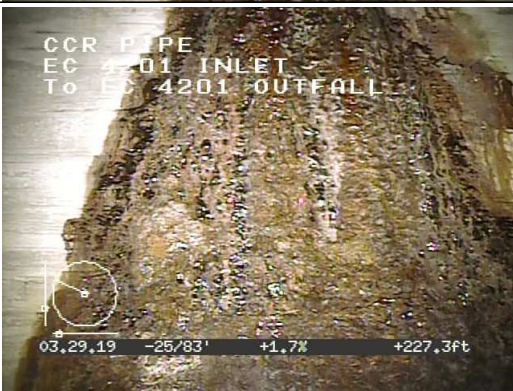
227.4	<b>Infil Weeper</b> <b>Position: 7 To 11</b> <b>Severity: None</b> <b>Maint Weight: 2</b>	1:12:32

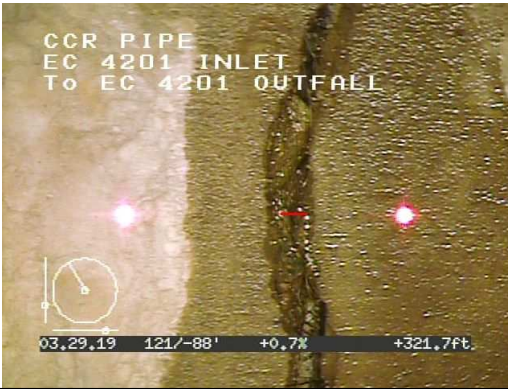
- 33) 311.0 feet – Transverse crack, fine root intrusion, and infiltration weeping on top of culvert.
  - 34) 321.8 feet – Severe transverse crack in top of culvert (0.23" gap); infiltration weeping on left and right sides of culvert.

Distance	Fault Observation	Time	Picture
321.8	<p style="text-align: center;"><b>General Observation</b>  <b>Severity: None</b>  <b>Remarks: 0.23</b></p>	1:41:37

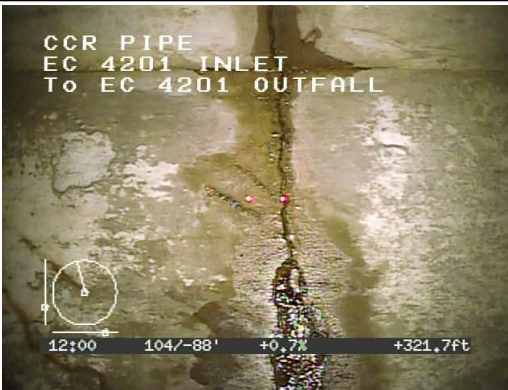
321.8	<p style="text-align: center;"><b>Crack Circumferential</b>  <b>Position: 11 To 1</b>  <b>Severity: None</b>  <b>Struct Weight: 1</b></p>	1:42:17

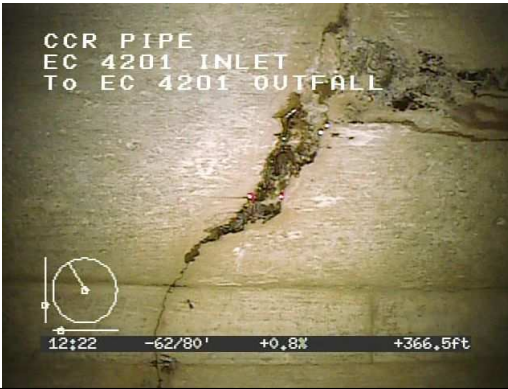
Distance	Fault Observation	Time	Picture
366.6	<b>Roots Fine Barrel</b> <b>Position: 11 To 12</b> <b>Severity: None</b> <b>Maint Weight: 2</b>	2:02:32

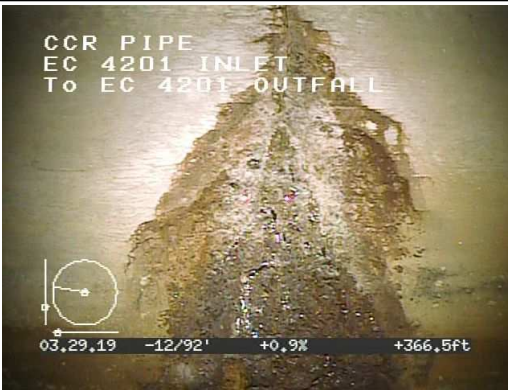
366.6	<b>Infil Stain</b> <b>Position: 7 To 10</b> <b>Severity: None</b>	2:02:59

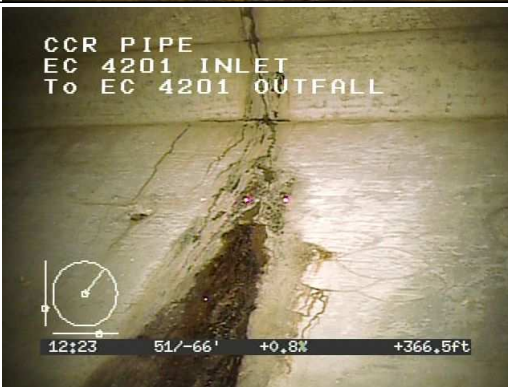
366.6	<b>Infil Weeper</b> <b>Position: 2 To 5</b> <b>Severity: None</b> <b>Maint Weight: 2</b>	2:03:41

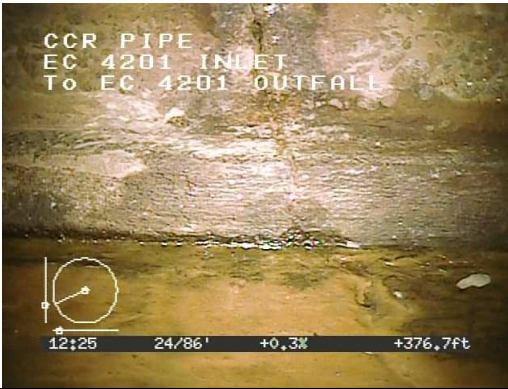
Distance	Fault Observation	Time	Picture
376.8	<p style="text-align: center;"><b>Crack</b>  <b>Circumferential</b>  <b>Position: 7 To 11</b>  <b>Severity: None</b>  <b>Struct Weight: 1</b></p>	2:05:32

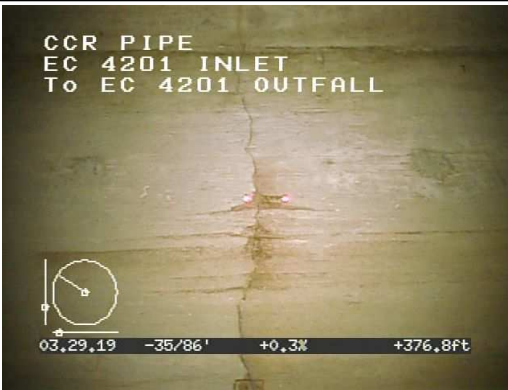
<p>CCR PIPE  EC 4201 INLET  To EC 4201 OUTFALL</p> <p>12:25    24/86'    +0.3%    +376.7ft</p>
376.8	<p style="text-align: center;"><b>Picture Number: 2</b>  <b>Crack</b>  <b>Circumferential</b>  <b>Position: 7 To 11</b></p>	0

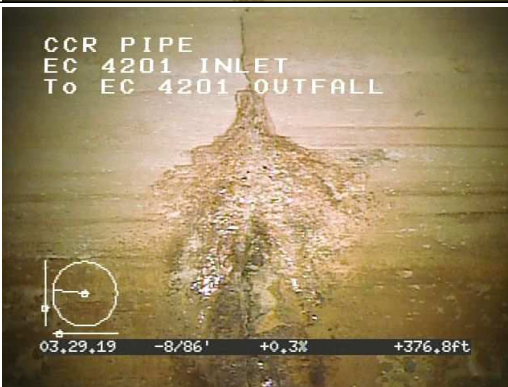
<p>CCR PIPE  EC 4201 INLET  To EC 4201 OUTFALL</p> <p>03:29.19    -35/86'    +0.3%    +376.8ft</p>
376.9	<p style="text-align: center;"><b>Infil Stain</b>  <b>Position: 7 To 9</b>  <b>Severity: None</b></p>	2:08:03

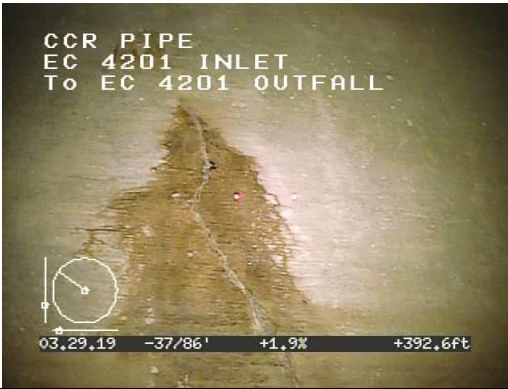
Distance	Fault Observation	Time	Picture
392.7	Picture Number: 2 Crack Circumferential Position: 8 To 10	0

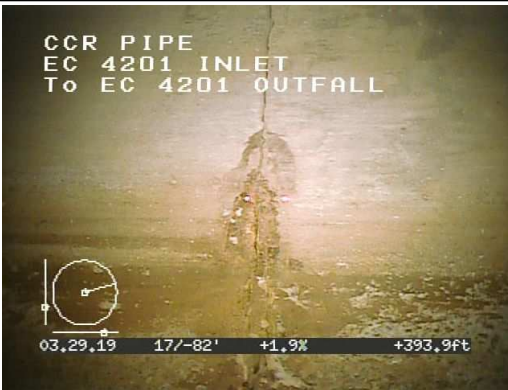
<p>CCR PIPE EC 4201 INLET To EC 4201 OUTFALL</p> <p>03,29,19 -37/86' +1.9% +392.6ft</p>
394.1	Infil Stain Position: 4 To 5 Severity: None Joint	2:16:21

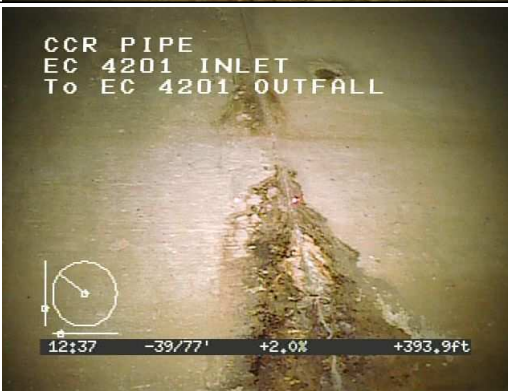
<p>CCR PIPE EC 4201 INLET To EC 4201 OUTFALL</p> <p>03,29,19 17/-82' +1.9% +393.9ft</p>
394.1	Infil Stain Position: 7 To 10 Severity: None Joint	2:17:19

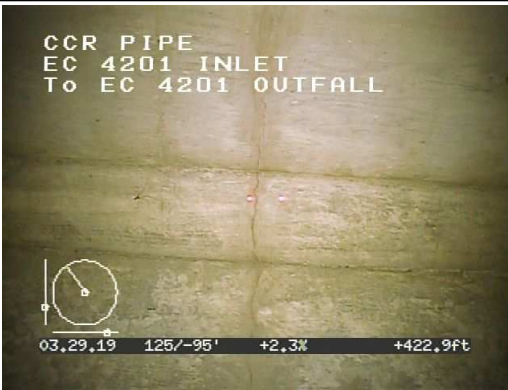
422.9	<p align="center"><b>Picture Number: 2</b>  <b>Crack</b>  <b>Circumferential</b>  <b>Position: 10 To 1</b></p>	0

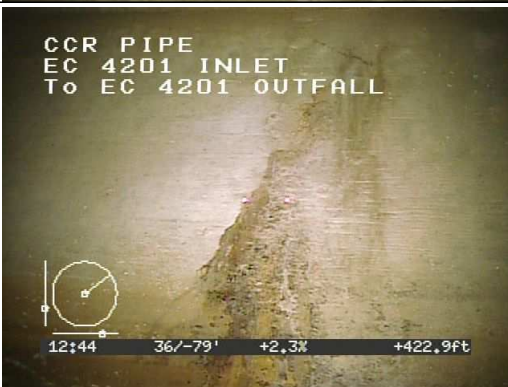
423.1	<p align="center"><b>Infil Stain</b>  <b>Position: 2 To 4</b>  <b>Severity: None</b></p>	2:24:31

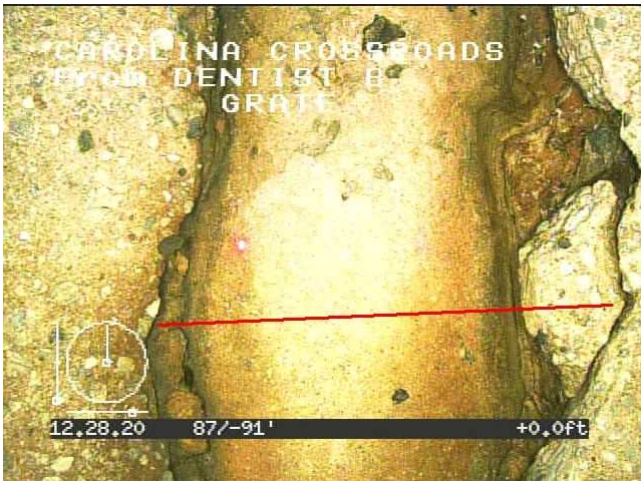
6.7	<p>Broken Position: 12 Severity: None Joint Remarks: BROKEN SPIGOT 6.208 Struct Weight: 4</p>	02:57

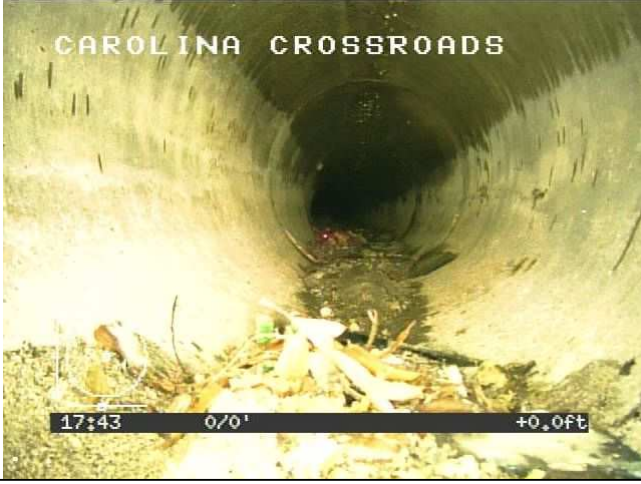
<p>CAROLINA CROSSROADS</p> <p>17:43 0/0' +0.0ft</p>
7.1	<p><b>Obstruction Other</b> Position: 5 To 7 Severity: None Cont Defect: S01 Percent: 15 Remarks: GRAVEL DIRT ETC IN PIPE Maint Weight: 3</p>	01:57

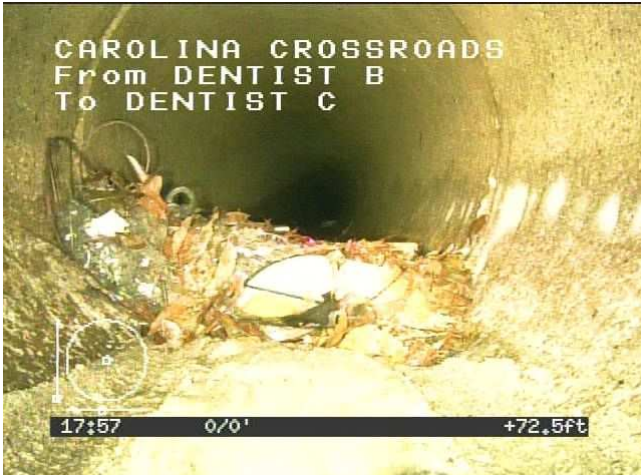
Distance	Fault Observation	Time	Picture
72.5	<p data-bbox="339 98 523 147"><b>EP-4242</b></p> <p data-bbox="308 181 584 495"><b>Obstruction Other</b>  <b>Position: 5 To 7</b>  <b>Severity: None</b>  <b>Cont Defect: F01</b>  <b>Percent: 15</b>  <b>Remarks: GRAVEL DIRT</b>  <b>ETC IN PIPE</b>  <b>Maint Weight: 3</b></p>	15:45

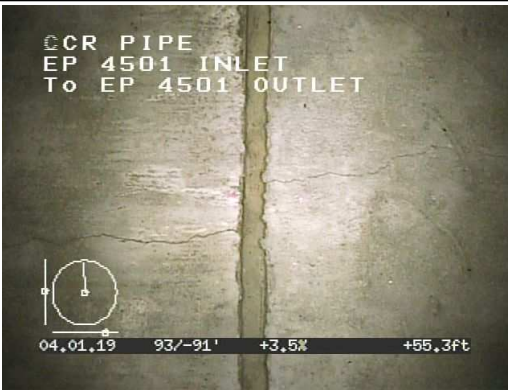
<p>CCR PIPE EP 4501 INLET To EP 4501 OUTLET</p> <p>04,01,19 93/-91' +3.5% +55.3ft</p>
55.3	<b>Infil Stain</b> <b>Position: 7 To 9</b> <b>Severity: None</b> <b>Joint</b>	20:40

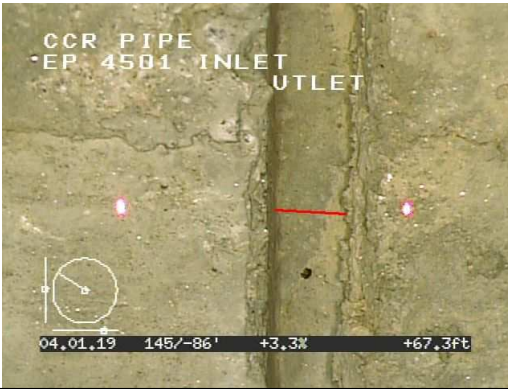
67.4	<p style="text-align: center;"><b>Crack Longitudinal</b>  <b>Position: 12</b>  <b>Severity: None</b>  <b>Joint</b>  <b>Struct Weight: 2</b></p>	28:26

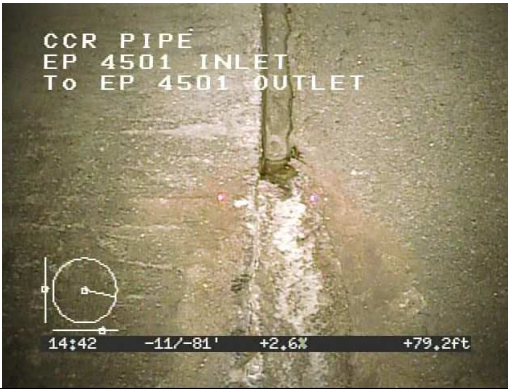
<p>CCR PIPE EP 4501 INLET To EP 4501 OUTLET</p> <p>14:42 -11/-81' +2.6% +79.2ft</p>
79.2	<p style="text-align: center;"><b>General Observation</b>  <b>Severity: None</b>  <b>Remarks: 0.82</b></p>	32:38

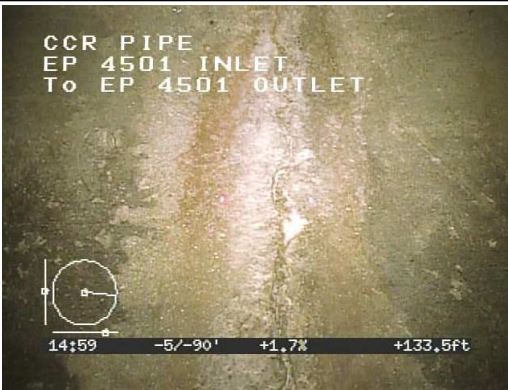
<p>CCR PIPE EP 4501 INLET To EP 4501 OUTLET</p> <p>14:59 -5/-90' +1.7% +133.5ft</p>
133.6	<p style="text-align: center;"><b>Infil Stain</b>  <b>Position: 3 To 5</b>  <b>Severity: None</b>  <b>Joint</b></p>	48:32

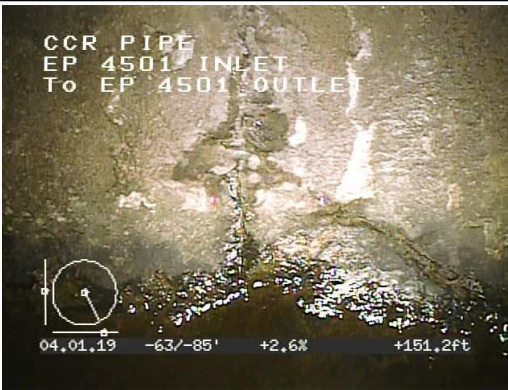
<p>CCr PIPE EP 4501 INLET To EP 4501 OUTLET</p> <p>04,01,19 -63/-85' +2.6% +151.2ft</p>
151.3	<b>Infil Stain</b> <b>Position: 7 To 5</b> <b>Severity: None</b> <b>Joint</b>	54:22	  <p>CCr PIPE EP 4501 INLET UTLET</p> <p>04,01,19 -23/-85' +2.5% +151.2ft</p>

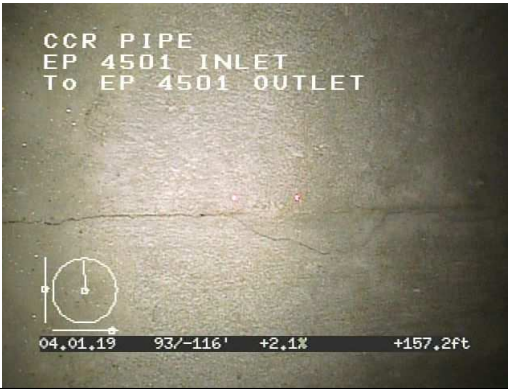
<p>CCR PIPE EP 4501 INLET To EP 4501 OUTLET</p> <p>04,01,19 93/-116' +2,1% +157,2ft</p>
157.3	<b>Picture Number: 2</b> <b>Crack Longitudinal</b> <b>Position: 12</b>	0

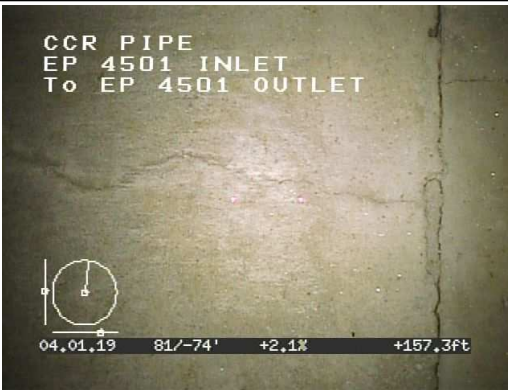
<p>CCR PIPE EP 4501 INLET To EP 4501 OUTLET</p> <p>04,01,19 81/-74' +2,1% +157,3ft</p>
157.3	<b>Infil Stain</b> <b>Position: 7 To 9</b> <b>Severity: None</b> <b>Joint</b>	56:01

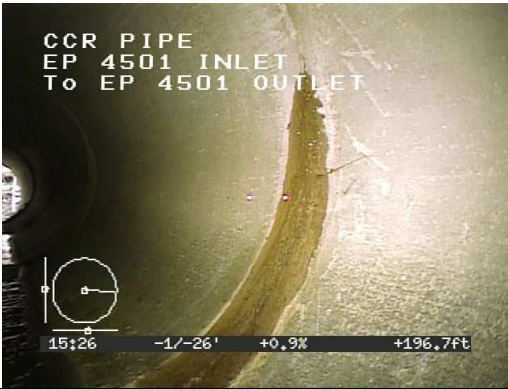
<p>CCR PIPE EP 4501 INLET To EP 4501 OUTLET</p> <p>15:26 -1/-26' +0.9% +196.7ft</p>
198.9	<p align="center"><b>Infil Stain</b>  <b>Position: 7 To 9</b>  <b>Severity: None</b>  <b>Joint</b></p>	1:14:05
