## ***I-26 Bridge Assessments***

# **Bridge Assessment Report for SC202 over I-26**

**Prepared for:**  
**The South Carolina Department of Transportation**

**November 11, 2016**

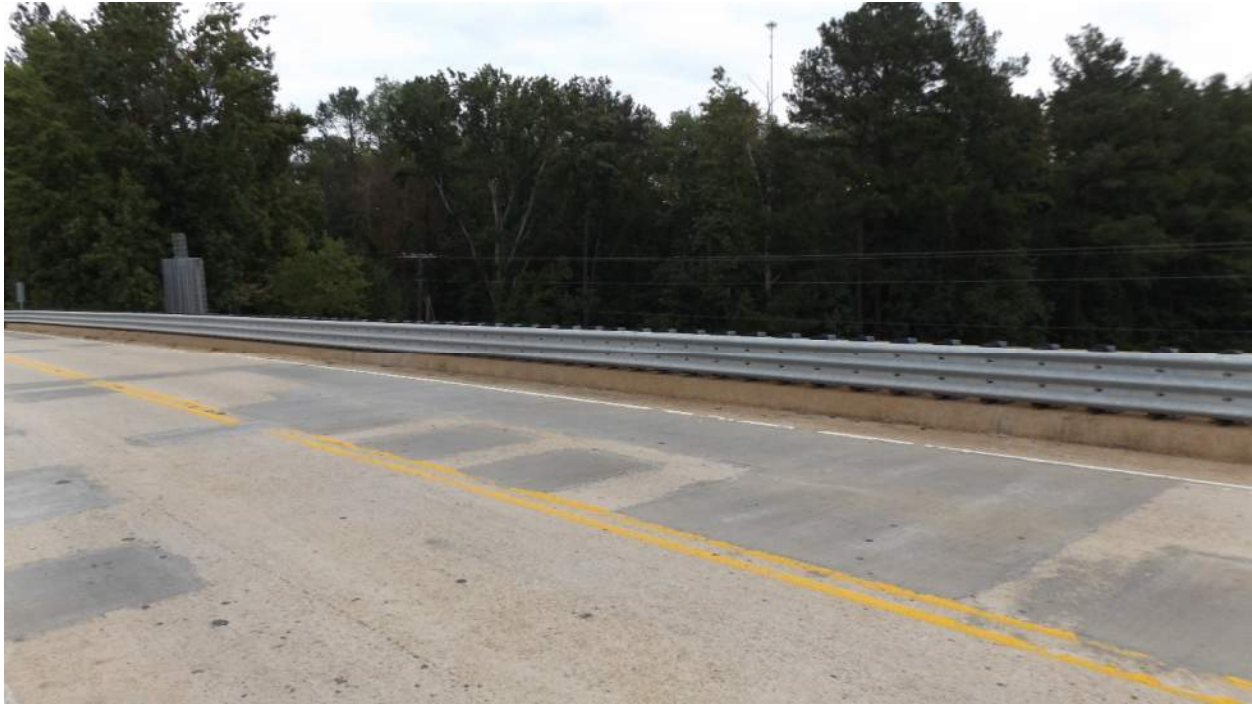
Figure 4 - Deck

The existing reinforced concrete deck was observed from the shoulder since the roadway wasn't closed. Overall, the bridge deck shows little deterioration. However, there are large areas that have been repaired, so there is potential deterioration that is not visible due to the repairs. The most recent Bridge Inspection Report documents that the deck was patched in 2011. The concrete end walls showed very little deterioration.

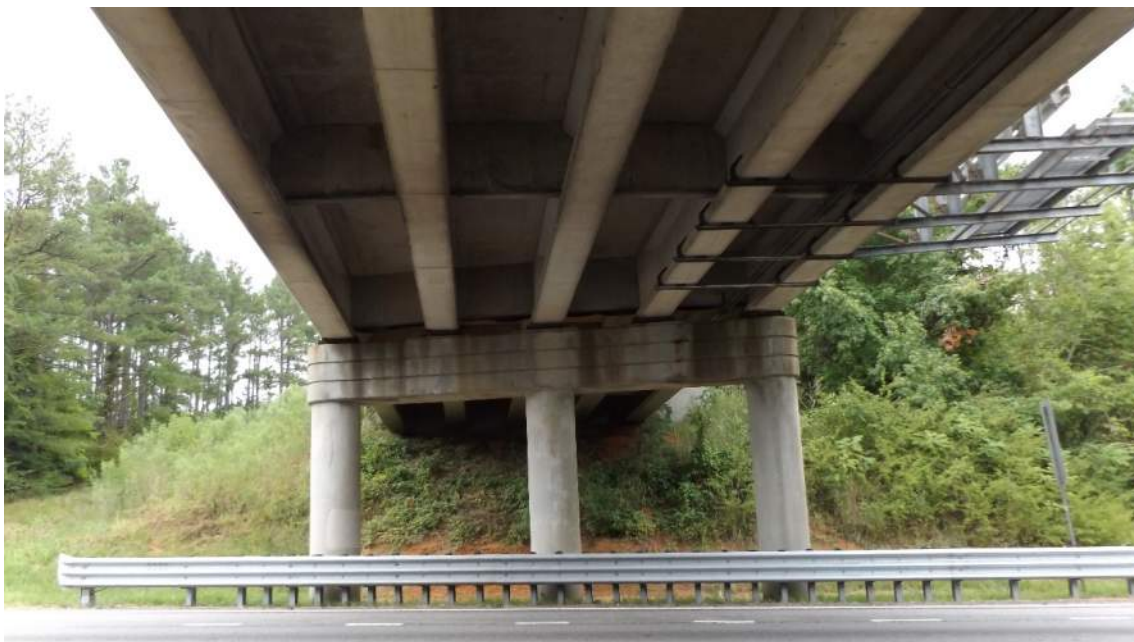
Figure 5 – Superstructure (from underneath)

The existing prestressed concrete beams were assessed from accessible areas on the ground for deterioration and cracks. No deterioration or cracks were observed from the ground. The most recent Bridge Inspection Report does document some cracking and delamination in the ends of the beams, including some diagonal cracking and spalling.

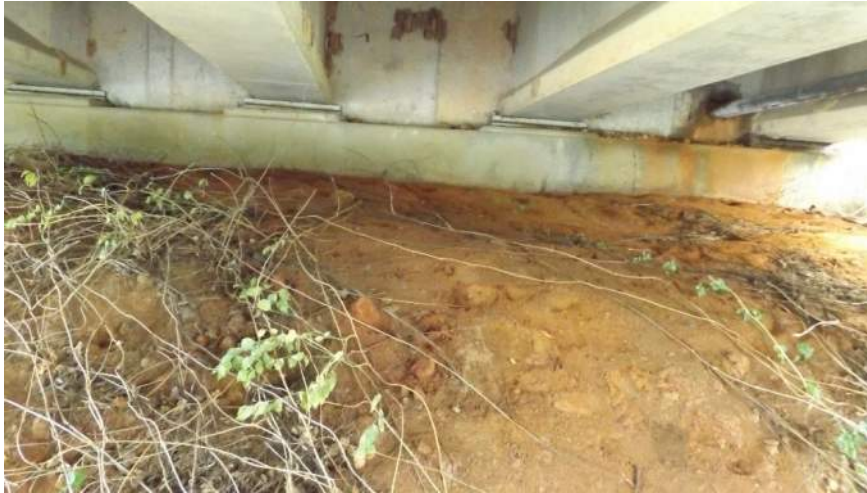
A small portion of the end bent bearings were visible due to the semi-integral end bent and very little deterioration was observed. The exterior bearings showed more deterioration than the interior bearings at the end bents. The interior bent bearings were not accessible from short distance, but were viewed from the ground and appeared to be in a medium state of deterioration with moderate corrosion.

*Figure 6 – End Bent Bearings*

- Raise bridge permanently or undercut I-26 WB lanes to achieve required vertical clearance
- Bearing replacement
- Joint replacement
- Crack repair – interior bent
- Spall repair – column
- General crack, spall, etc. repairs throughout bridge
- Wing wall repair
- Utility repair
- Potential addition of closed drainage system
- Potential seismic modifications

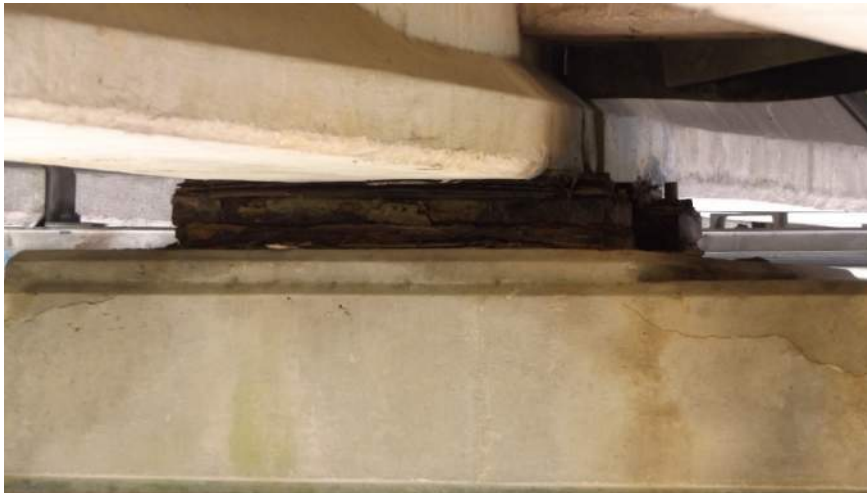
*Figure 7 – Interior Bent Bearing*

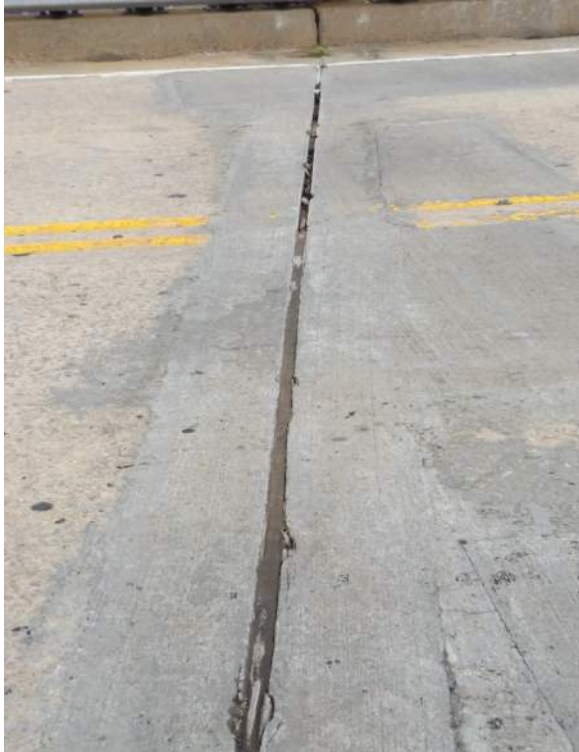
There are three deck expansion joints located within the bridge. They are located at Interior Bent 2, Interior Bent 3, and Interior Bent 4. All three expansion joints were observed from the shoulders due to the roadway not being closed. The joint filler is starting to fall through the opening at several locations. Where the joint filler hasn't fallen through, the material is in a moderate state of deterioration.

*Figure 8 – Expansion Joint*

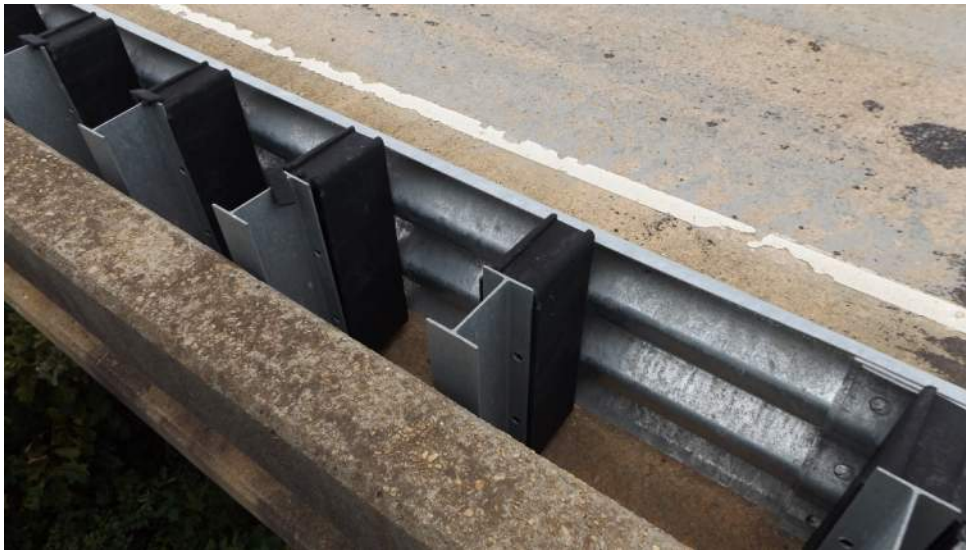
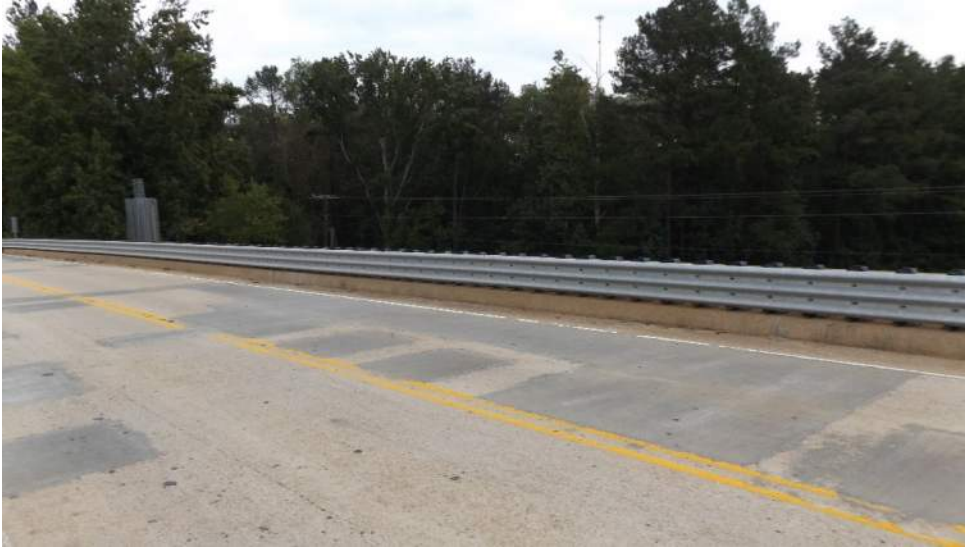
The bridge railing (Figures 9 and 10) is a concrete railing on a concrete curb with guardrail attached to it and showed minimal signs of deterioration.

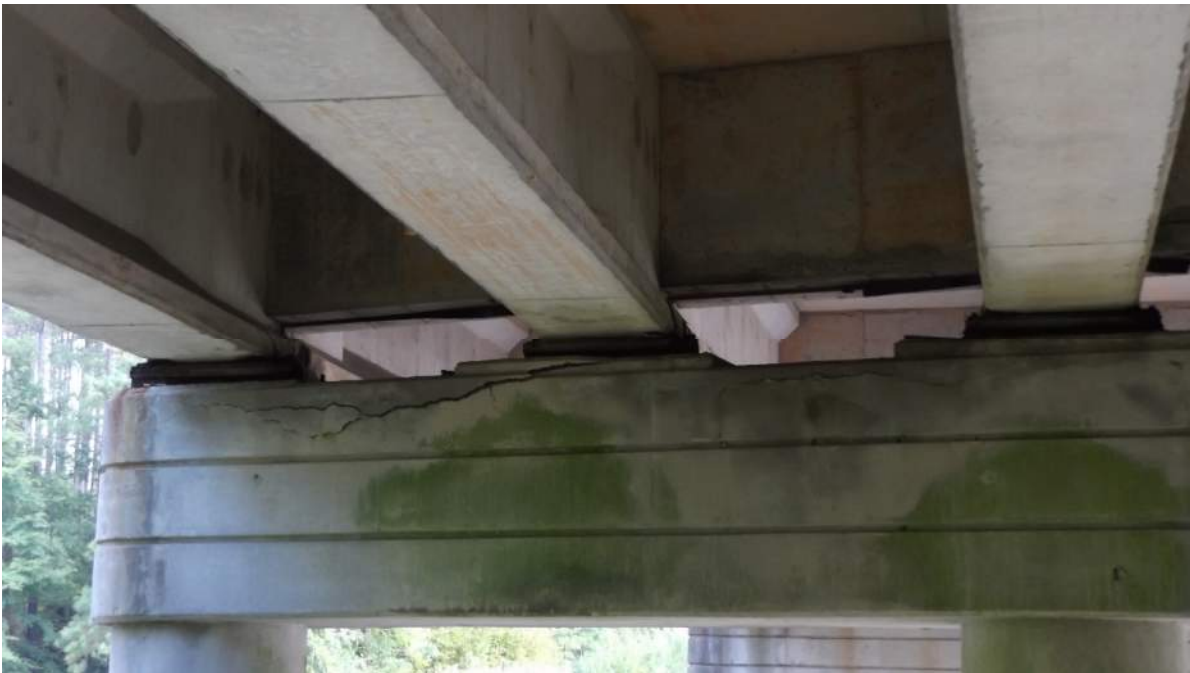
The interior bents are showing signs of deterioration in a few locations. There is a horizontal crack in one of the caps (see Figure 11) and a spall in one of the columns (see Figure 12). The most recent Bridge Inspection Report documents these two items and some additional cracking in the columns.

*Figure 11 – Horizontal Crack in Bent Cap*

The most recent Bridge Inspection Report documents the crack in the bent cap and the spall in the column and other hairline cracks, delamination in various members of the bridge.

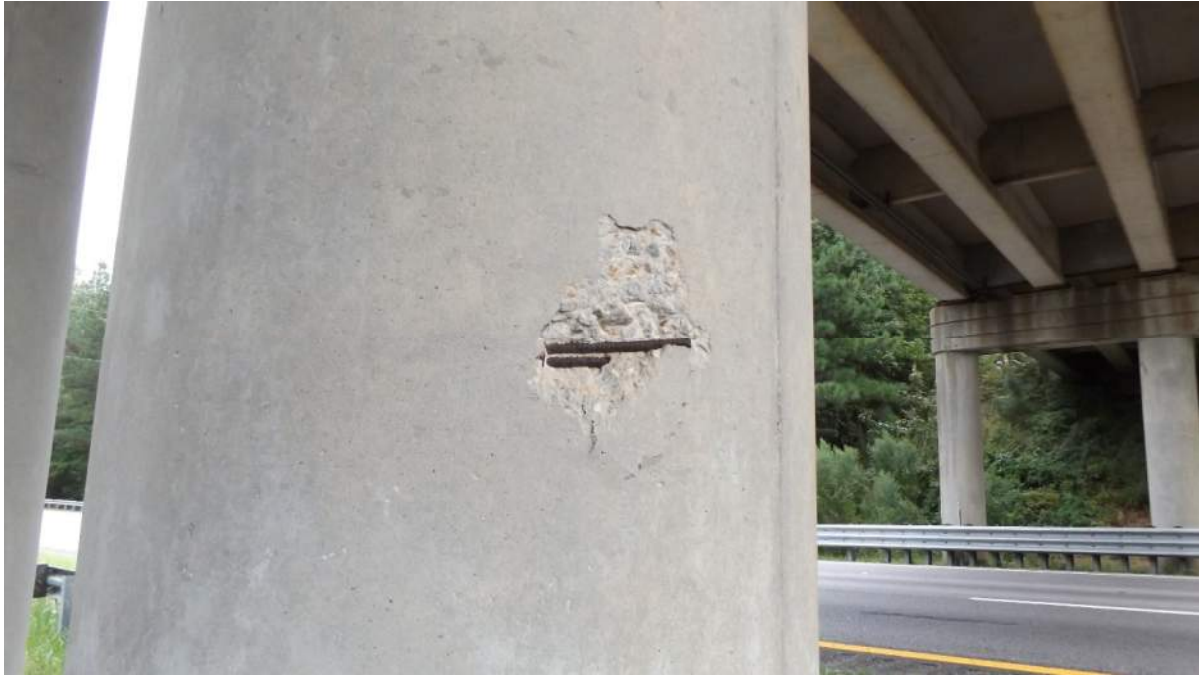
*Figure 12 – Spall in Column*

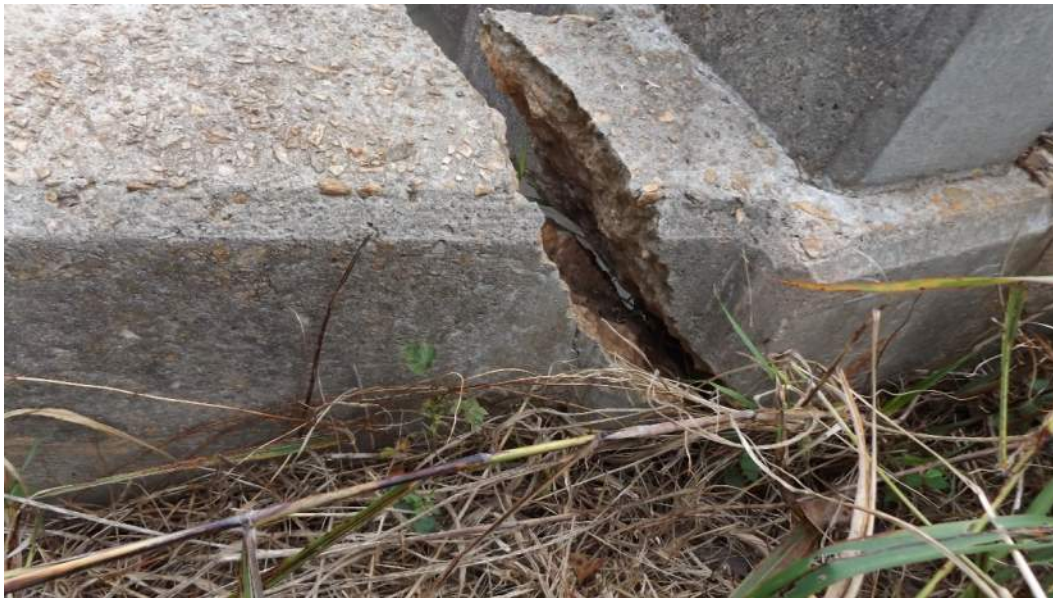
The end bent caps show minimal signs of deterioration. Some of the end bent wing walls have wide, full-width cracks (see Figure 13).

*Figure 13 – Crack in Wing Wall*

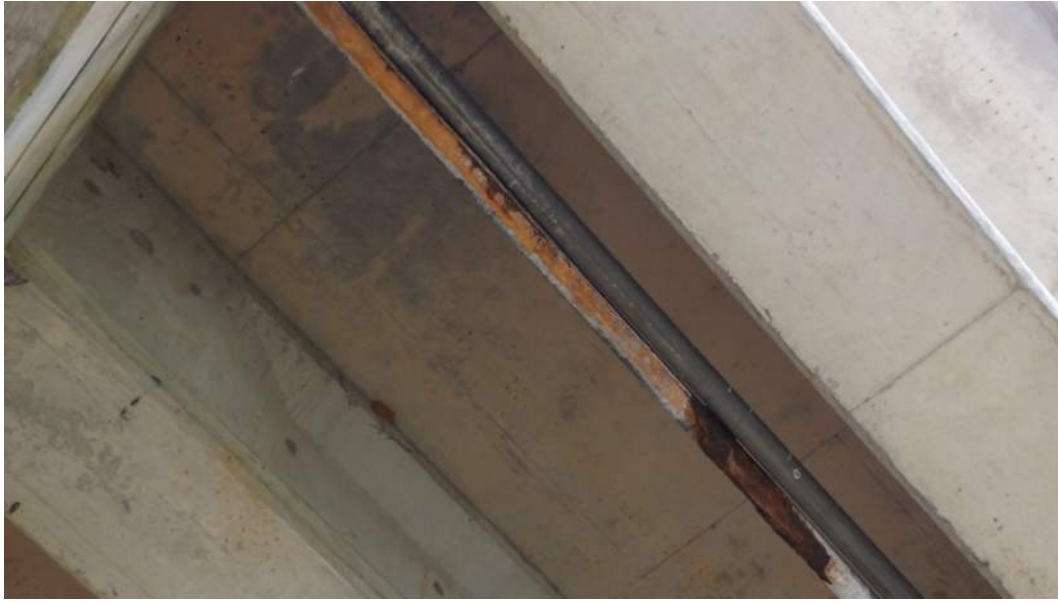
The conduit running between beams for the length of the bridge shows signs of deterioration. Additionally, wires from the conduit are hanging loose and an object the wires are connected to is laying on the ground (see Figures 14 thru 16).

*Figure 14 – Conduit Corrosion*

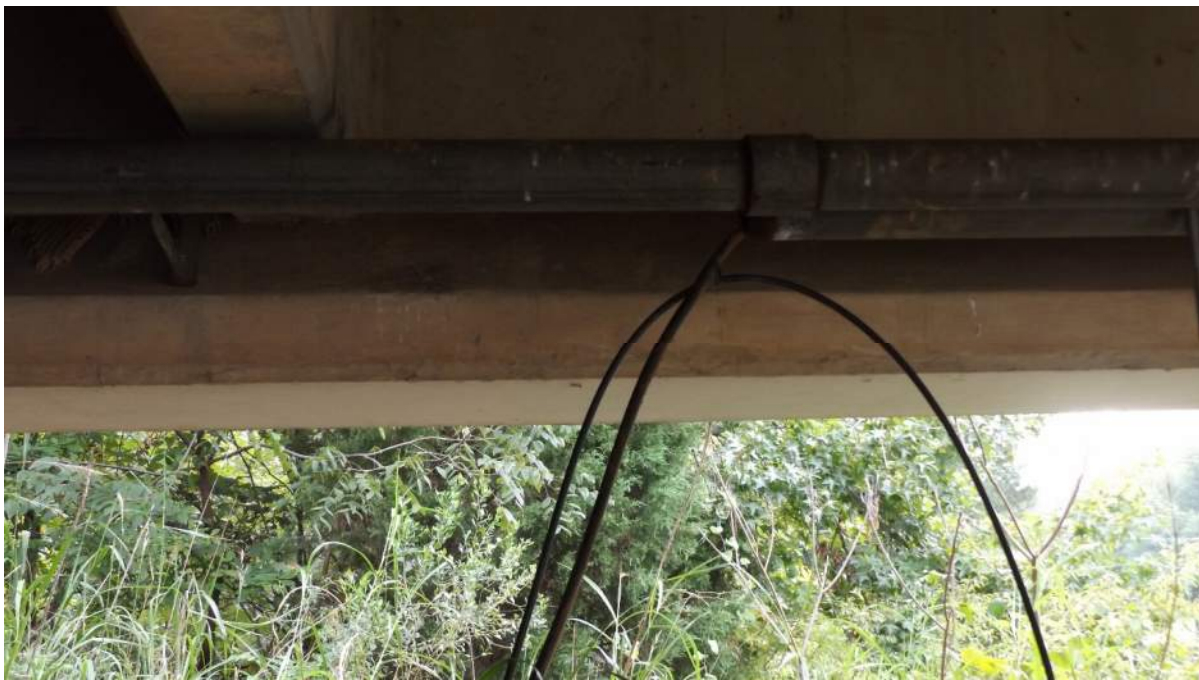
*Figure 15 – Hanging Wires*

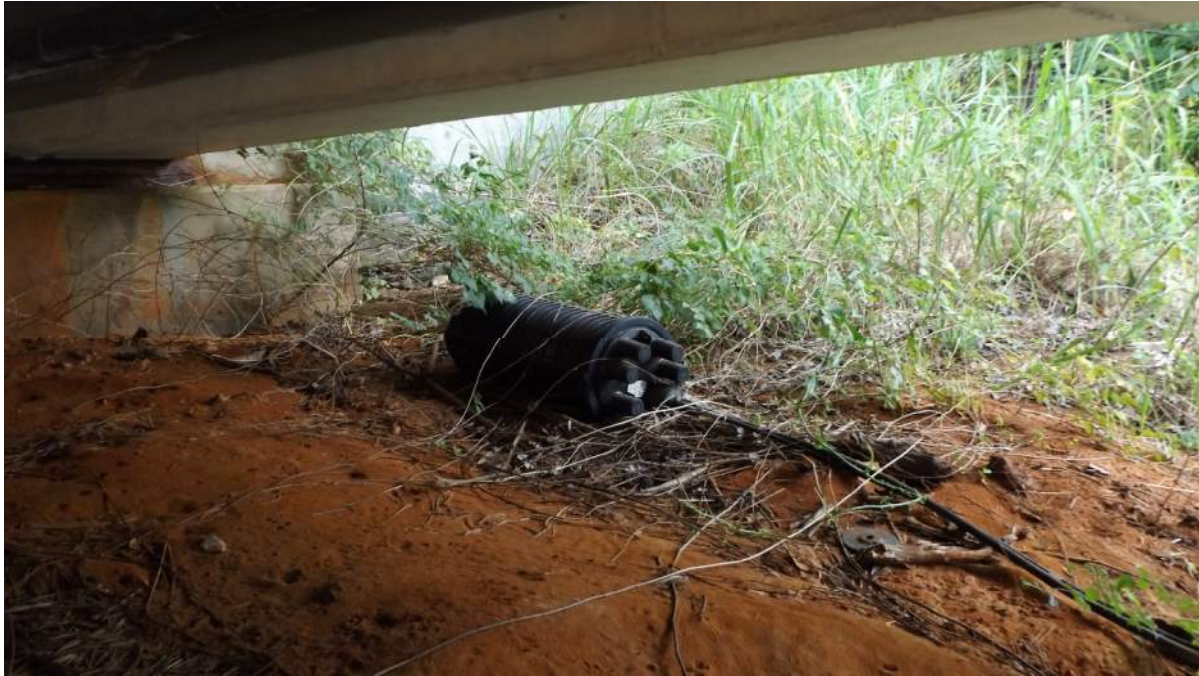
Figure 16 – Utility Object on Ground

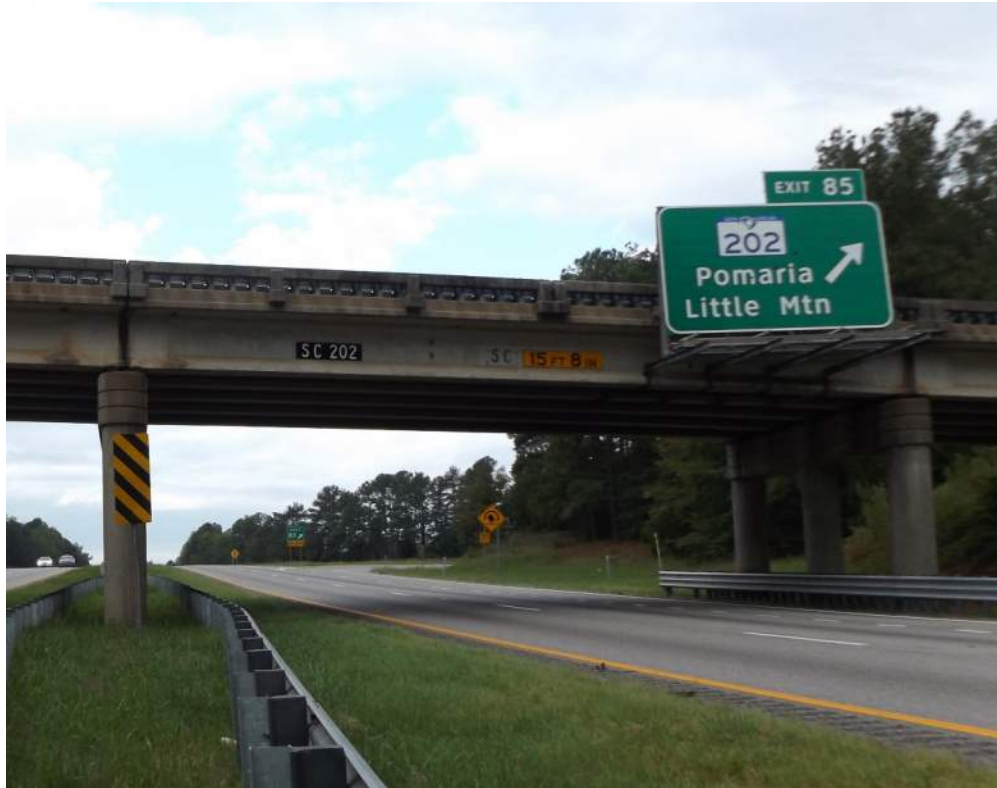
Figure 17 - Vertical Clearance

The posted minimum vertical clearance under the existing bridge is 15'-8" (I-26 WB) which does not meet the 16'-0" minimum specified for freeway under existing overpassing bridges in the SCDOT Highway Design Manual. The posted vertical clearance under the existing bridge on I-26 EB is 16'-10".
