## ***I-26 Bridge Assessments***

# **Bridge Assessment Report for Mt. Vernon Church Road (S-40-234) over I-26**

**Prepared for:**  
**The South Carolina Department of Transportation**

**November 11, 2016**

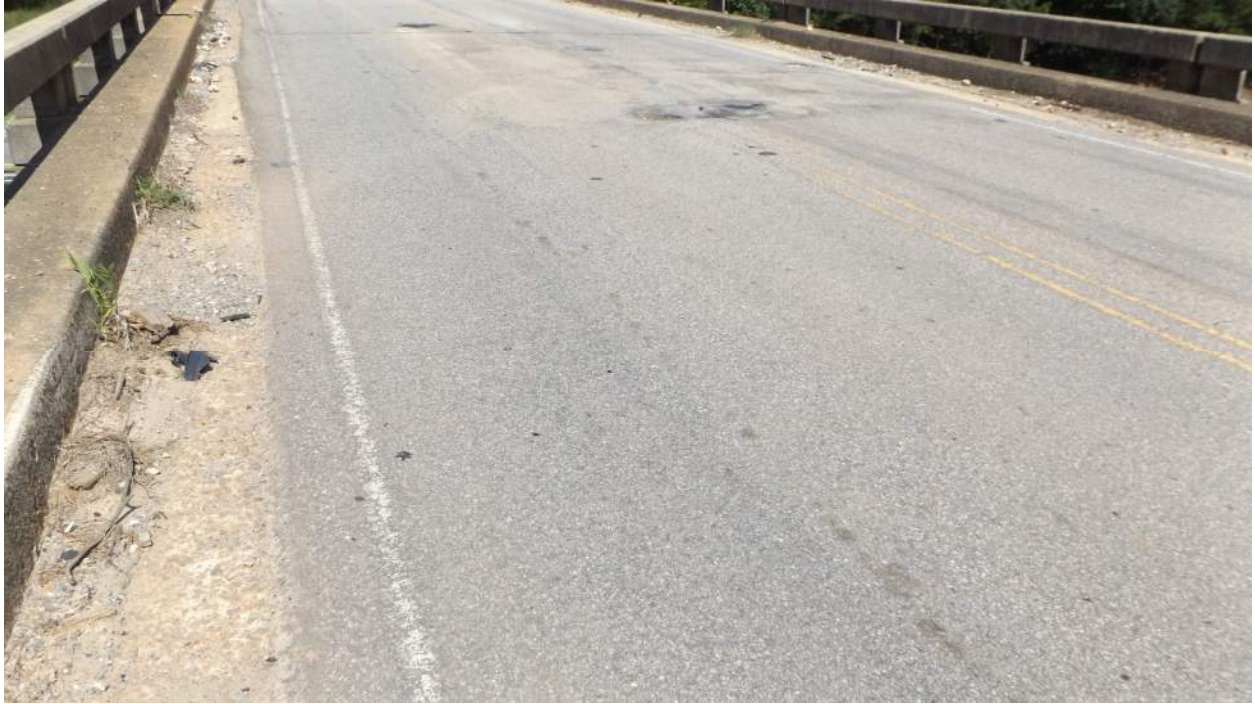
The existing reinforced concrete deck was observed from the shoulder since the roadway wasn't closed (see Figure 4). There are several areas on the deck where concrete has spalled off and the reinforcing steel is exposed and corroded (see Figure 5). Additionally, there are patched areas of the bridge deck that potentially conceal corroded rebar. The most recent Bridge Inspection Report documents that 56% of the deck is delaminated and has minor spalls. The concrete end walls showed very little deterioration.

*Figure 4 – General View of Deck*

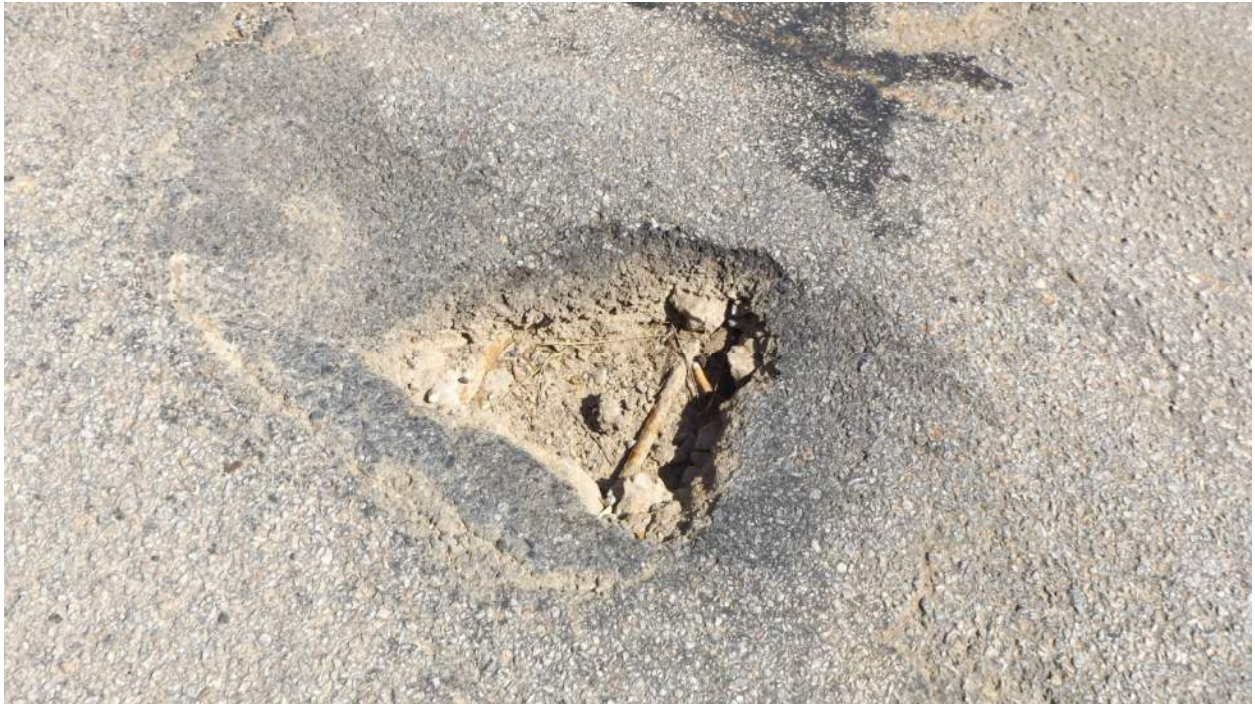
*Figure 5 – Exposed Rebar in Concrete Deck*

The two options to consider for this bridge are replacement and rehabilitation. Rehabilitation for this existing Mt. Vernon Church Road Bridge would consist of deck replacement, bearing replacement, joint replacement, crack/spall repairs, a potential closed drainage system, and permanently raising the bridge (and likely a portion of the roadway approaches) to achieve the required vertical clearance. Also, since the beams are monolithic with the deck, the beams would likely be replaced as part of a bridge rehabilitation. The estimated cost of rehabilitating this bridge is approximately \$890,000. The estimated cost of replacing this bridge is approximately \$3.2 million. Both estimated costs (rehabilitation and replacement) include design and construction costs for the bridge and roadway approaches.

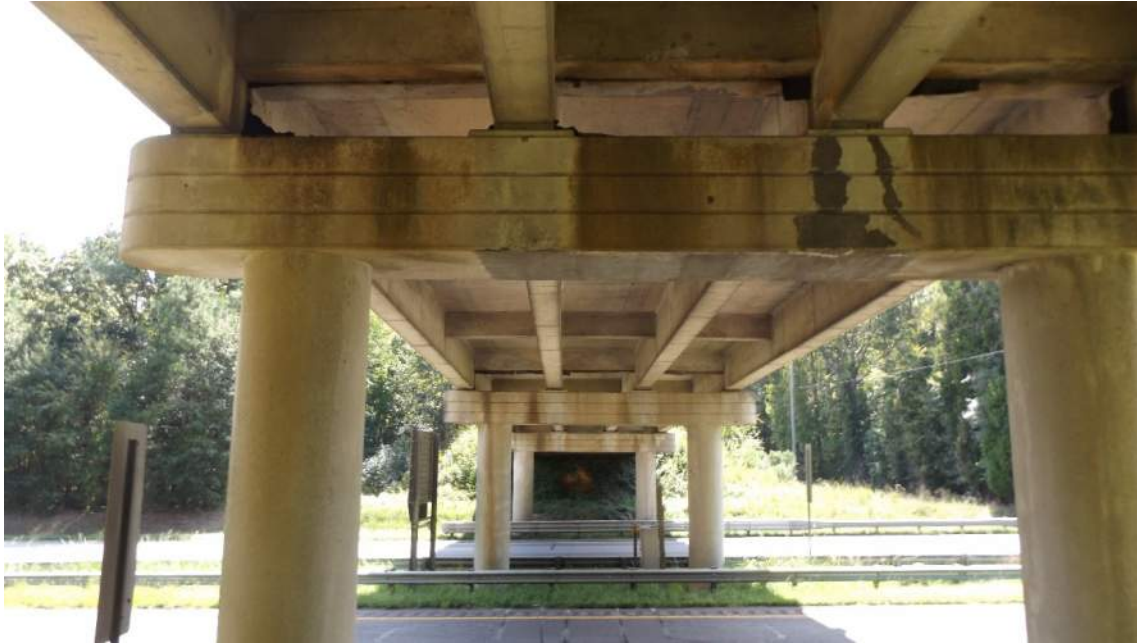
The existing reinforced concrete beams were assessed from accessible areas on the ground for deterioration and cracks. No deterioration or cracks were observed from the ground. The most recent Bridge Inspection Report documents some flexural cracking at mid-span of most beams, additional cracking, some diagonal, near the bearings, and collision damage in one of the beams.

Figure 6 – Superstructure (from underneath)

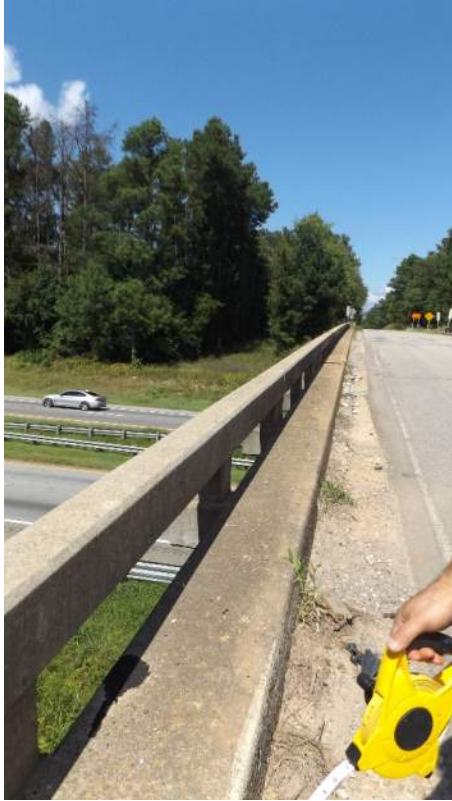
The bridge railing (Figure 7) is a concrete railing on a concrete curb and showed minimal signs of deterioration.

*Figure 7 – Bridge Railing*

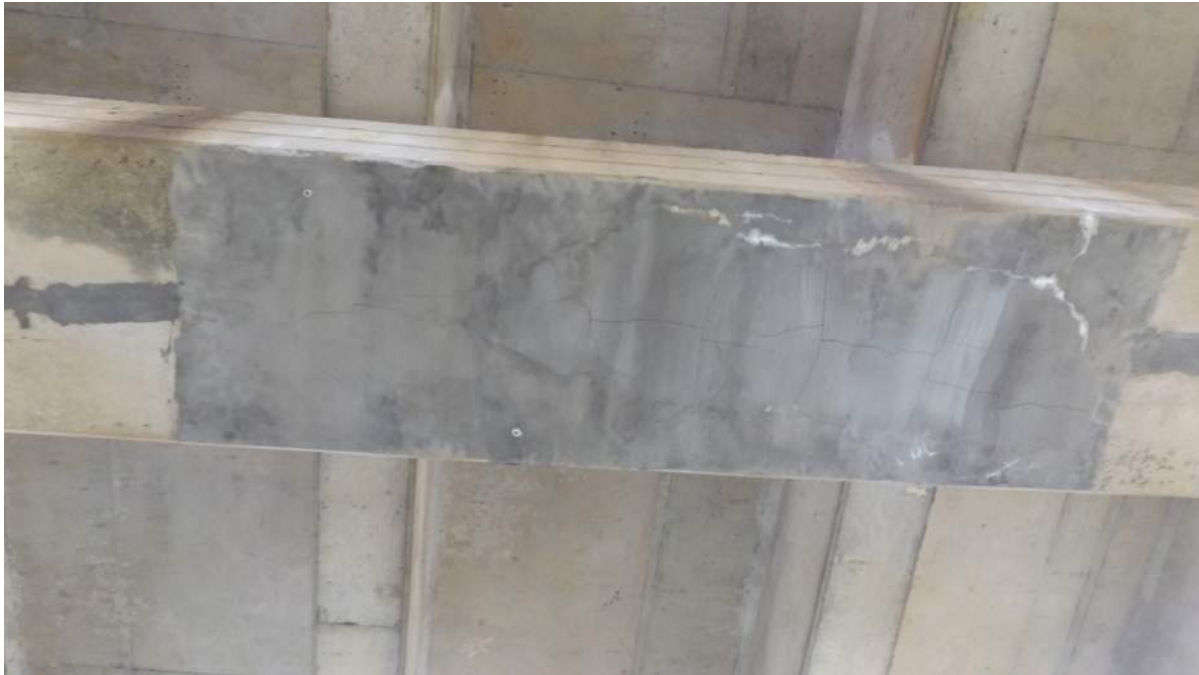
The interior bents are showing minor signs of deterioration. A repaired area has some web cracking (see Figure 8). The most recent Bridge Inspection Report documents additional cracking and repairs in the caps and columns.

*Figure 8 – Repaired Area in Cap*

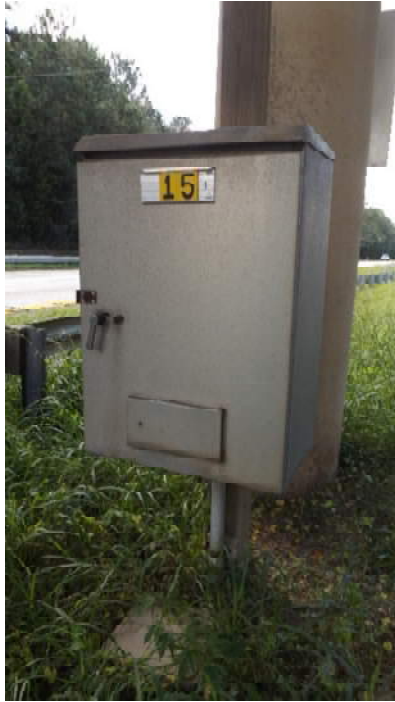
No utilities were observed on/attached to the bridge, but there is what appears to be an electrical box and a "Weigh Station" sign in close proximity to Interior Bent 3 (median bent) (see Figure 9).

Figure 9 – Electrical Box near Interior Bent 3

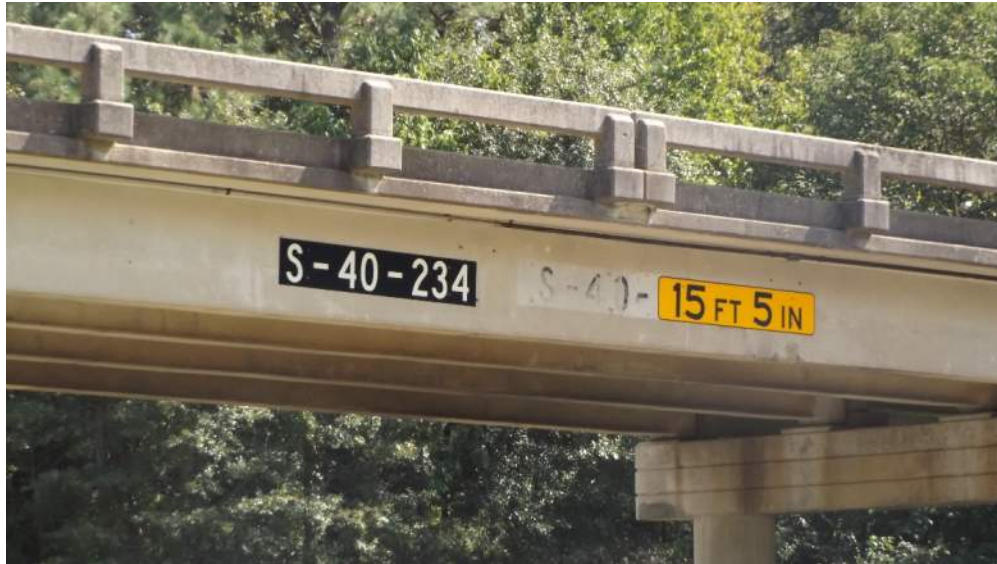
The posted minimum vertical clearance under the existing bridge is 15'-5" (I-26 EB) which does not meet the 16'-0" minimum specified for freeway under existing overpassing bridges in the SCDOT Highway Design Manual. The posted vertical clearance under the existing bridge on I-26 WB is 16'-0".

Figure 10 - Vertical Clearance (I-26 EB)
