I-26 Bridge Assessments

Bridge Assessment Report for Peak Street (S-32-49) over I-26

Prepared for:
The South Carolina Department of Transportation

November 11, 2016

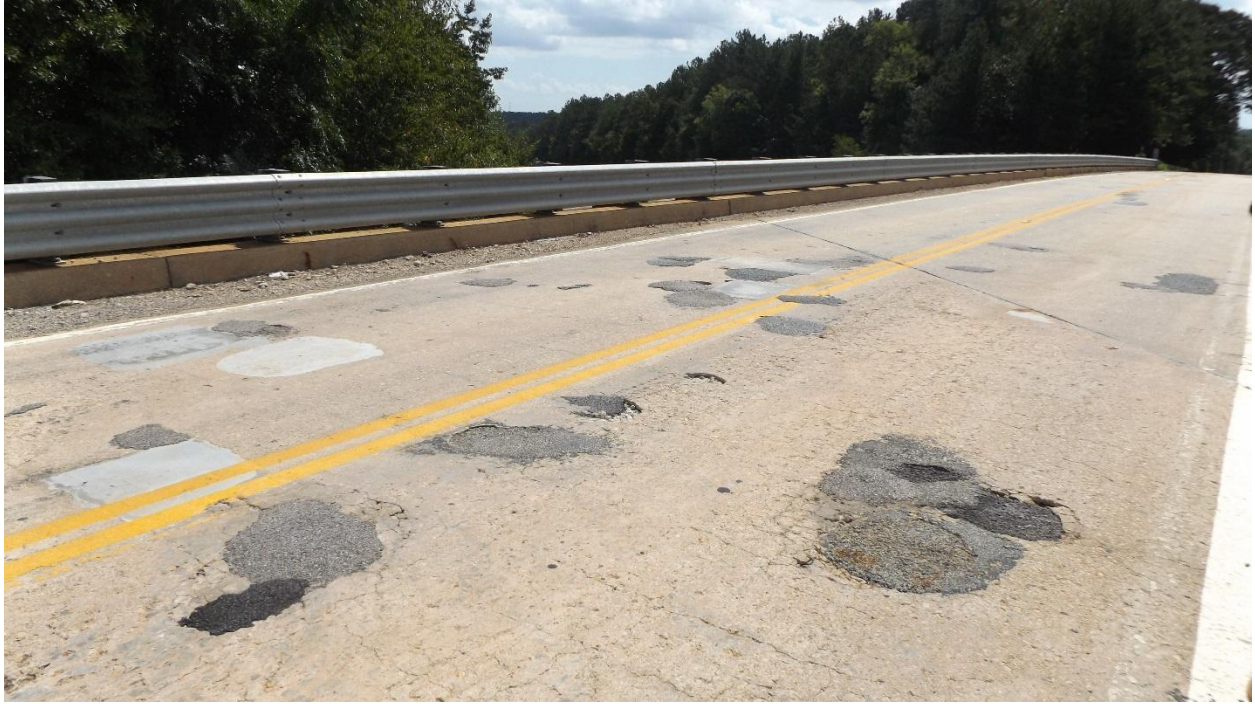
The existing reinforced concrete deck was observed from the shoulder since the roadway wasn't closed (see Figure 4). There are several areas on the deck where concrete has spalled off and the reinforcing steel is exposed and corroded (see Figure 5). Additionally, there are patched areas of the bridge deck that potentially conceal corroded rebar. The most recent Bridge Inspection Report documents that 80% of the deck is delaminated and the deck has significant cracking, spalls, and scaling, some of which has been repaired. The concrete end walls showed very little deterioration.

Figure 4 – General View of Deck

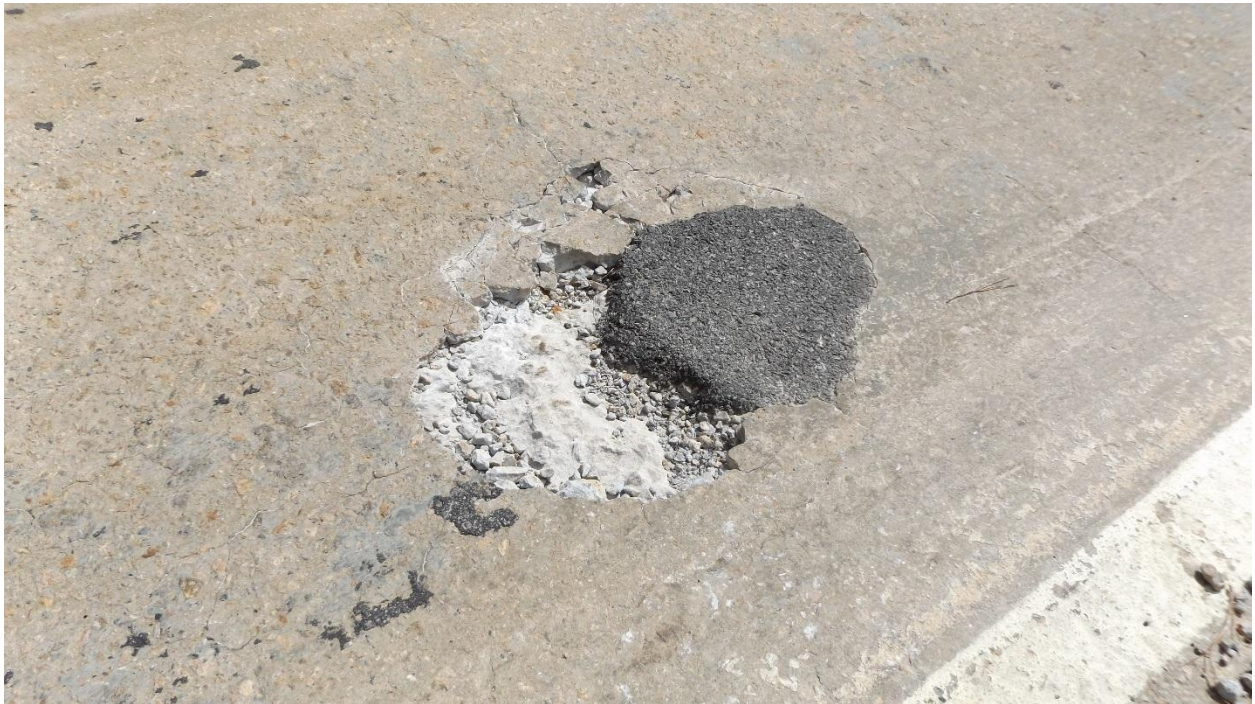
Figure 5 – Exposed Rebar in Concrete Deck

- Sufficiency rating of 56.8
- 80% of the deck is delaminated and there are numerous locations on the deck where the concrete has spalled off and rebar is exposed. Deck replacement is necessary and would be costly, especially if new deck needs to meet current thickness requirements and beams and substructure would need to be analyzed to see if they can support the extra deck thickness.
- Joints, bearings, vertical clearance would all be improved to meet current requirements
- New bridge can be designed for current live load requirements
- New bridge can be designed for current seismic requirements

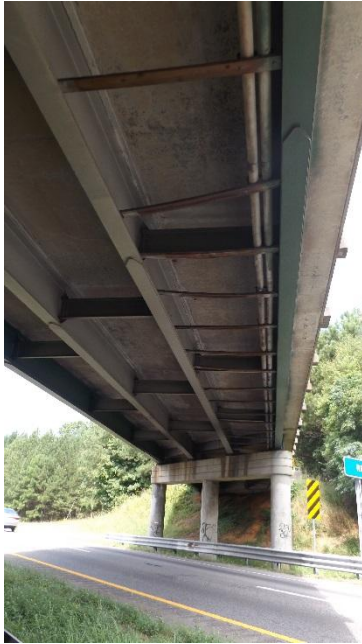
The existing steel beams were assessed from accessible areas on the ground for deterioration. Minor deterioration was observed from the ground. The most recent Bridge Inspection Report documents that the steel beams were re-painted but metal loss and minor corrosion still exists.

Figure 6 – Superstructure (from underneath)

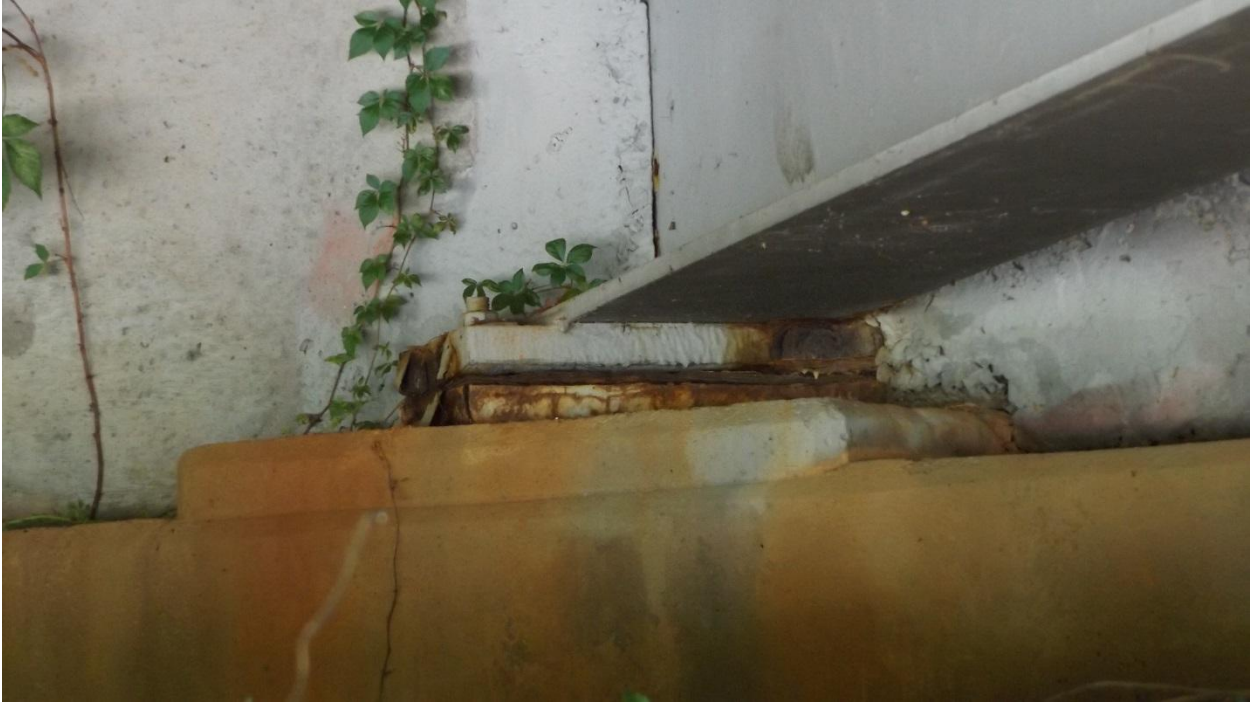
A portion of the end bent bearings were visible due to the semi-integral end bent and moderate/severe corrosion was observed (see Figure 7). The exterior bearings showed more deterioration than the interior bearings at the end bents. The interior bent bearings were not accessible from short distance, but were viewed from the ground and appeared to be in a moderate/severe state of deterioration with heavy corrosion (see Figure 8). The most recent Bridge Inspection Report documents moderate/heavy rust on bearings and some missing anchor bolt nuts.

Figure 7 – End Bent Bearing

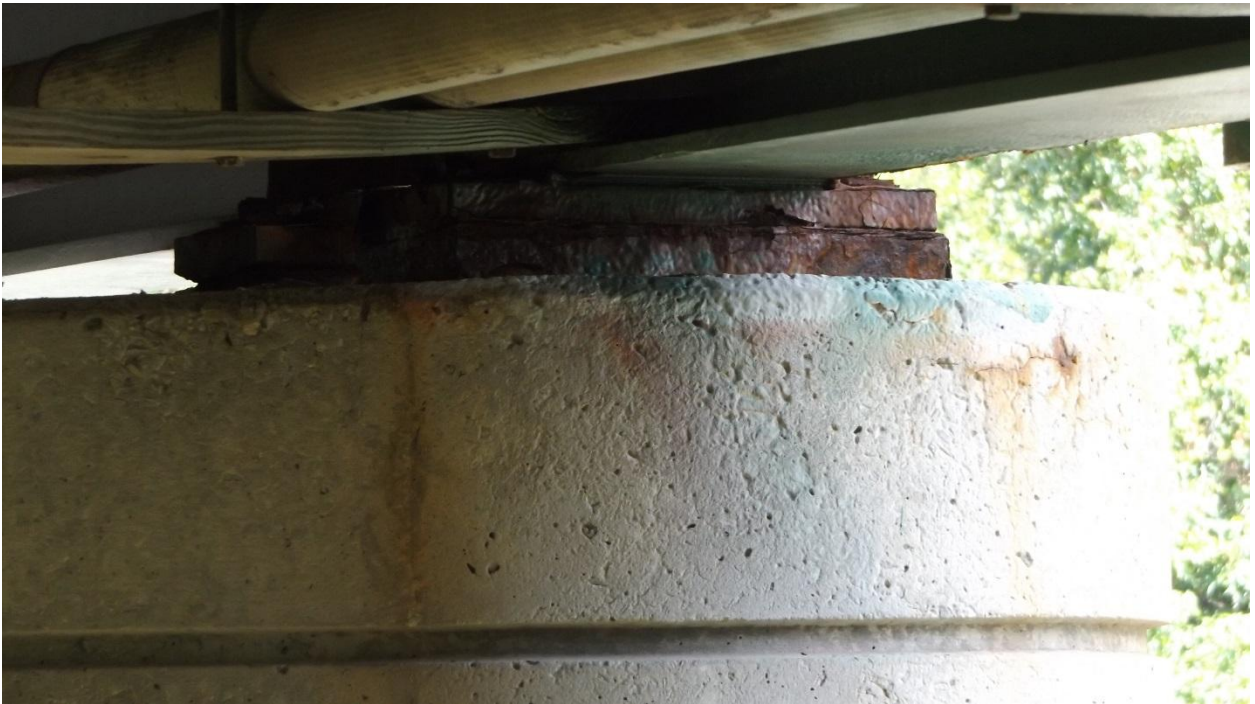
Figure 8 – Interior Bent Bearing

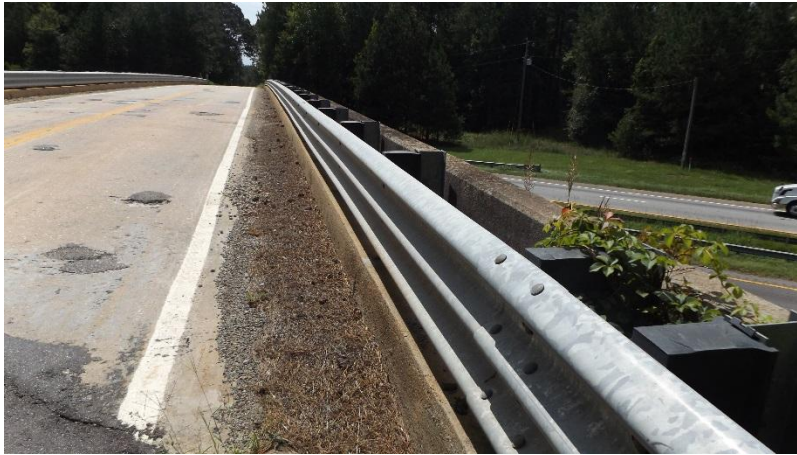
The bridge railing (Figure 9) is a concrete railing on a concrete curb with guardrail attached to it and showed minimal signs of deterioration.

Figure 9 – Bridge Railing

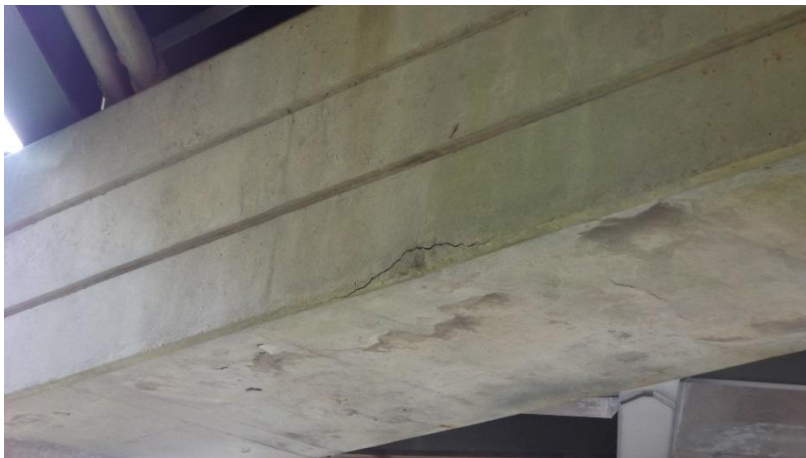
The interior bents are showing minor signs of deterioration. Figure 10 shows a crack in one of the interior bent caps. The most recent Bridge Inspection Report documents hairline cracks and minor spalls in caps and hairline cracks and minor spalls in columns, some of which have been patched.

Figure 10 – Crack in Interior Bent Cap

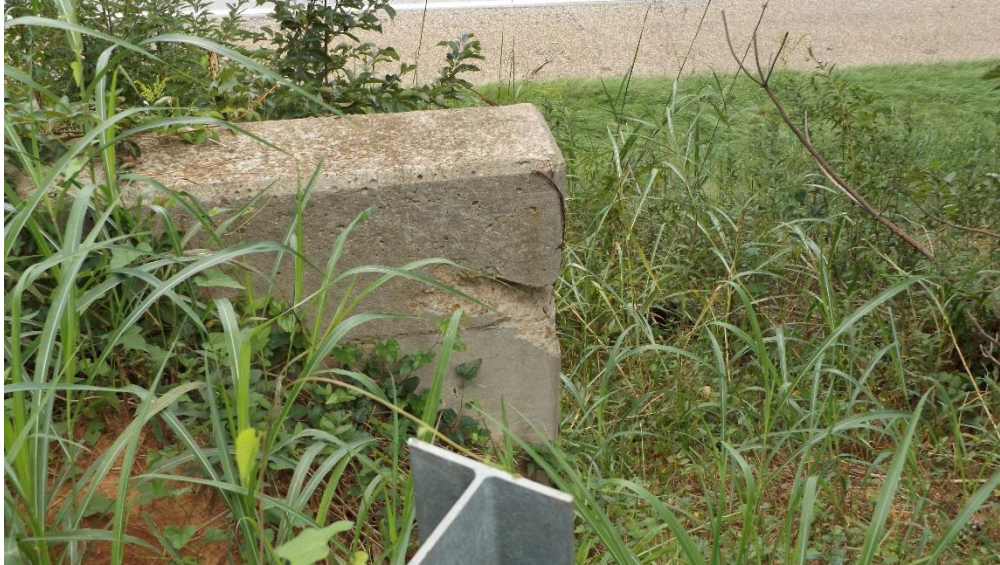
The end bent caps show minimal signs of deterioration. One of the wing walls had a large chunk missing (see Figure 11). The most recent Bridge Inspection Report documents minor spalls with rebar exposed at End Bent 1.

Figure 11 – End Bent Wing Wall

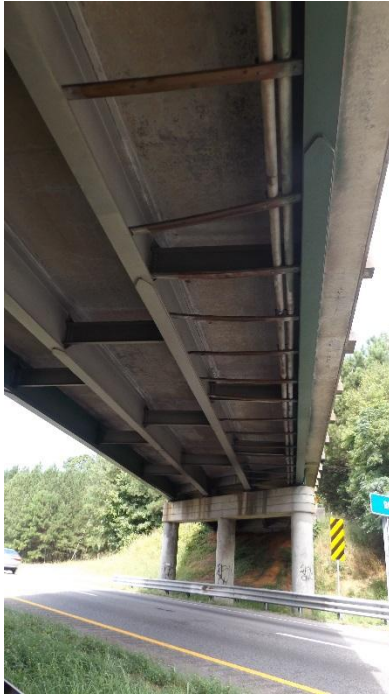
Two conduits are located in an exterior bay and run the entire length of the bridge (see Figure 12). At the end of the conduit, the wires go underground near the end bent (see Figure 13). The wooden slats that help support the conduits were all in place, but there is probably a more stable support system that could be used (see Figures 14 and 15).

Figure 12 – Conduit under Bridge

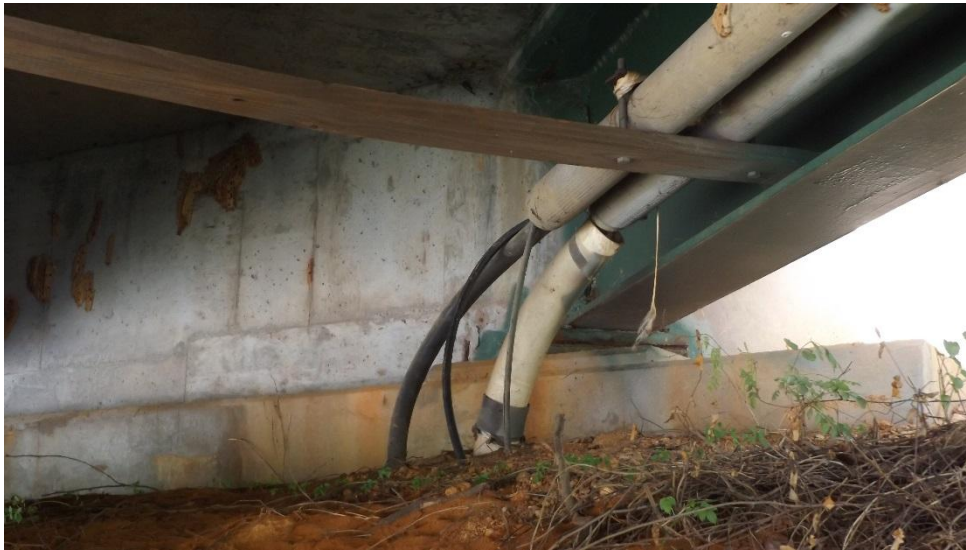
Figure 13 – Utilities going underground near End Bent

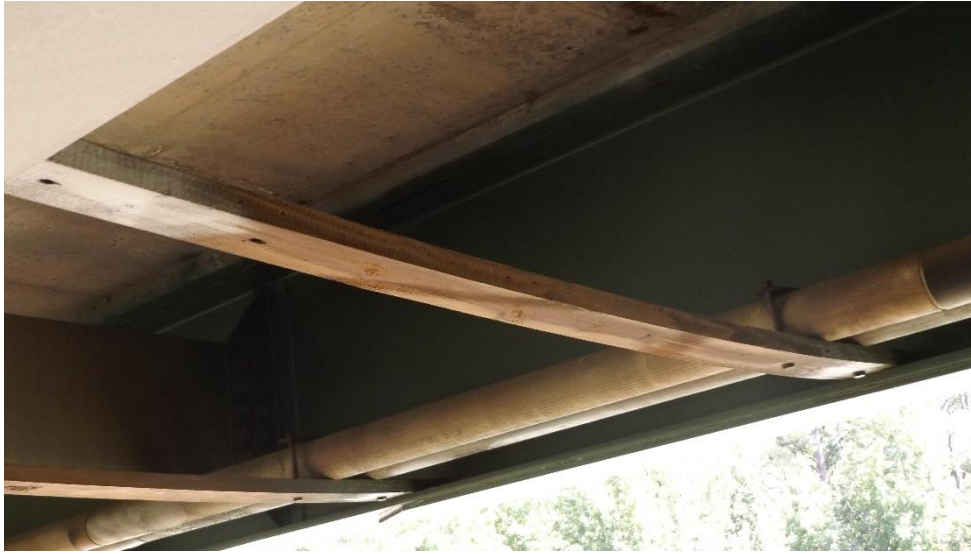
Figure 14 – Wooden Slats supporting Conduit

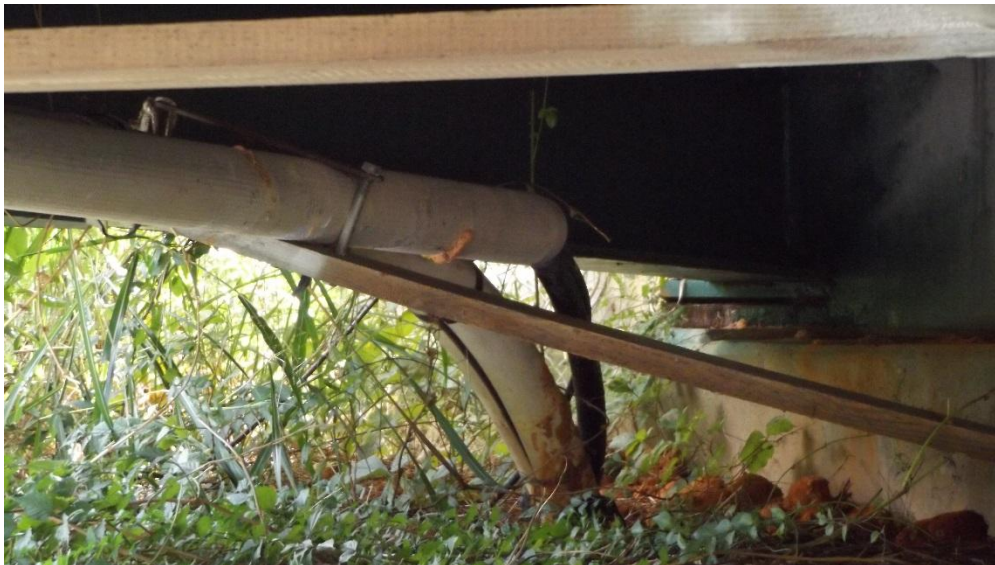
Figure 15 – Wooden Slat has fallen off the Beam

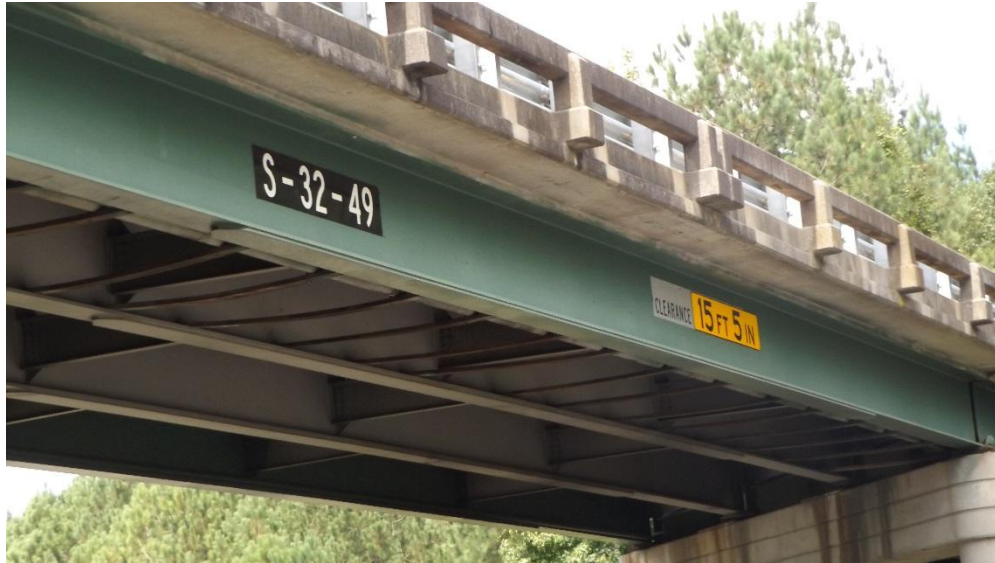
The posted minimum vertical clearances under the existing bridge are 15'-5" (I-26 WB) and 15'-10" (I-26 EB), neither of which meets the 16'-0" minimum specified for freeway under existing overpassing bridges in the SCDOT Highway Design Manual.

Figure 16 - Vertical Clearance (I-26 WB)
