I-26 Bridge Assessments

Bridge Assessment Report for Holy Trinity Church Road (S-36-39) over I-26

Prepared for:
The South Carolina Department of Transportation

November 11, 2016

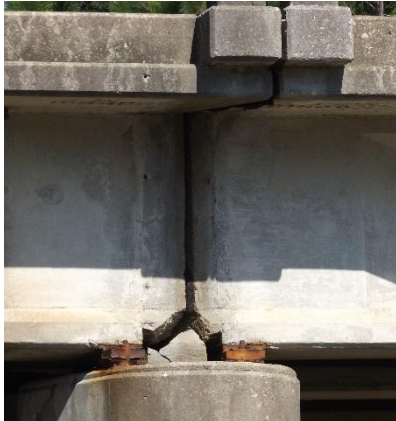
Figure 4 – Portion of Beam cracked off

The existing prestressed concrete beams were assessed from accessible areas on the ground for deterioration and cracks. A piece of the beam has cracked off at one of the bearing locations (see Figure 4). There is also a small spall on the bottom of one of the concrete beams where reinforcing steel is exposed and corroded (see Figure 5). The most recent Bridge Inspection Report does document some light collision damage that has been repaired.

Is the broken piece part of the beam or is it part of an end diaphragm?

It may be part of the diaphragm.

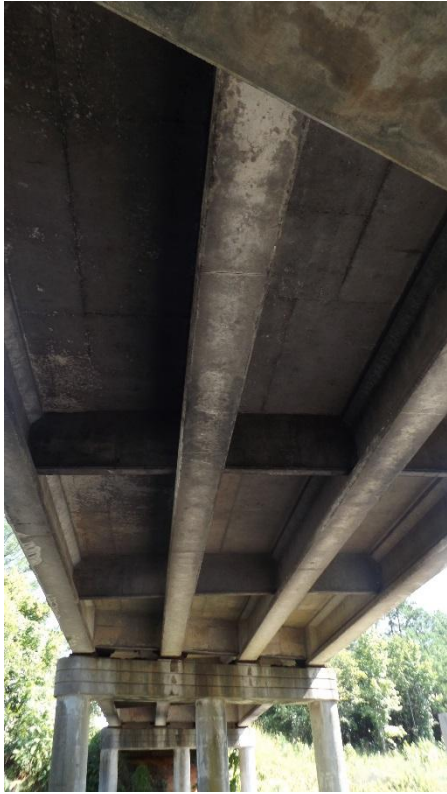
Figure 6 – Superstructure (from underneath) and Collision Damage to Bottom of Beam

The posted vertical clearances under the existing bridge are 15'-3" (I-26 EB) and 15'-6" (I-26 WB). Neither of these meet the 16'-0" minimum specified for freeway under existing overpassing bridges in the SCDOT Highway Design Manual. The most recent Bridge Inspection Report documents collision damage to the beams that has been repaired.

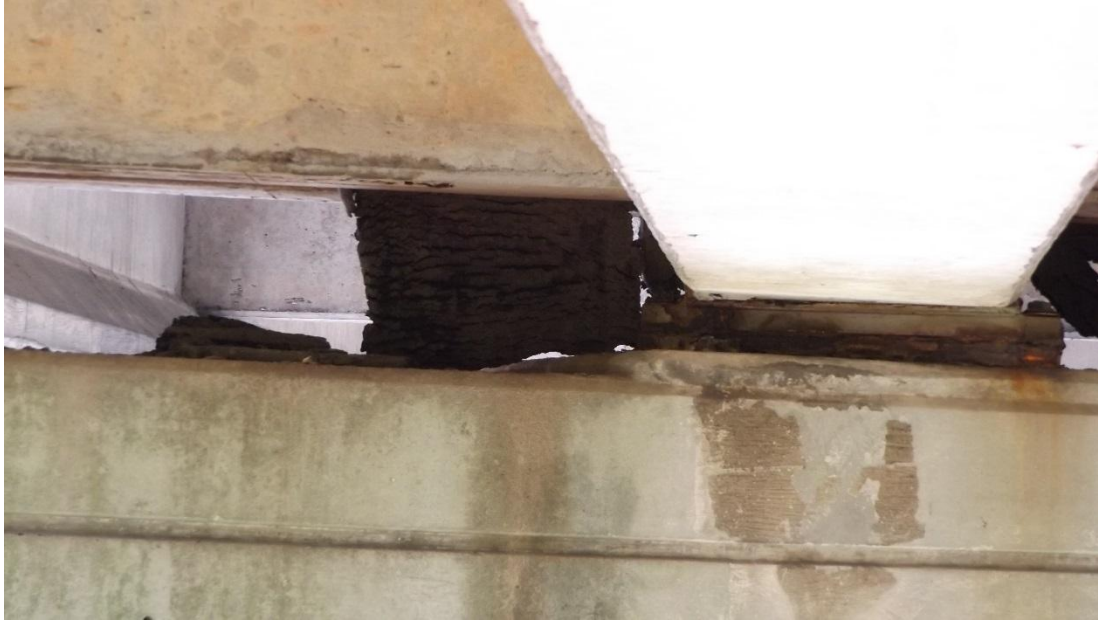
Figure 7 - Bearing Corrosion and Expansion Joint material falling through joint opening

A portion of the end bent bearings were visible due to the semi-integral end bent and very little deterioration was observed. The exterior bearings showed more deterioration than the interior bearings at the end bents. The interior bent bearings were not accessible from short distance, but were viewed from the ground and appeared to be in a medium state of deterioration with moderate to severe corrosion.

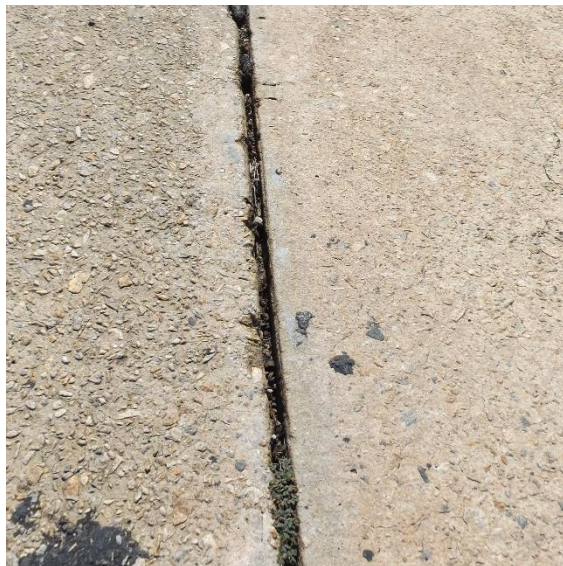
Figure 8 - Expansion Joint

There are three deck expansion joints located within the bridge. They are located at Interior Bent 2, Interior Bent 3, and Interior Bent 4. All three expansion joints were observed from the shoulders due to the roadway not being closed. The joint filler is falling through the opening at several locations (see Figure 7). Where the joint filler hasn't fallen through, the material is in an advanced state of deterioration (see Figure 8).

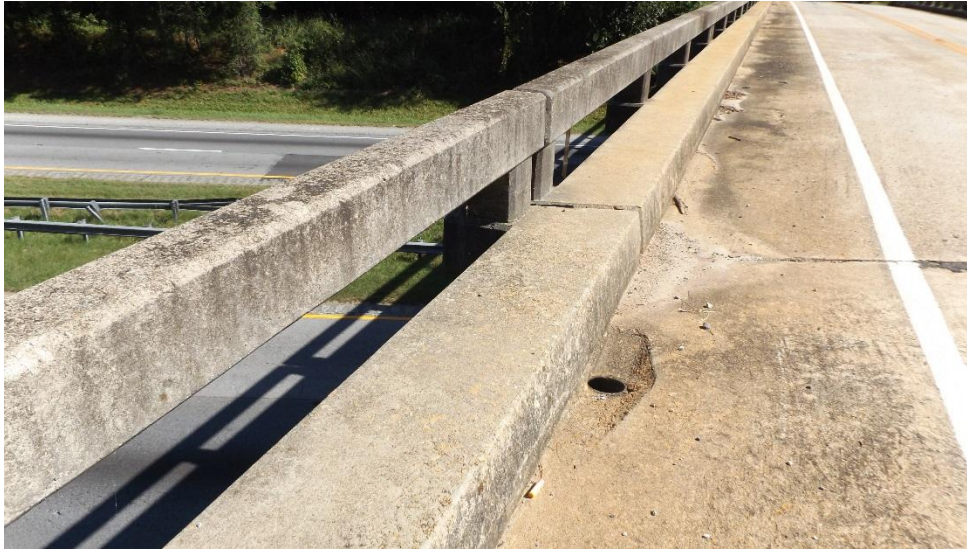
Figure 9 - Bridge Railing

The bridge railing (Figure 9) is a concrete railing on a concrete curb and showed minimal signs of deterioration.

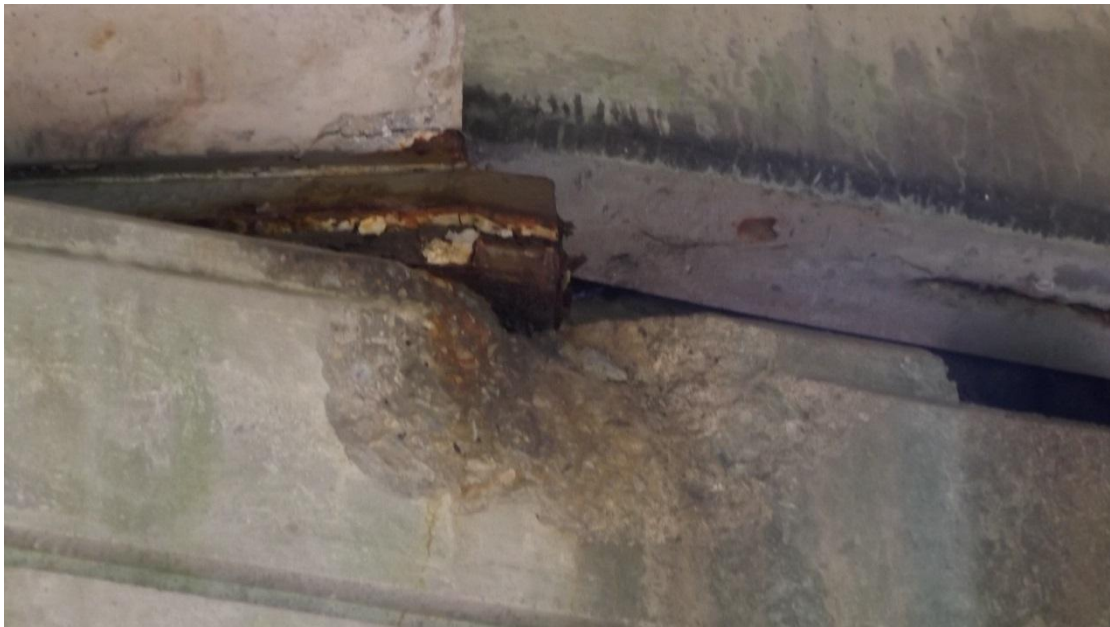
Figure 10 - Spall on Top of Pier Cap

The interior bents show minimal signs of deterioration with the exception of a large spall on the top of one of the concrete caps where the concrete has spalled off and exposed the bottom of the bearing (see Figure 10). The columns also show minimal signs of deterioration with the exception of a large spall where the reinforcing steel is exposed and corroded with vertical cracks (See Figure 11). The most recent Bridge Inspection Report documents some spalling on all columns and the bottom of all interior bent caps along with a diagonal crack on one interior bent.

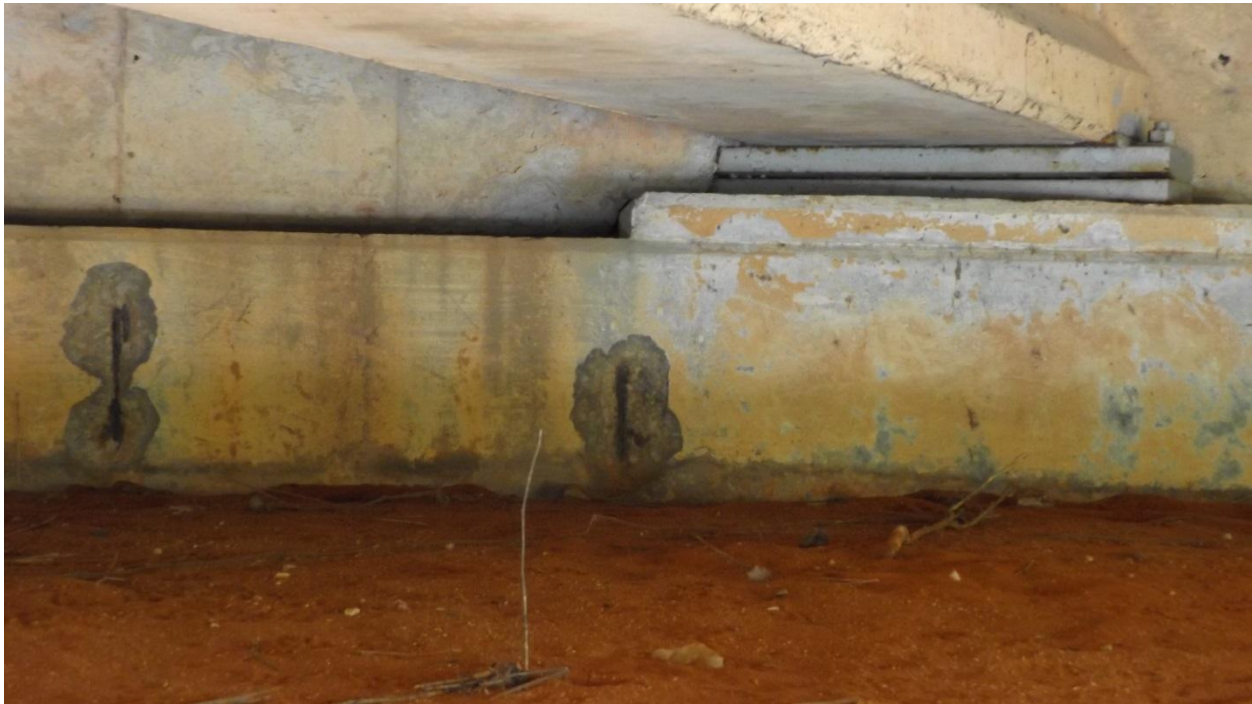
Figure 12 - End Bent Spalling

The end bent caps and wing walls show minimal signs of deterioration with the exception of a few small spalls on the face of the end bent cap where reinforcing steel is exposed (see Figure 12).

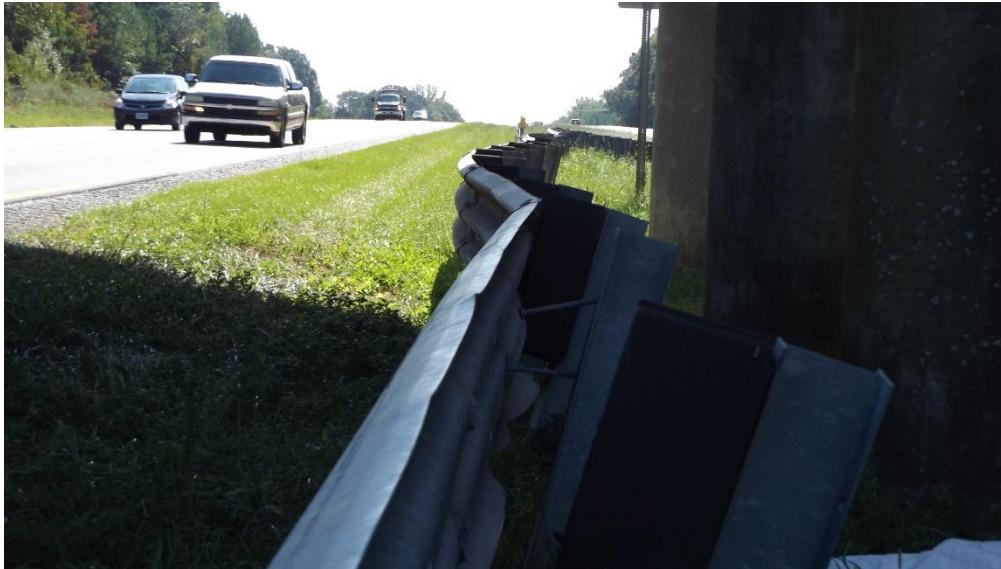
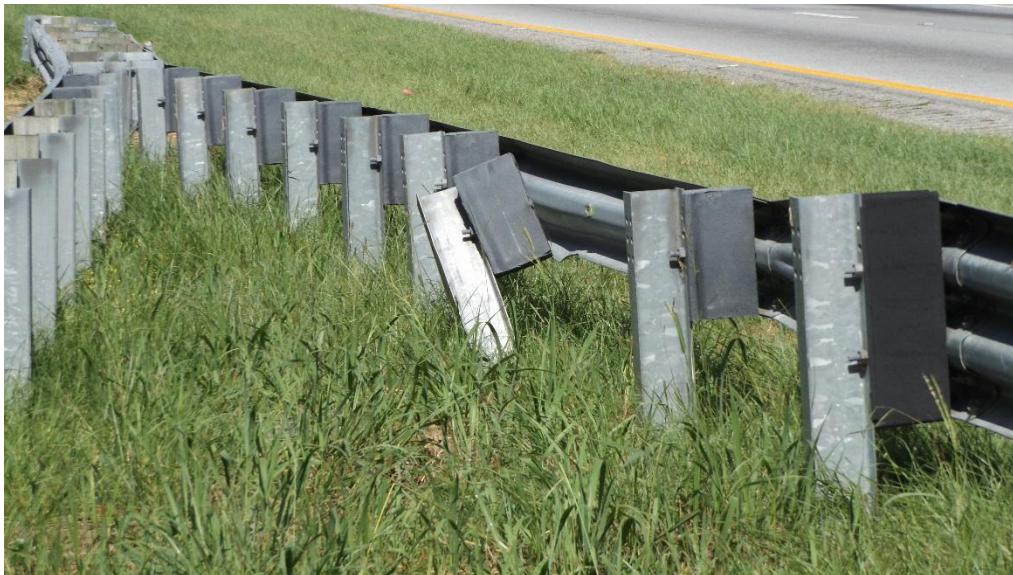
The guardrail in the median of I-26 at this bridge location is damaged in a few locations (see Figures 13 and 14).

Figure 13 – Guardrail Damage
