LEAD-BASED PAINT INVESTIGATION REPORT

**S-40-234 BRIDGE OVER I-26
SCDOT #407023400100
RICHLAND COUNTY, SOUTH CAROLINA**

Re.: Lead-Based Paint Investigation Report
S-40-234 Bridge over I-26
SCDOT #407023400100
Richland County, South Carolina
F&ME Project No.: E5350.02

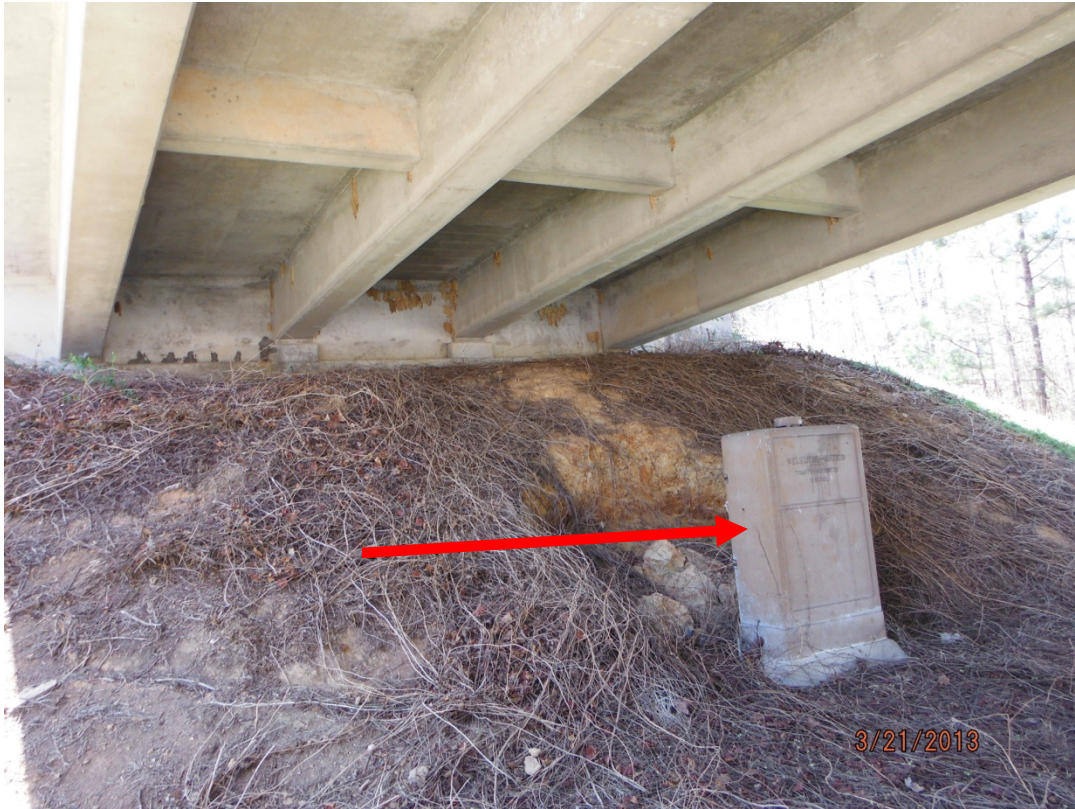
During the investigation, two (2) suspect paints/coatings were noted. The first is a suspect tan paint observed on the traffic control box that is positioned underneath the south end of the bridge. The second suspect paint is the black striping on the center drilled shafts. The XRF data indicated that the tan paint/ coating tested positive for lead content $\geq 0.7 \text{ mg/cm}^2$, while the black paint was negative for lead at this action level. See Appendix A for the XRF data (Table I) and photographs of the item that tested positive for lead content.

Tan Painted Traffic Control Box

All lead-based paint covered bridge components that will be affected by the planned demolition/ renovation activities must be carefully removed and properly disposed of by certified personnel experienced in handling and removing lead-based painted materials. All lead waste must be deposited in a SCDHEC-approved landfill. Removal, handling, transportation, storage and disposal shall be in accordance with 40 CFR 260 through 40 CFR 265, and shall also comply with land disposal restriction notification requirements as required by 40 CFR 268. Metal components painted with lead based paint may be recycled if they are taken to a recycling facility that accepts lead-based painted materials.
