## I-77 Scout Project – MM 27-25 SB Outside Lane

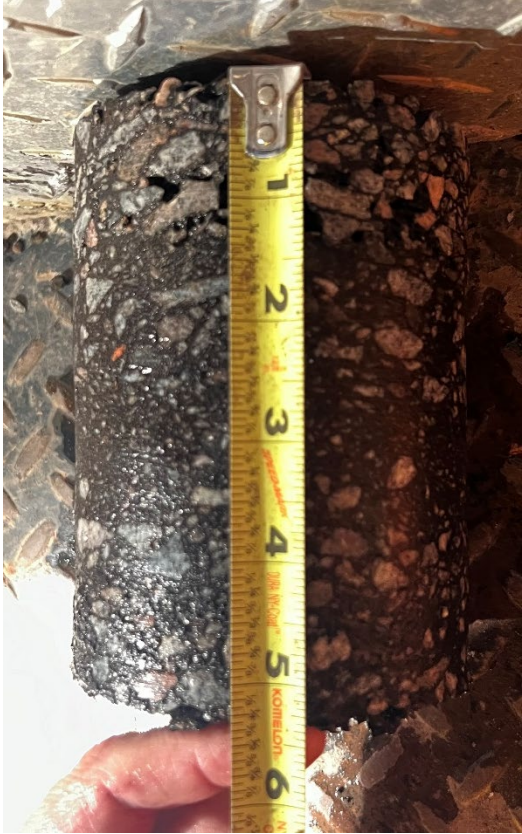
Core #	Core 1	Core 2
<b>Notes</b>	Good condition	Good condition
<b>Core Pictures</b>

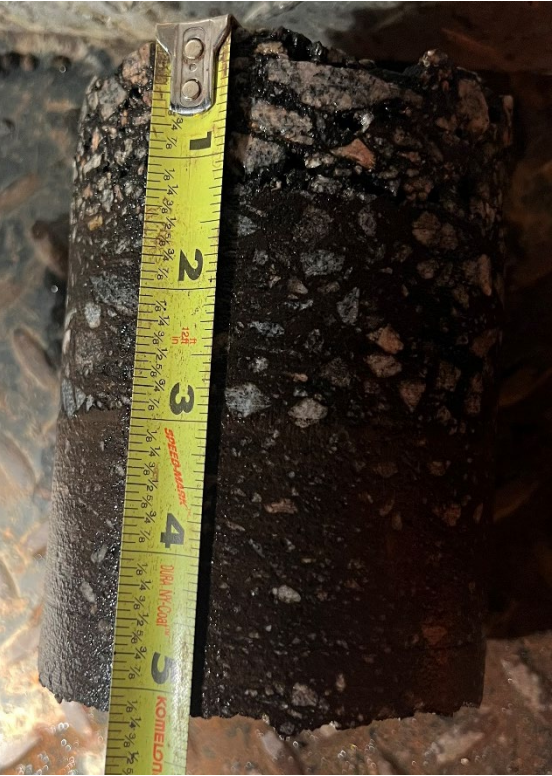
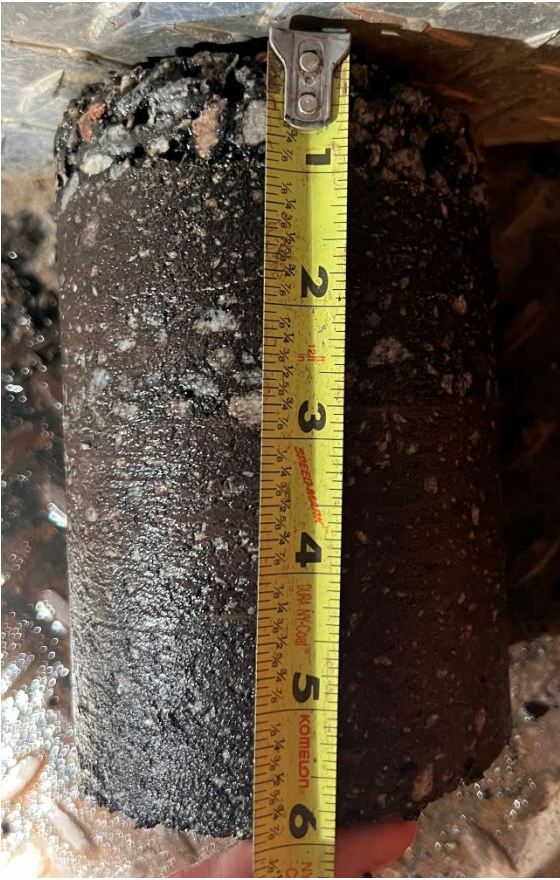
Core #	Core 3	Core 4
Notes	Good condition	Good condition
Core Pictures

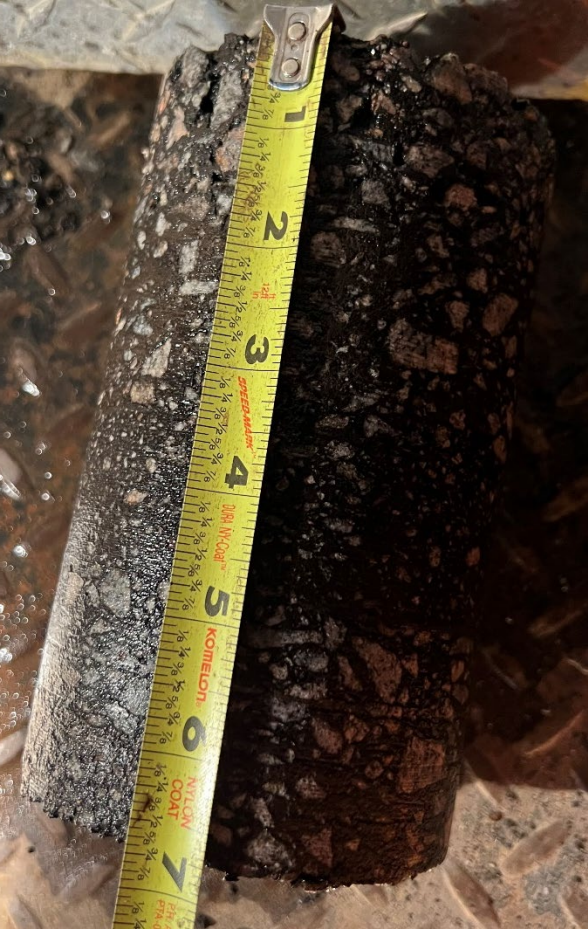
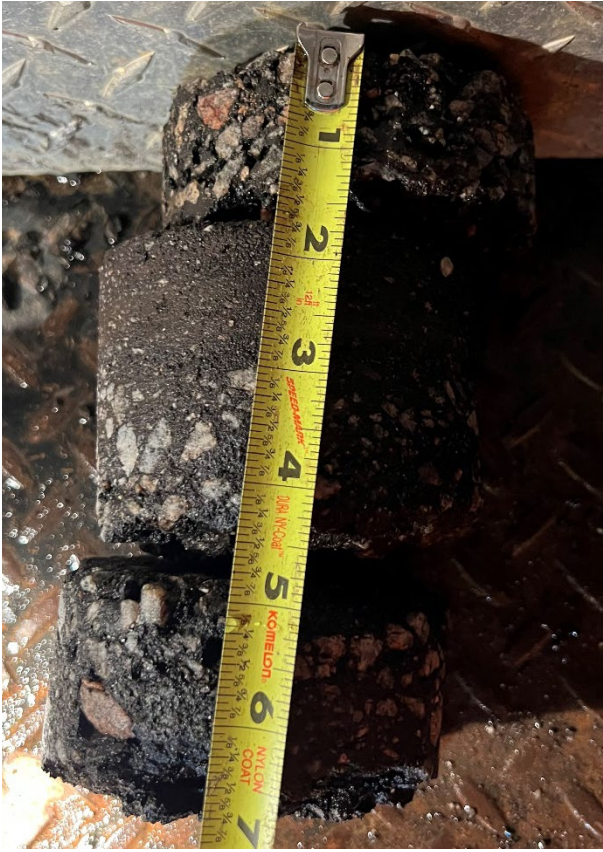
Core #	Core 5	Core 6
Notes	Good condition	Debonding but relatively in fair condition
Core Pictures
