# LEAD-BASED PAINT INVESTIGATION REPORT

NORTHBOUND I-95 BRIDGE OVER LAKE MARION  
CLARENDON & ORANGEBURG COUNTIES, SOUTH CAROLINA

**August 18, 2023**

FME Project No.: G6744.000

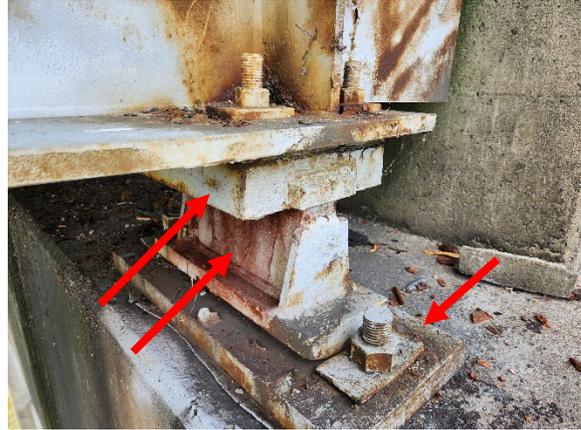
- Silver/Gray Steel Rocker Bearings
- Silver/Gray Steel Top Bearing Plates above Steel Rocker Bearings
- Silver/Gray Steel Tie-Rod Washers
- Silver/Gray Steel Bearing Plates

**Photo 2.** LBP on Rocker Bearing Top Plates, Rocker Bearing and Bearing Plates Associated with Bridge #2.

Therefore, OSHA regulations and procedures should be followed when impacting these components. If possible, they should be removed in whole and disposed of properly. Also, SCDHEC disposal requirements for lead containing materials should also be followed.

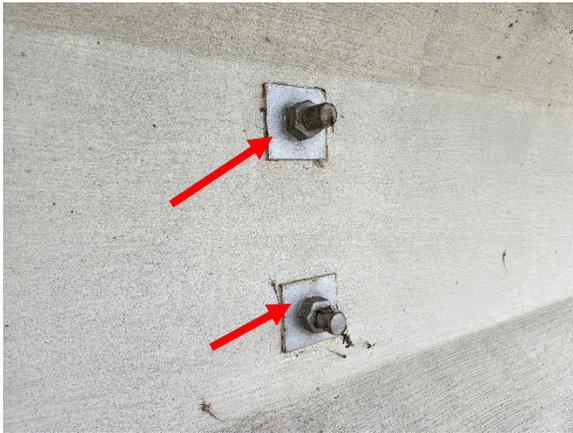
**Photo 3.** LBP on Tie-Rod Washers Located along each Side of Bridge #2.
