ASBESTOS CONTAINING MATERIAL INVESTIGATION REPORT

US 301/15 TRAIL BRIDGE OVER LAKE MARION OVERFLOW
CLARENDON & ORANGEBURG COUNTIES, SOUTH CAROLINA

August 18, 2023

F&ME Project No.: G6744.000

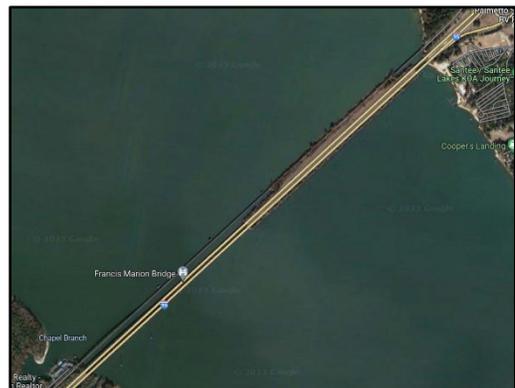
Photo 1 – I-95 over Lake Marion Bridges in Clarendon & Orangeburg Counties, SC.

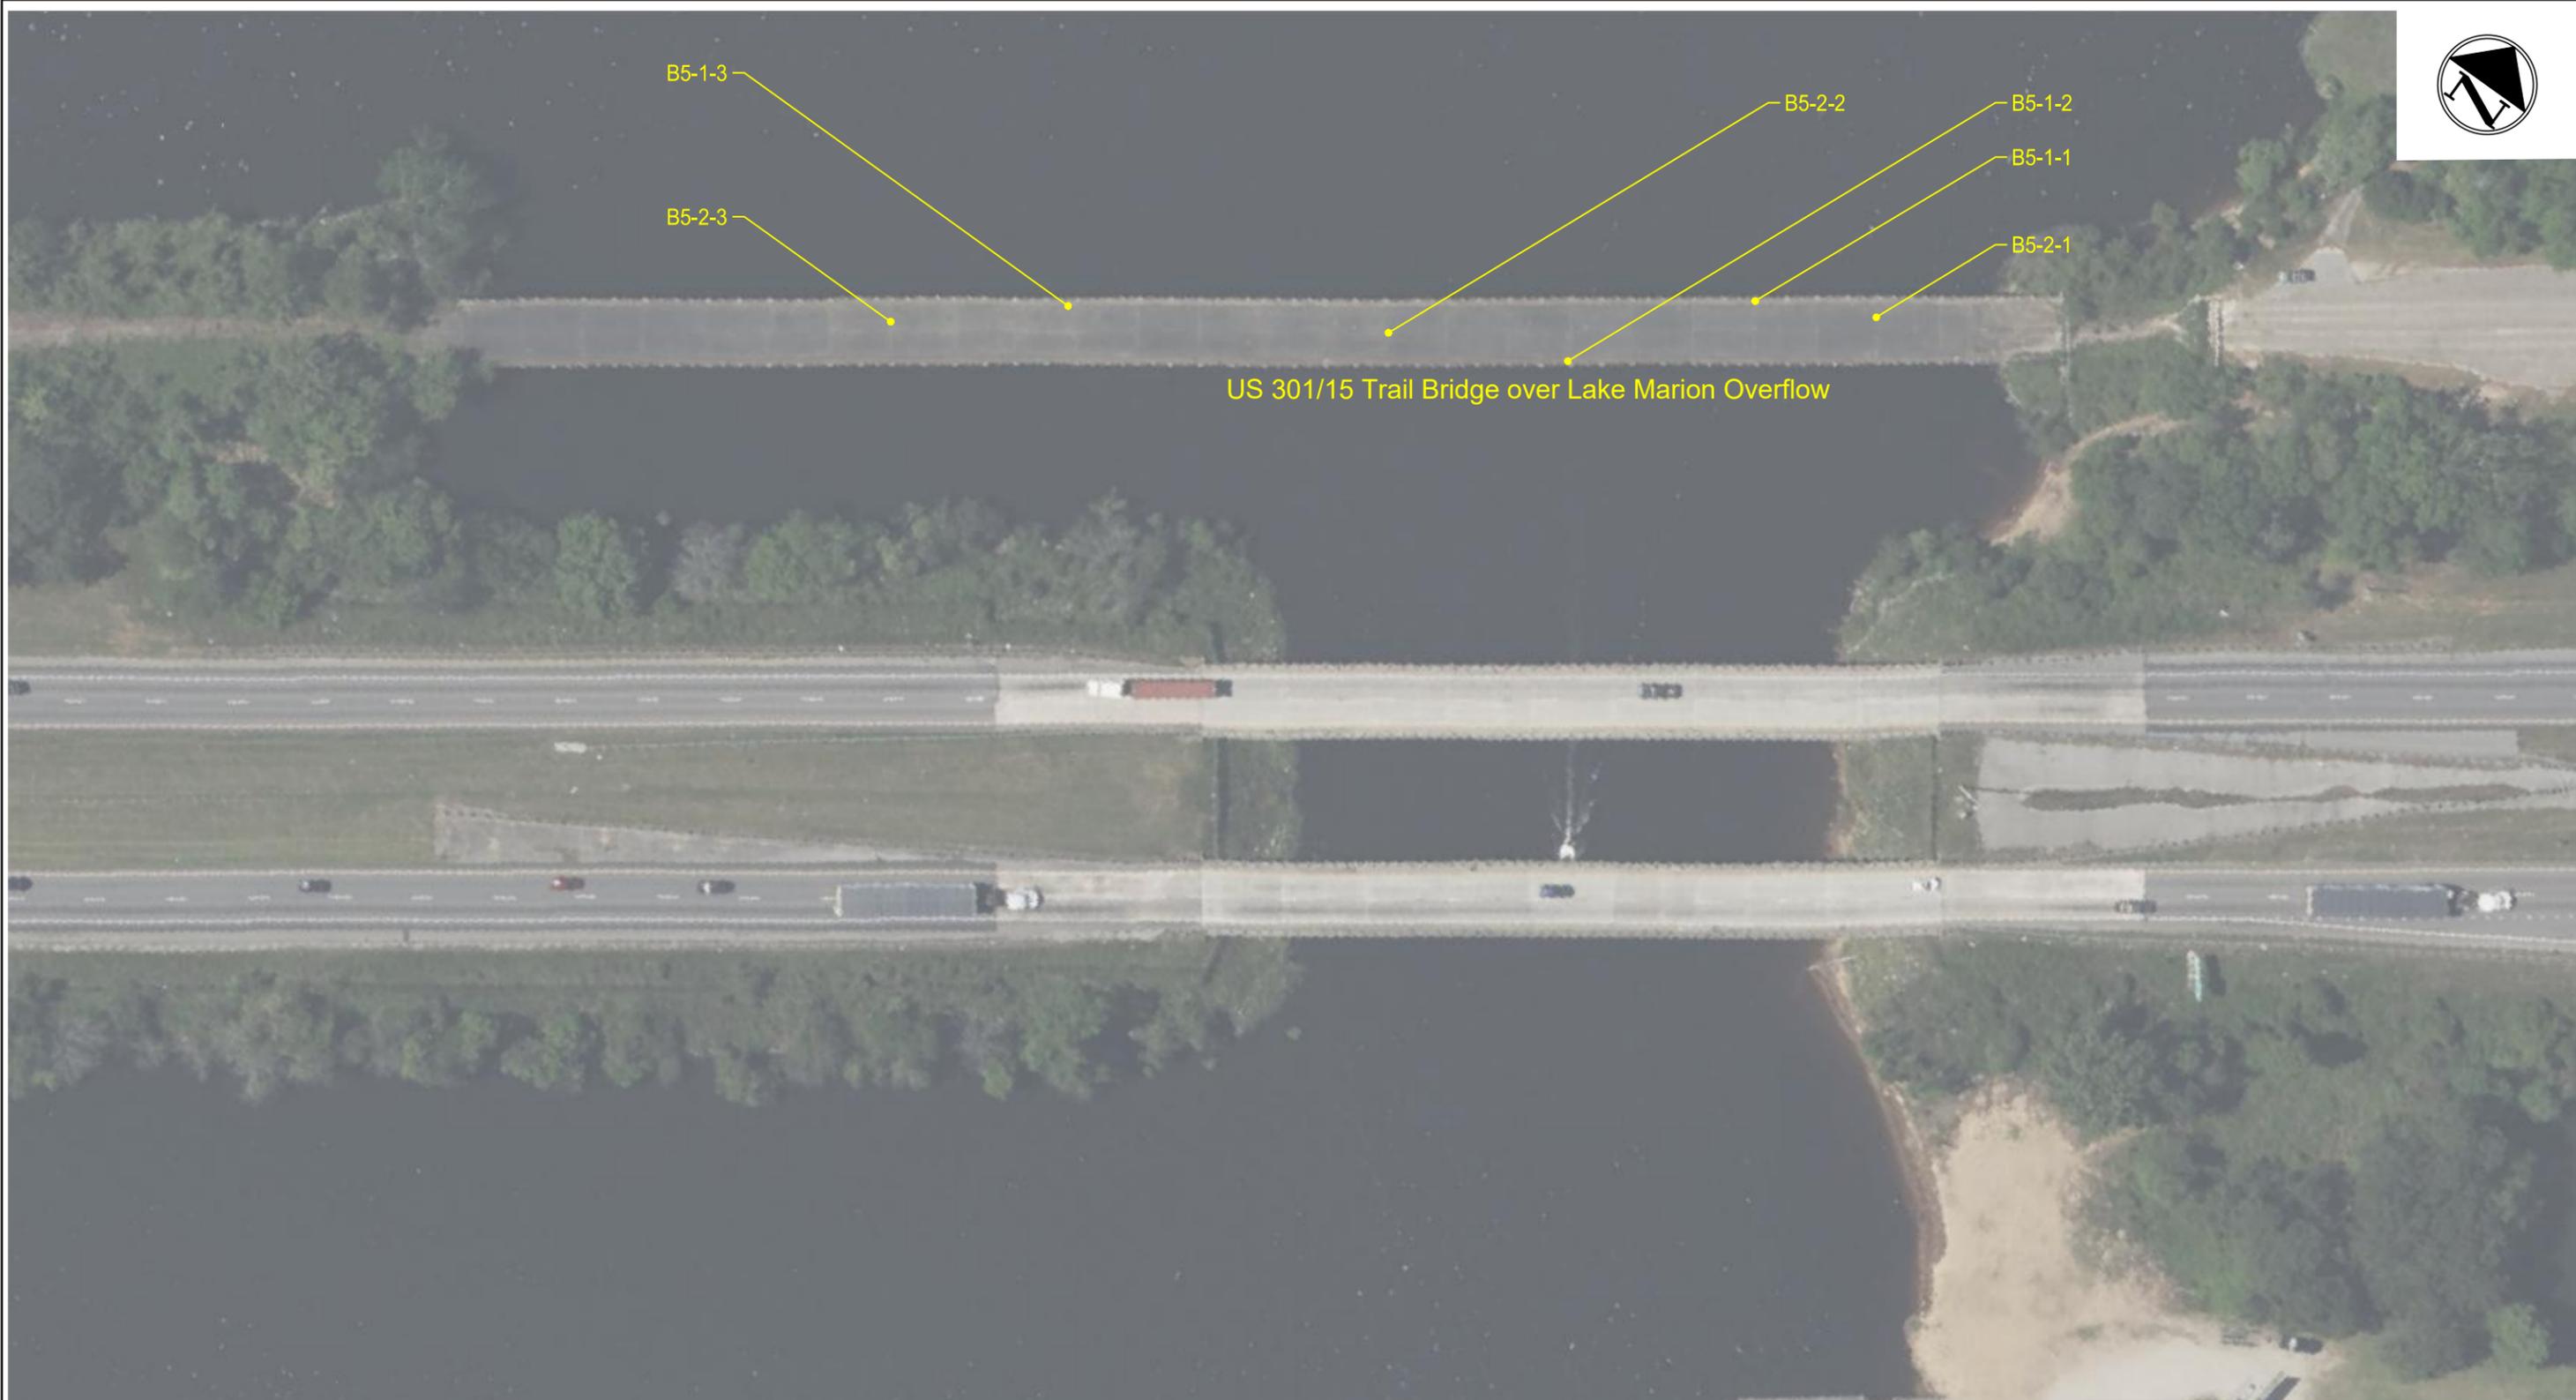
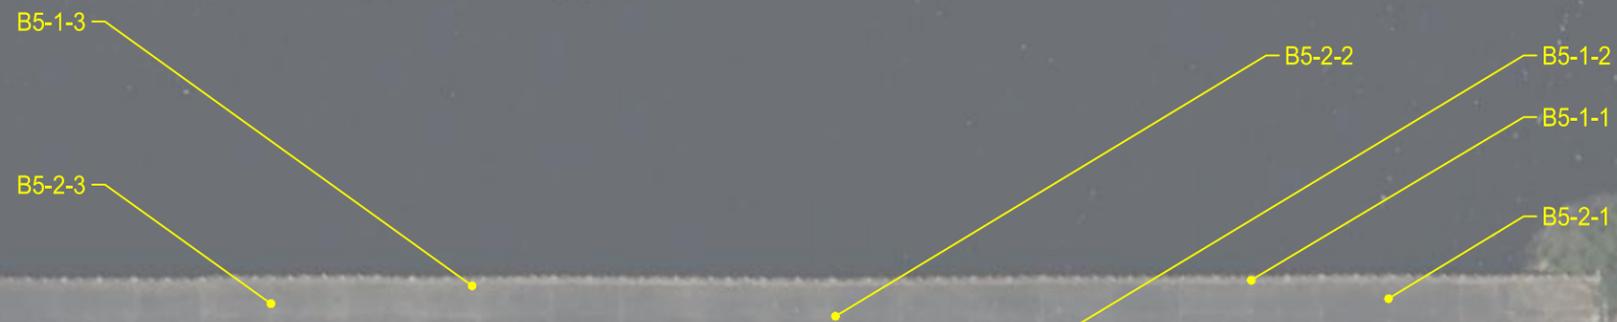
FIGURE 2

Sample ID	Description
Bridge #5 (US 301 Overflow Pedestrian Bridge over Lake Marion)	
B5-1-1	Expansion Joint Sealer
B5-1-2	Expansion Joint Sealer
B5-1-3	Expansion Joint Sealer
B5-2-1	Repair Bond Break Pad
B5-2-2	Repair Bond Break Pad
B5-2-3	Repair Bond Break Pad

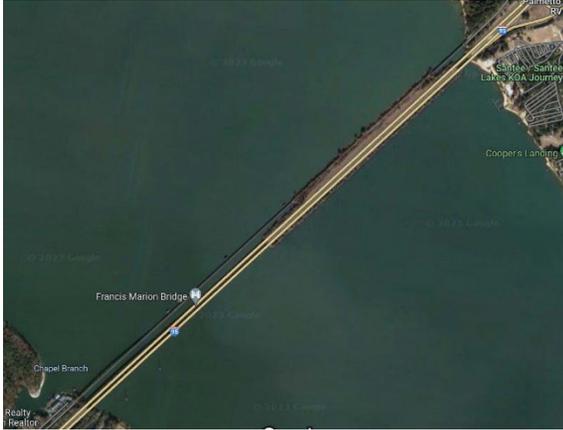
Photo 1. Top Side View of Bridges.

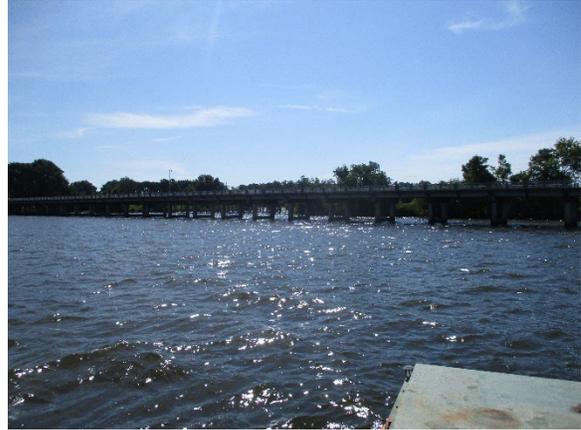
Photo 2. Southwest View of US 301/15 Trail Bridge over Lake Marion Overflow.

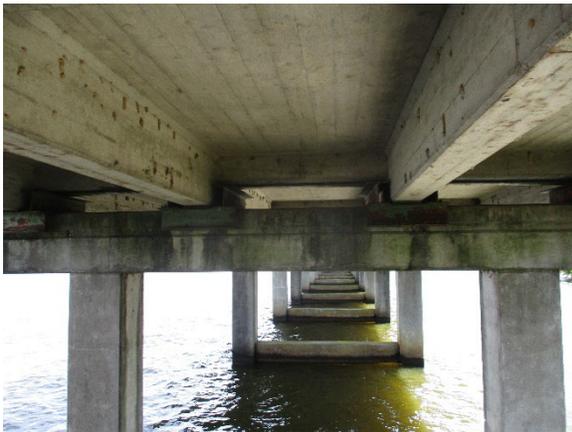
Photo 3. Underside View of US 301/15 Trail Bridge over Lake Marion Overflow.

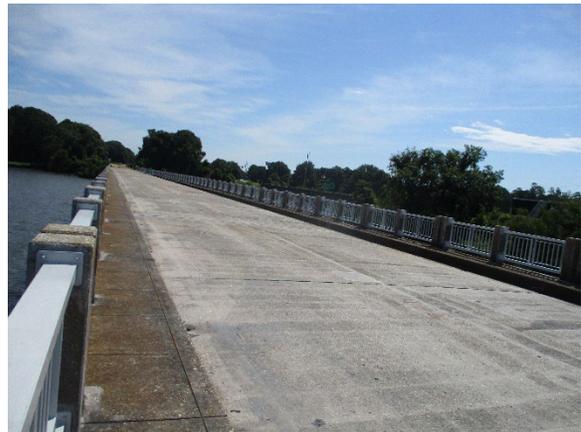
Photo 4. Top View of Bridge Deck of Bridge #5.

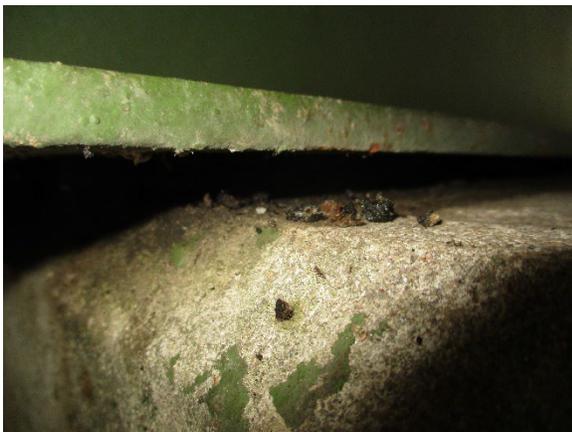
Sample ID	Description	Appearance	% Matrix Material	% Non-Asbestos Fibers	Asbestos Types
B5 1-3 022304973-0005	Expansion Joint Sealer	Gray/Black Non-Fibrous Heterogeneous	100.0 Other	None	No Asbestos Detected
B5 2-3 022304973-0006	Bond Break Pad (Repair)	Gray/Black Non-Fibrous Heterogeneous	100.0 Other	None	No Asbestos Detected

Photo 5. Non-ACM Bond Break Bearing Pad.

It is our understanding that the existing Bridge may undergo a planned demolition at some future time. **Laboratory results indicate that the materials sampled during this investigation were negative for asbestos.** Therefore, there are no foreseen special handling or disposal requirements, regarding asbestos, that will be required for the demolition of this bridge.

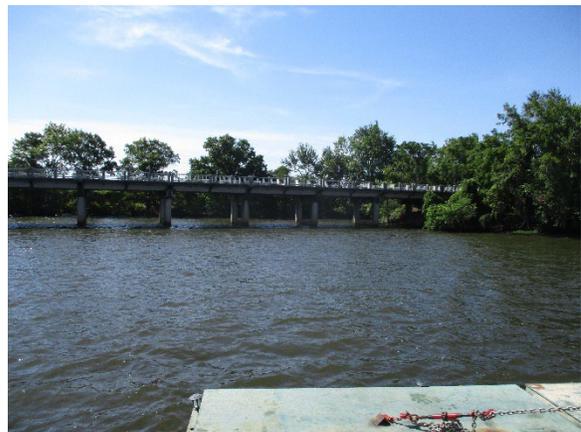
Photo 6. West View of the Southwest Side of Bridge #5.
