# ASBESTOS CONTAINING MATERIAL INVESTIGATION REPORT

SOUTHBOUND I-95 OVER LAKE MARION OVERFLOW BRIDGE  
CLARENDON & ORANGEBURG COUNTIES, SOUTH CAROLINA

**August 18, 2023**

F&ME Project No.: G6744.000

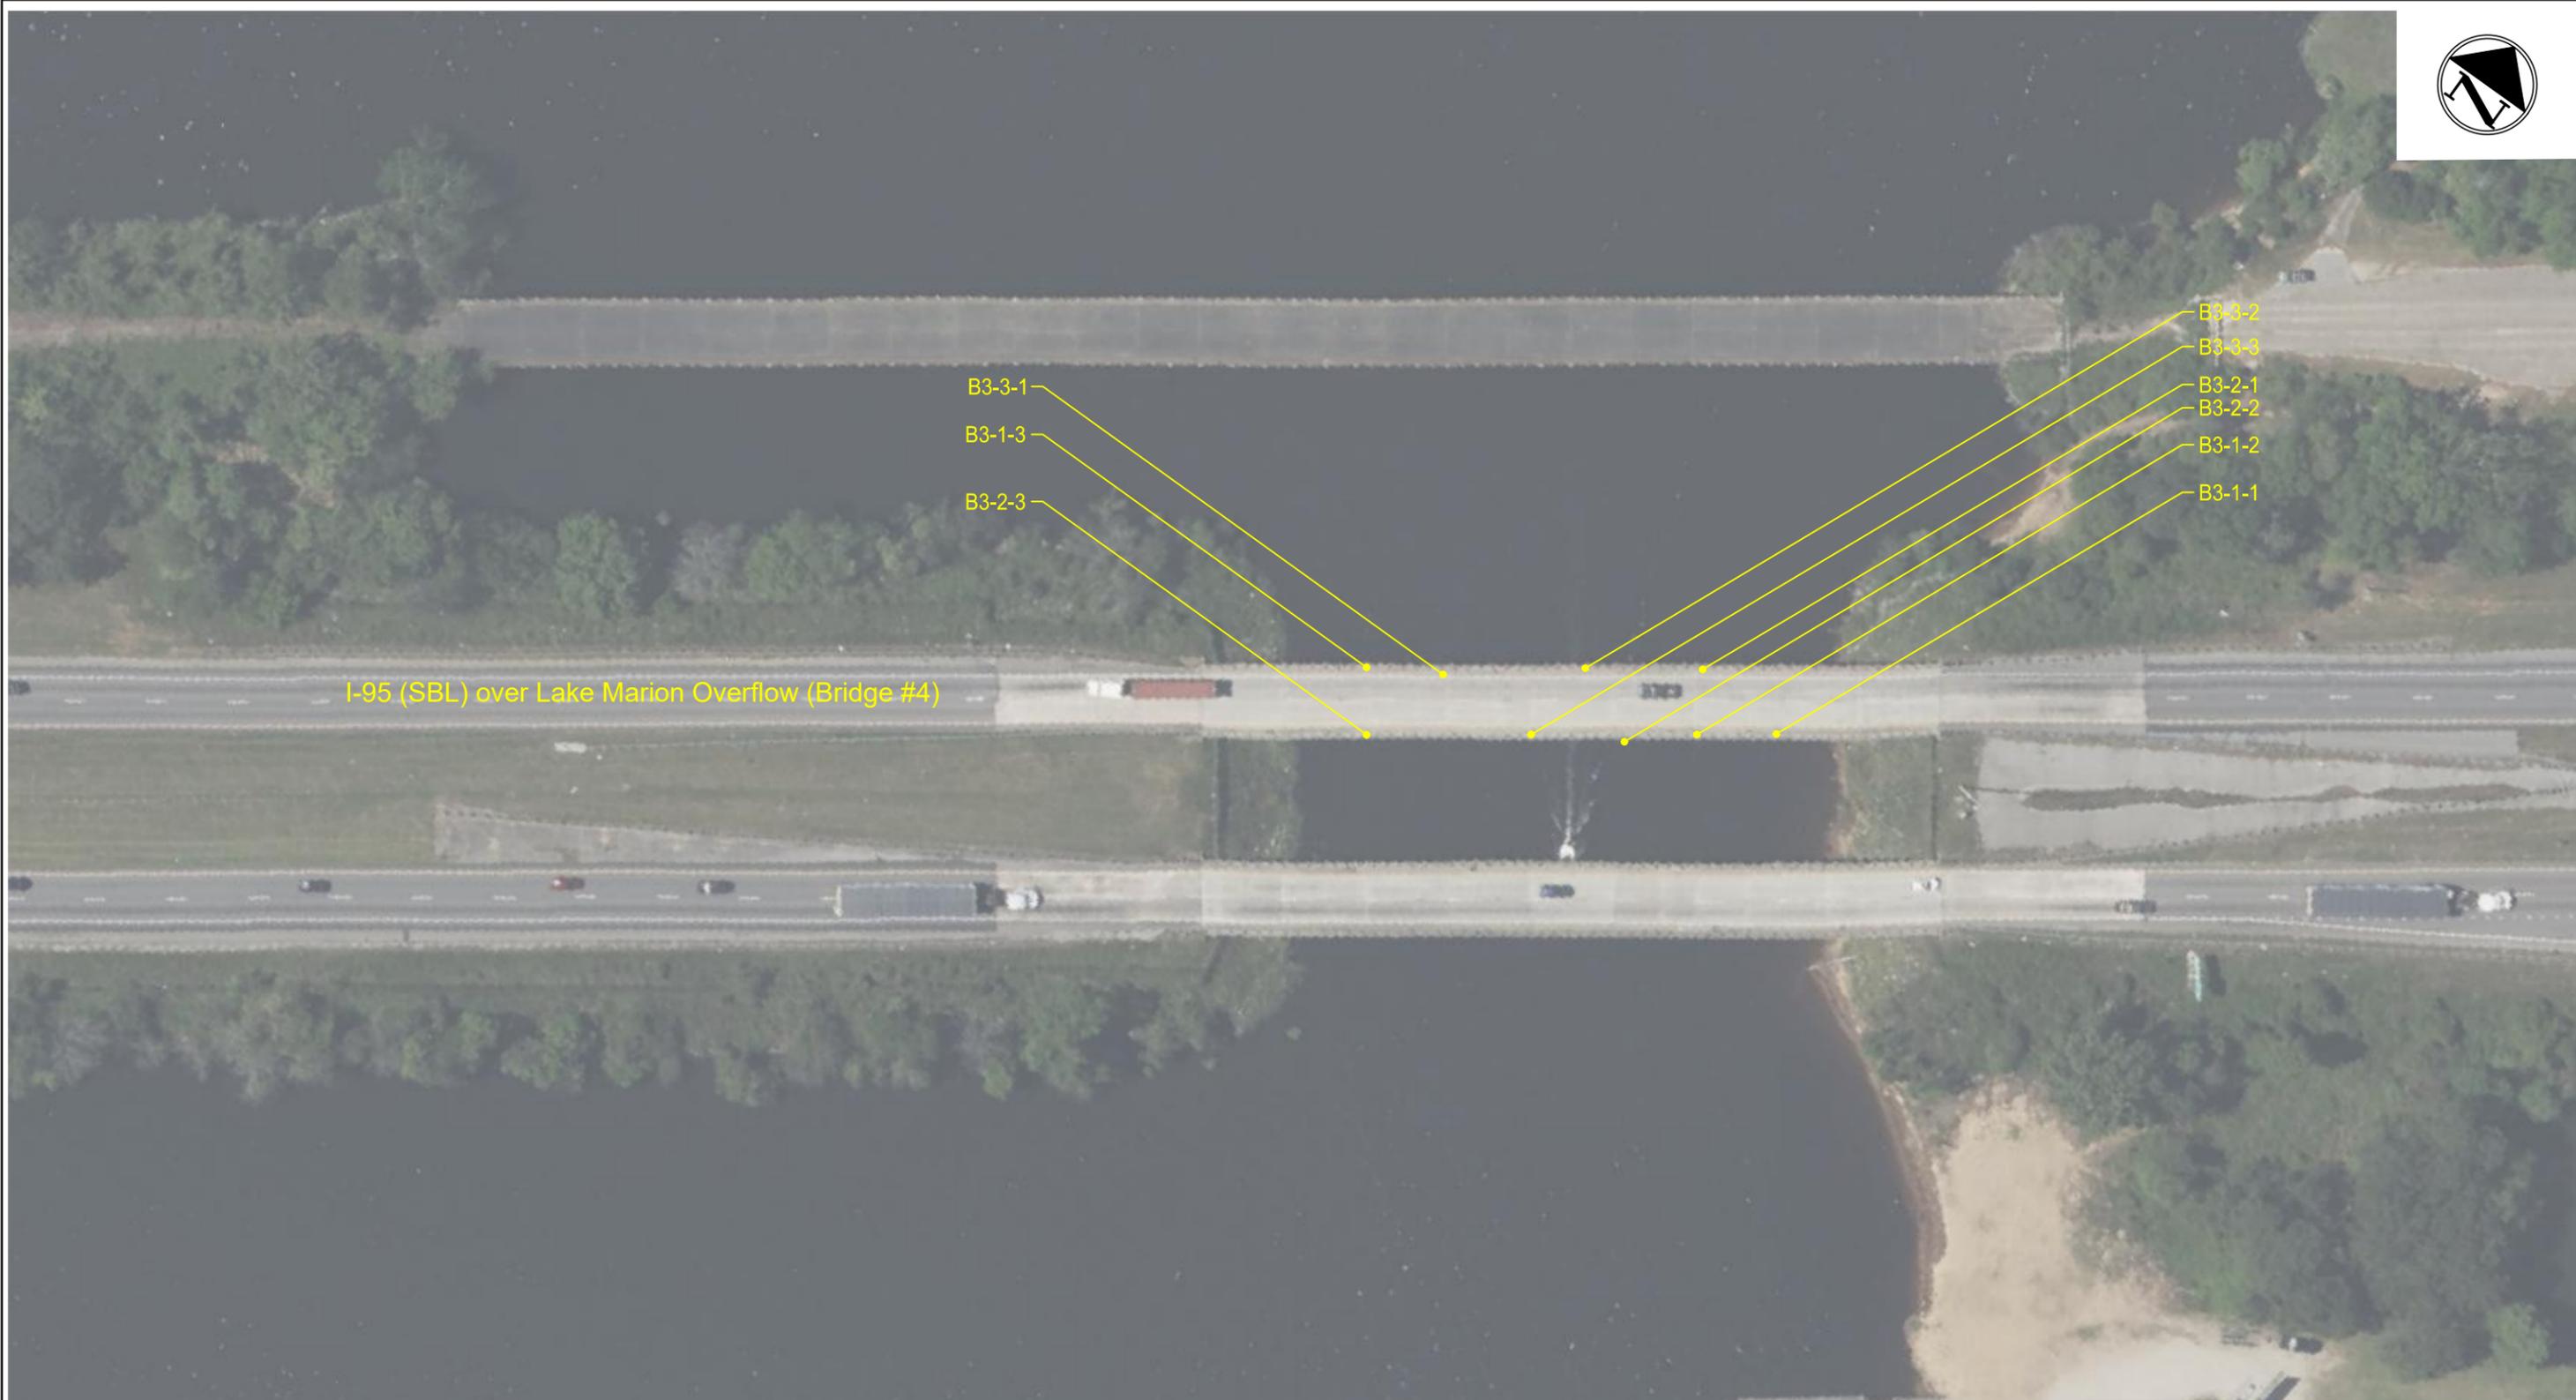
FIGURE 2

SAMPLE LOCATION PLAN

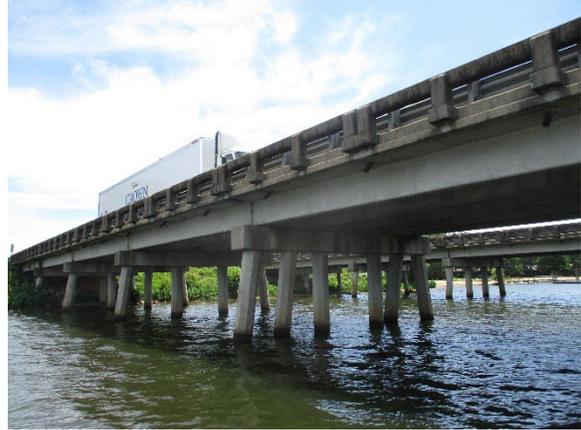
**Photo 2.** Southwest Corner View of SB I-95 Overflow Bridge #4.

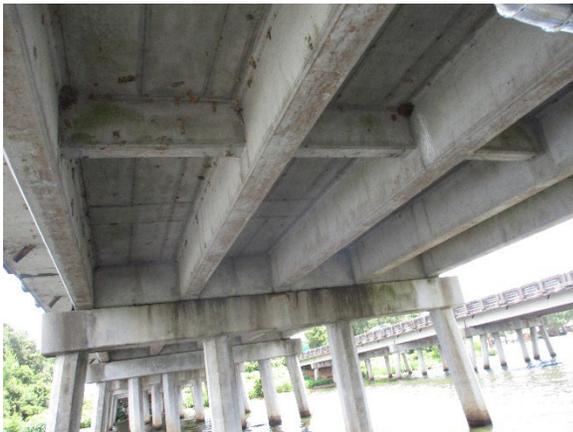
**Photo 3.** Underside View of SB I-95 NBL Overflow Bridge #4.

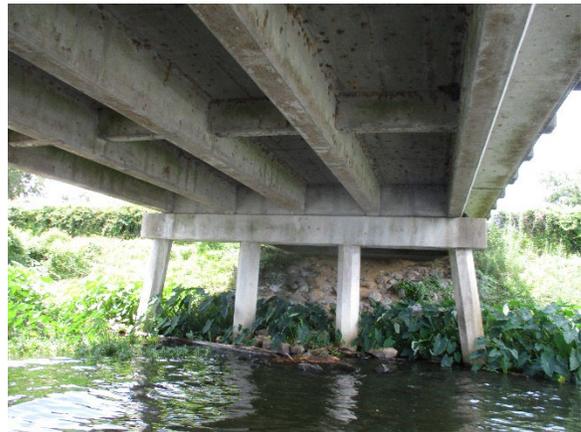
**Photo 4.** View of South End Bent.

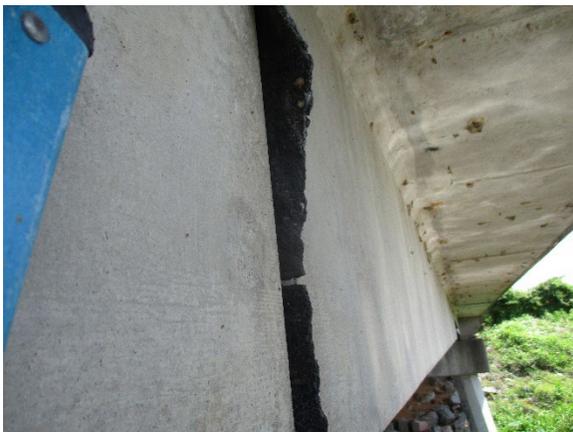
It is our understanding that the existing Bridge will to be demolished, in anticipation of the off-alignment replacement of the existing I-95 Bridge. **Laboratory results indicate that the materials sampled during this investigation were negative for asbestos.** Therefore, there are no foreseen special handling or disposal requirements, regarding asbestos, that will be required for the demolition of this bridge.

**Photo 5.** Non-ACM Expansion Joint Material.

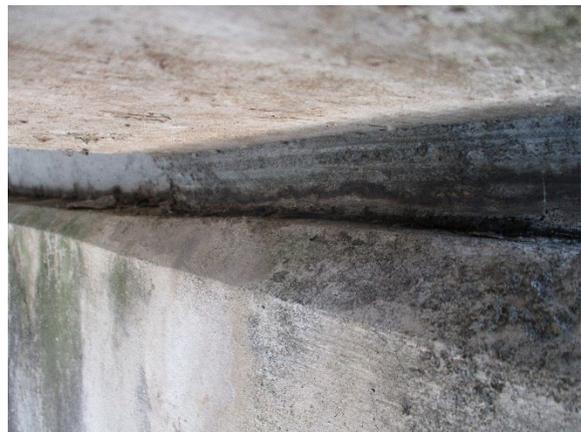
**Photo 6.** Non-ACM Bond Break Bearing Pad.
