LEAD-BASED PAINT INVESTIGATION REPORT

NORTHBOUND I-95 OVER LAKE MARION OVERFLOW BRIDGE
CLARENDON & ORANGEBURG COUNTIES, SOUTH CAROLINA

August 18, 2023

FME Project No.: G6744.000

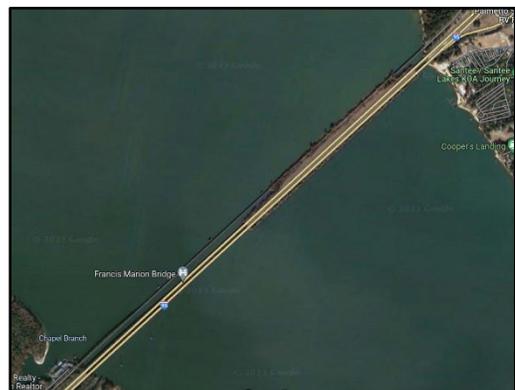
Photo 1 – Northbound I-95 over Lake Marion Overflow Bridge in Clarendon & Orangeburg Counties, SC.

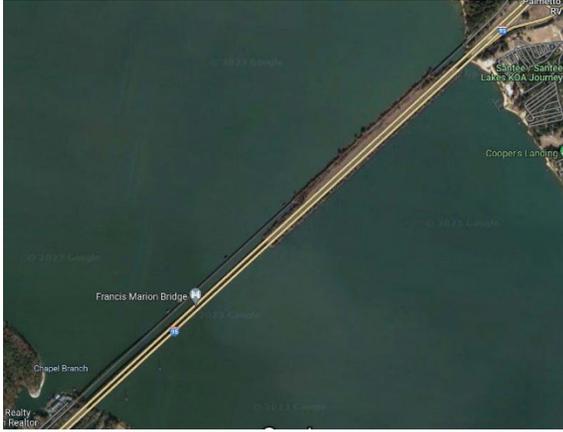
Photo 1. Top View of Bridges.

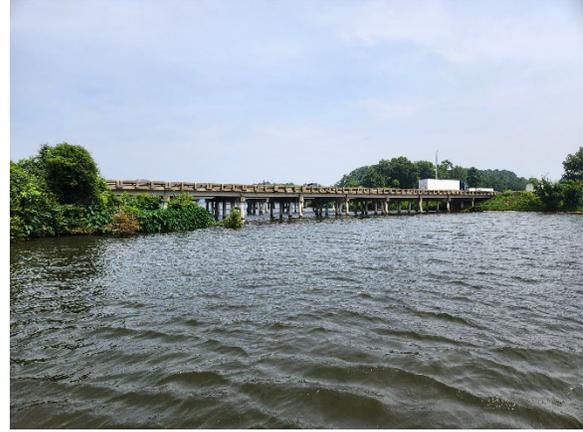
Photo 2. Southeast Corner View of Bridge #1.

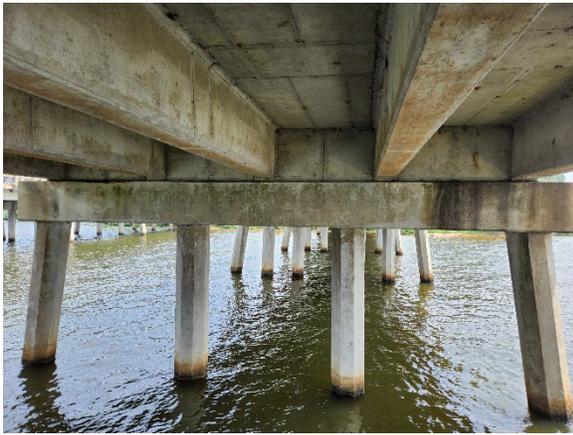
Photo 3. Underside View of Bridge #1.

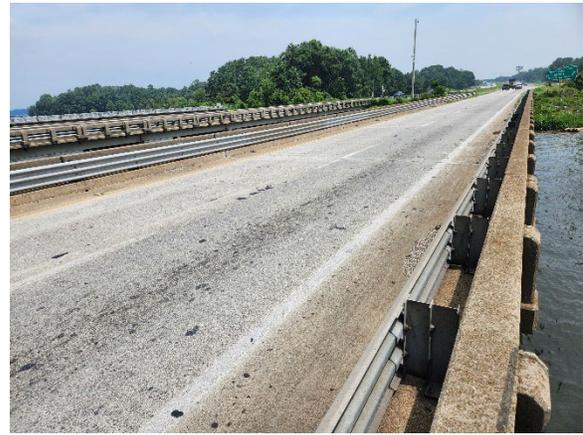
Photo 4. Topside View of Bridge #1.

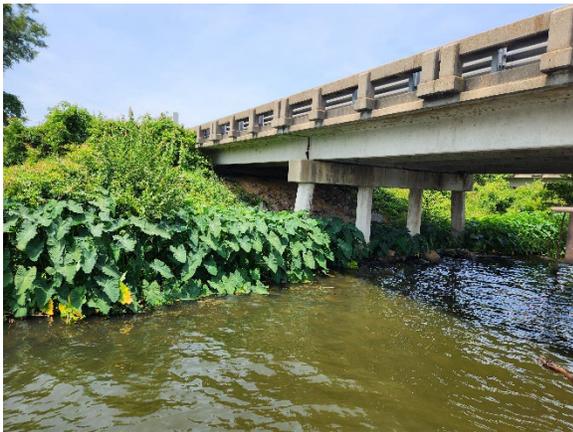
Photo 5. Northeast View of South End Bent.
