LEAD-BASED PAINT INVESTIGATION REPORT

SOUTHBOUND I-95 OVER LAKE MARION OVERFLOW BRIDGE
CLARENDON & ORANGEBURG COUNTIES, SOUTH CAROLINA

August 18, 2023

FME Project No.: G6744.000

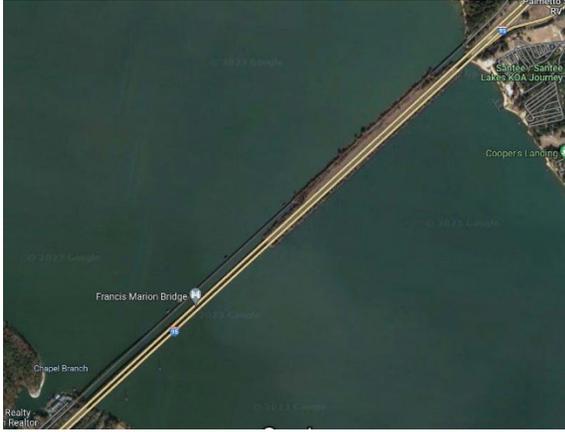
Photo 1. Top Side View of Bridges.

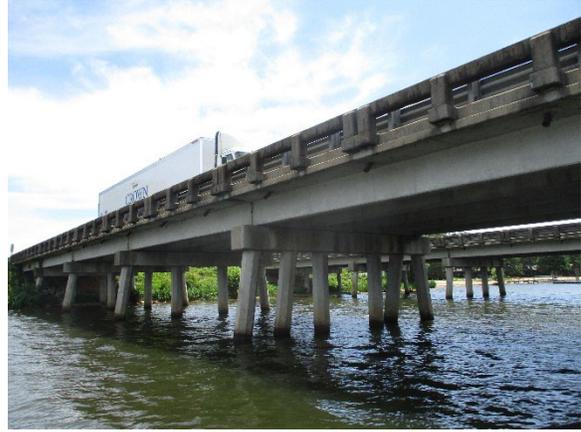
Photo 2. Southwest Corner View of SB I-95 Overflow Bridge #4.

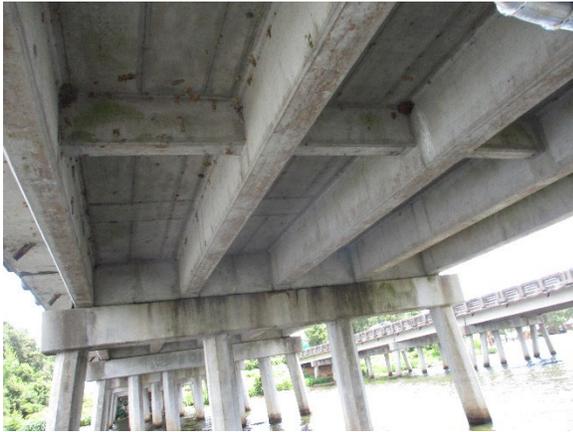
There were no painted and/or coated bridge components noted during this investigation of the subject Bridge. Therefore, no XRF scans were required during this investigation.

Photo 3. Underside View of SB I-95 NBL Overflow Bridge #4.

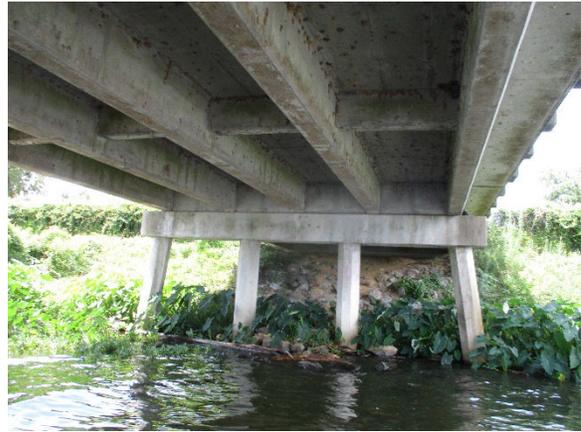
Photo 4. View of South End Bent.
