LEAD-BASED PAINT INVESTIGATION REPORT

US 301/15 TRAIL BRIDGE OVER LAKE MARION
CLARENDON & ORANGEBURG COUNTIES, SOUTH CAROLINA

August 18, 2023

FME Project No.: G6744.000

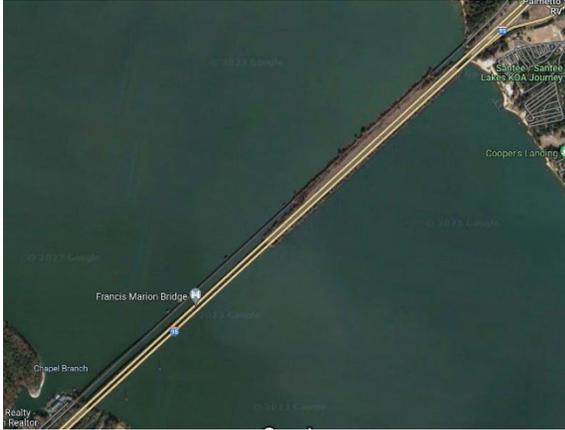
Photo 1. Top View of Bridges.

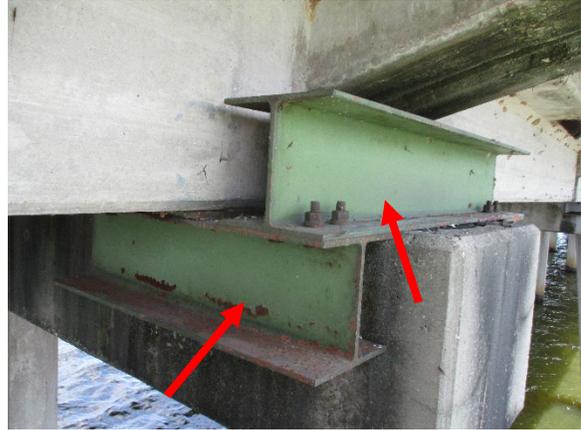
Photo 2. LBP on Green Repair I-Beams Associated with Bridge #6.

Therefore, OSHA regulations and procedures should be followed when impacting these components. If possible, they should be removed in whole and disposed of properly. Also, SCDHEC disposal requirements for lead containing materials should also be followed.

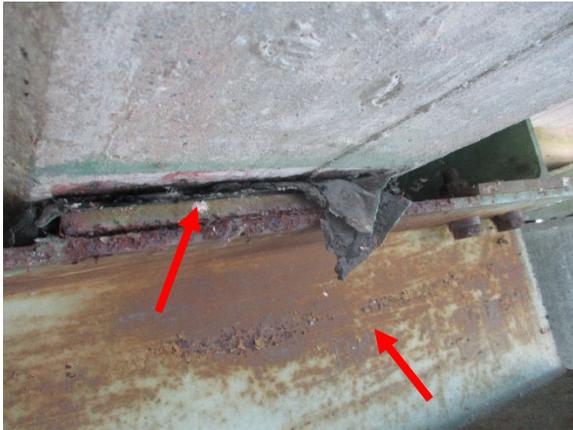
Photo 3. LBP on Gray Repair I Beam and Top Bearing Plate.

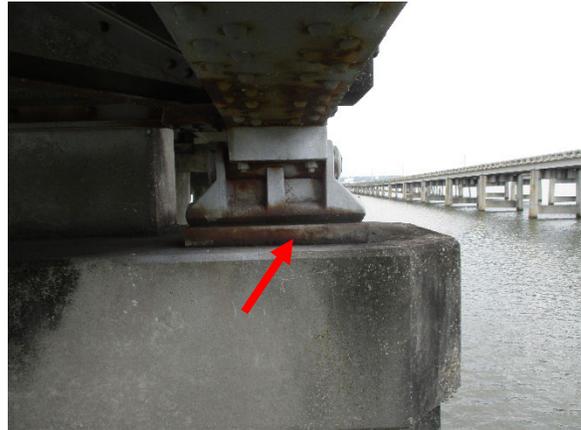
Photo 4. LBP on Gray Bearing Plate under Rocker Bearing on South End of Bridge #6.

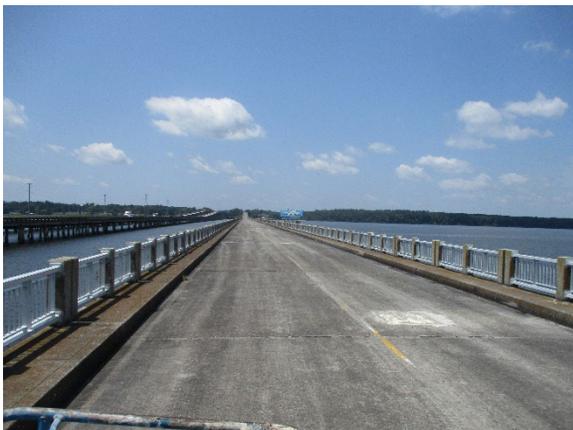
Photo 5. Top Side View of Bridge Deck.

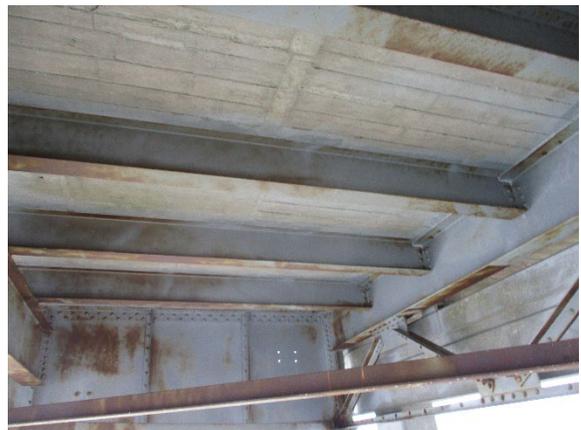
Photo 6. Underside View of Bridge #6.
