LEAD-BASED PAINT INVESTIGATION REPORT

SOUTHBOUND I-95 BRIDGE OVER LAKE MARION
CLARENDON & ORANGEBURG COUNTIES, SOUTH CAROLINA

August 18, 2023

FME Project No.: G6744.000

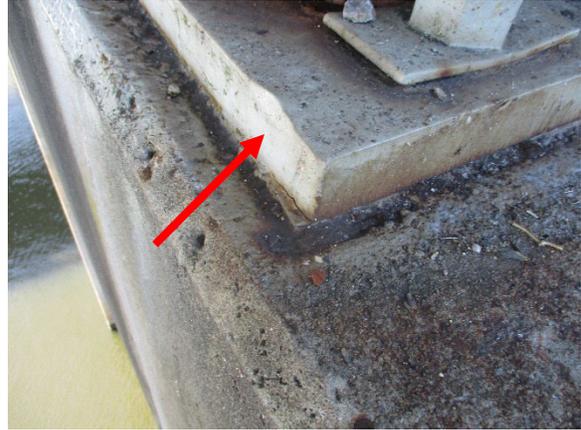
Photo 2. LBP on Bearing Plates Associated with Bridge #3.

Therefore, OSHA regulations and procedures should be followed when impacting these components. If possible, they should be removed in whole and disposed of properly. Also, SCDHEC disposal requirements for lead containing materials should also be followed.

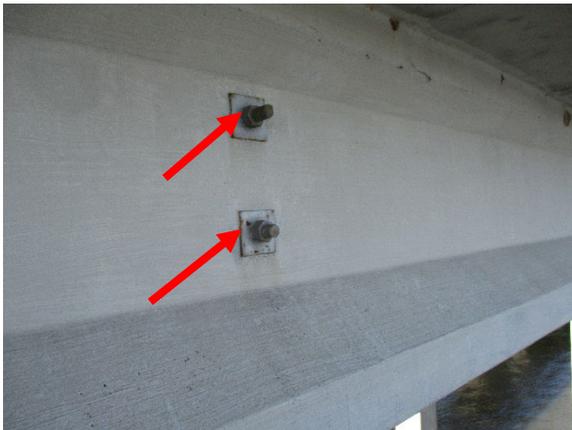
Photo 3. LBP on Tie-Rod Washers Located along each Side of Bridge #3.

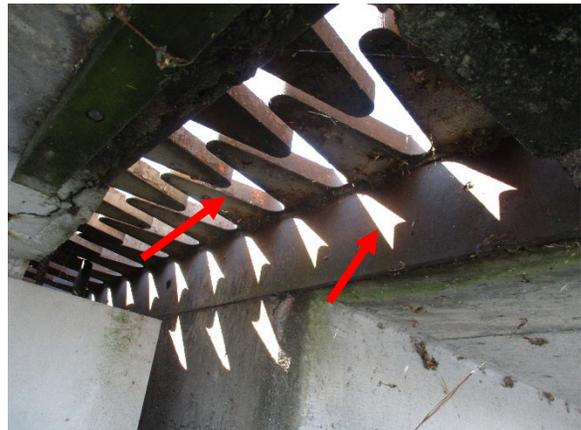
Photo 4. LBP on Metal Expansion Joint on Decking of Bridge #3.
