# LEAD-BASED PAINT INVESTIGATION REPORT

US 301/15 TRAIL BRIDGE OVER LAKE MARION OVERFLOW  
CLARENDON & ORANGEBURG COUNTIES, SOUTH CAROLINA

**August 18, 2023**

FME Project No.: G6744.000

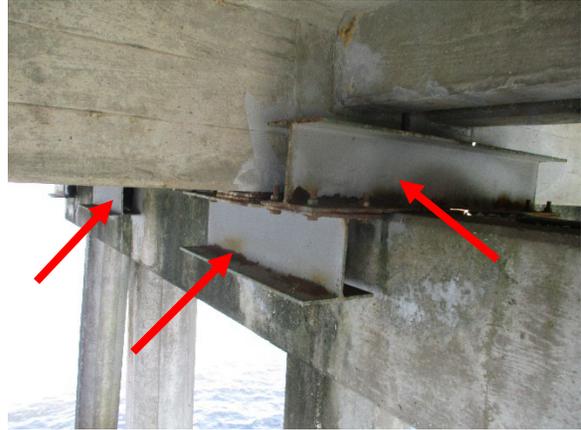
**Photo 2.** LBP on Gray Repair I-Beams on Underside of Bridge #5 .

Therefore, OSHA regulations and procedures should be followed when impacting these components. If possible, they should be removed in whole and disposed of properly. Also, SCDHEC disposal requirements for lead containing materials should also be followed.

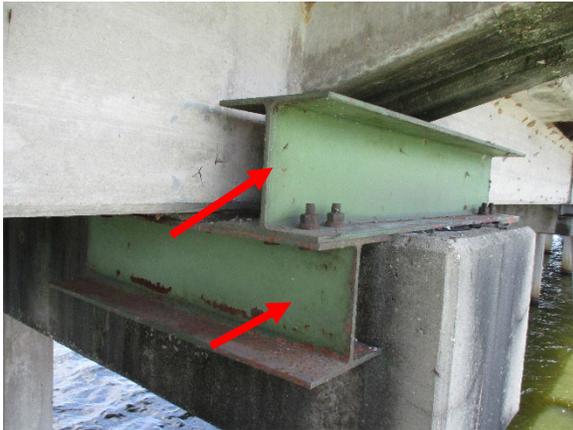
**Photo 3.** LBP on Green Repair I-Beams on Underside of Bridge #5.

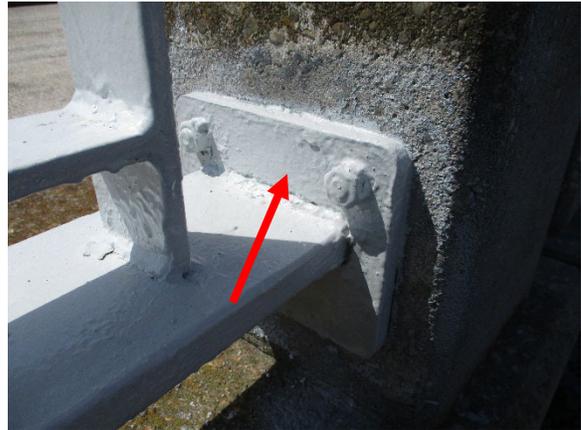
**Photo 4.** LBP on Gray Metal Handrail Plates along each Side of Bridge #5.
