LEAD-BASED PAINT INVESTIGATION REPORT

BRIDGE REMNANTS ON LAKE MARION
CLARENDON & ORANGEBURG COUNTIES, SOUTH CAROLINA

August 18, 2023

FME Project No.: G6744.000

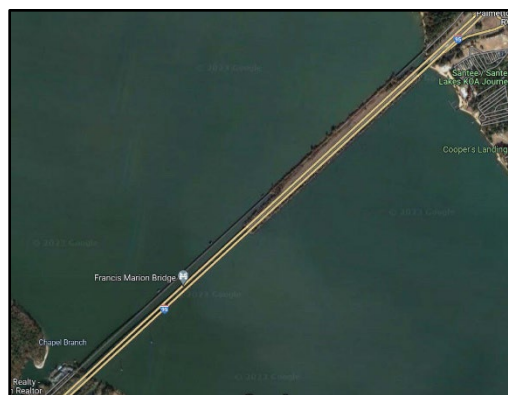
Photo 1 – Northbound I-95 over Lake Marion Overflow Bridge in Clarendon & Orangeburg Counties, SC.

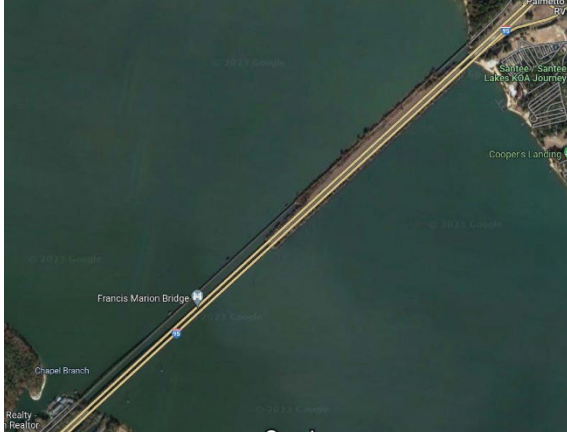
Photo 1. Top View of Bridges.

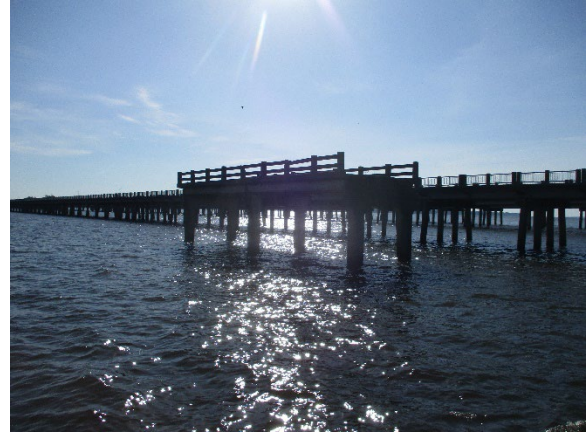
Photo 2. Bridge Remnant on West Side of US 301/15 Trail Bridge over Lake Marion.

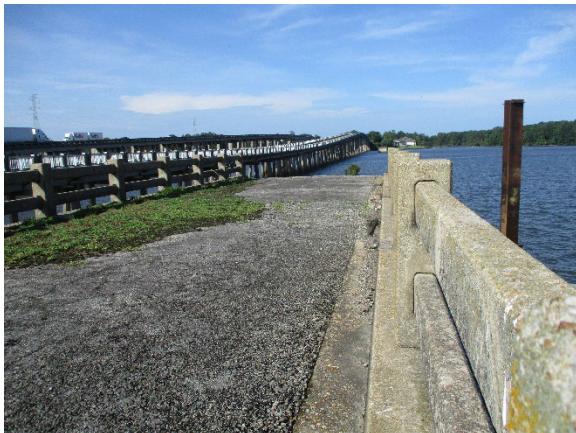
Photo 3. Top View of Deck of Bridge Remnant.

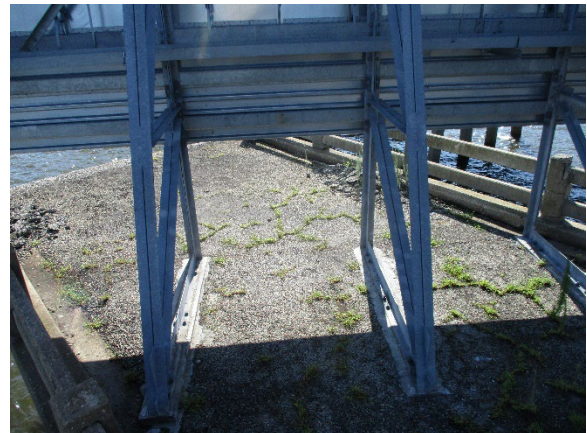
| Scan No. | Pbc (mg/cm ²) | Component | Substrate | Side | Condition | Color |
|---|---|---|---|---|---|---|
| 4 | <LOD | Sign Bottom Plate | Metal | Center | Intact | Gray |

Photo 4. Galvanized Metal Sign Attached to Top of Deck on Bridge Remnant.

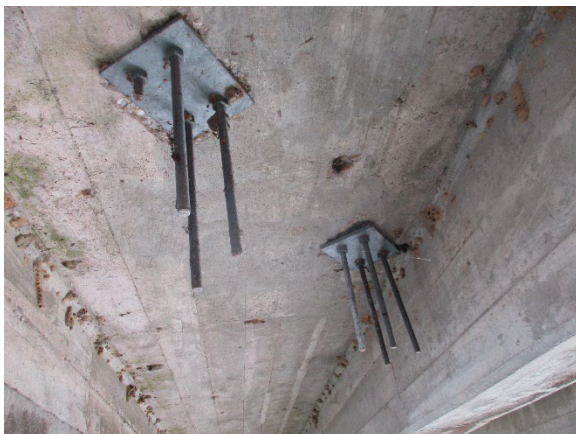
Photo 5. Galvanized Metal Sign Anchor Plates on Underside of Bridge Remnant.
