# ASBESTOS CONTAINING MATERIAL INVESTIGATION REPORT

NORTHBOUND I-95 OVER LAKE MARION OVERFLOW BRIDGE  
CLARENDON & ORANGEBURG COUNTIES, SOUTH CAROLINA

**August 18, 2023**

F&ME Project No.: G6744.000

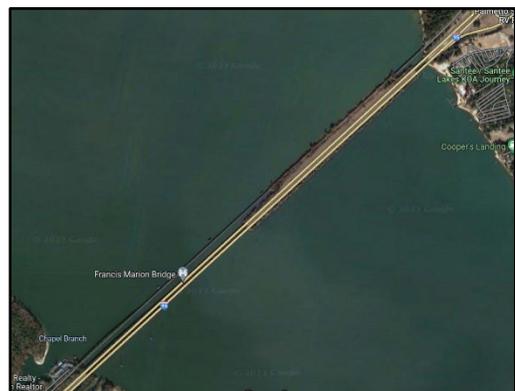
*Photo 1 – Northbound I-95 over Lake Marion Overflow Bridge in Clarendon & Orangeburg Counties, SC.*

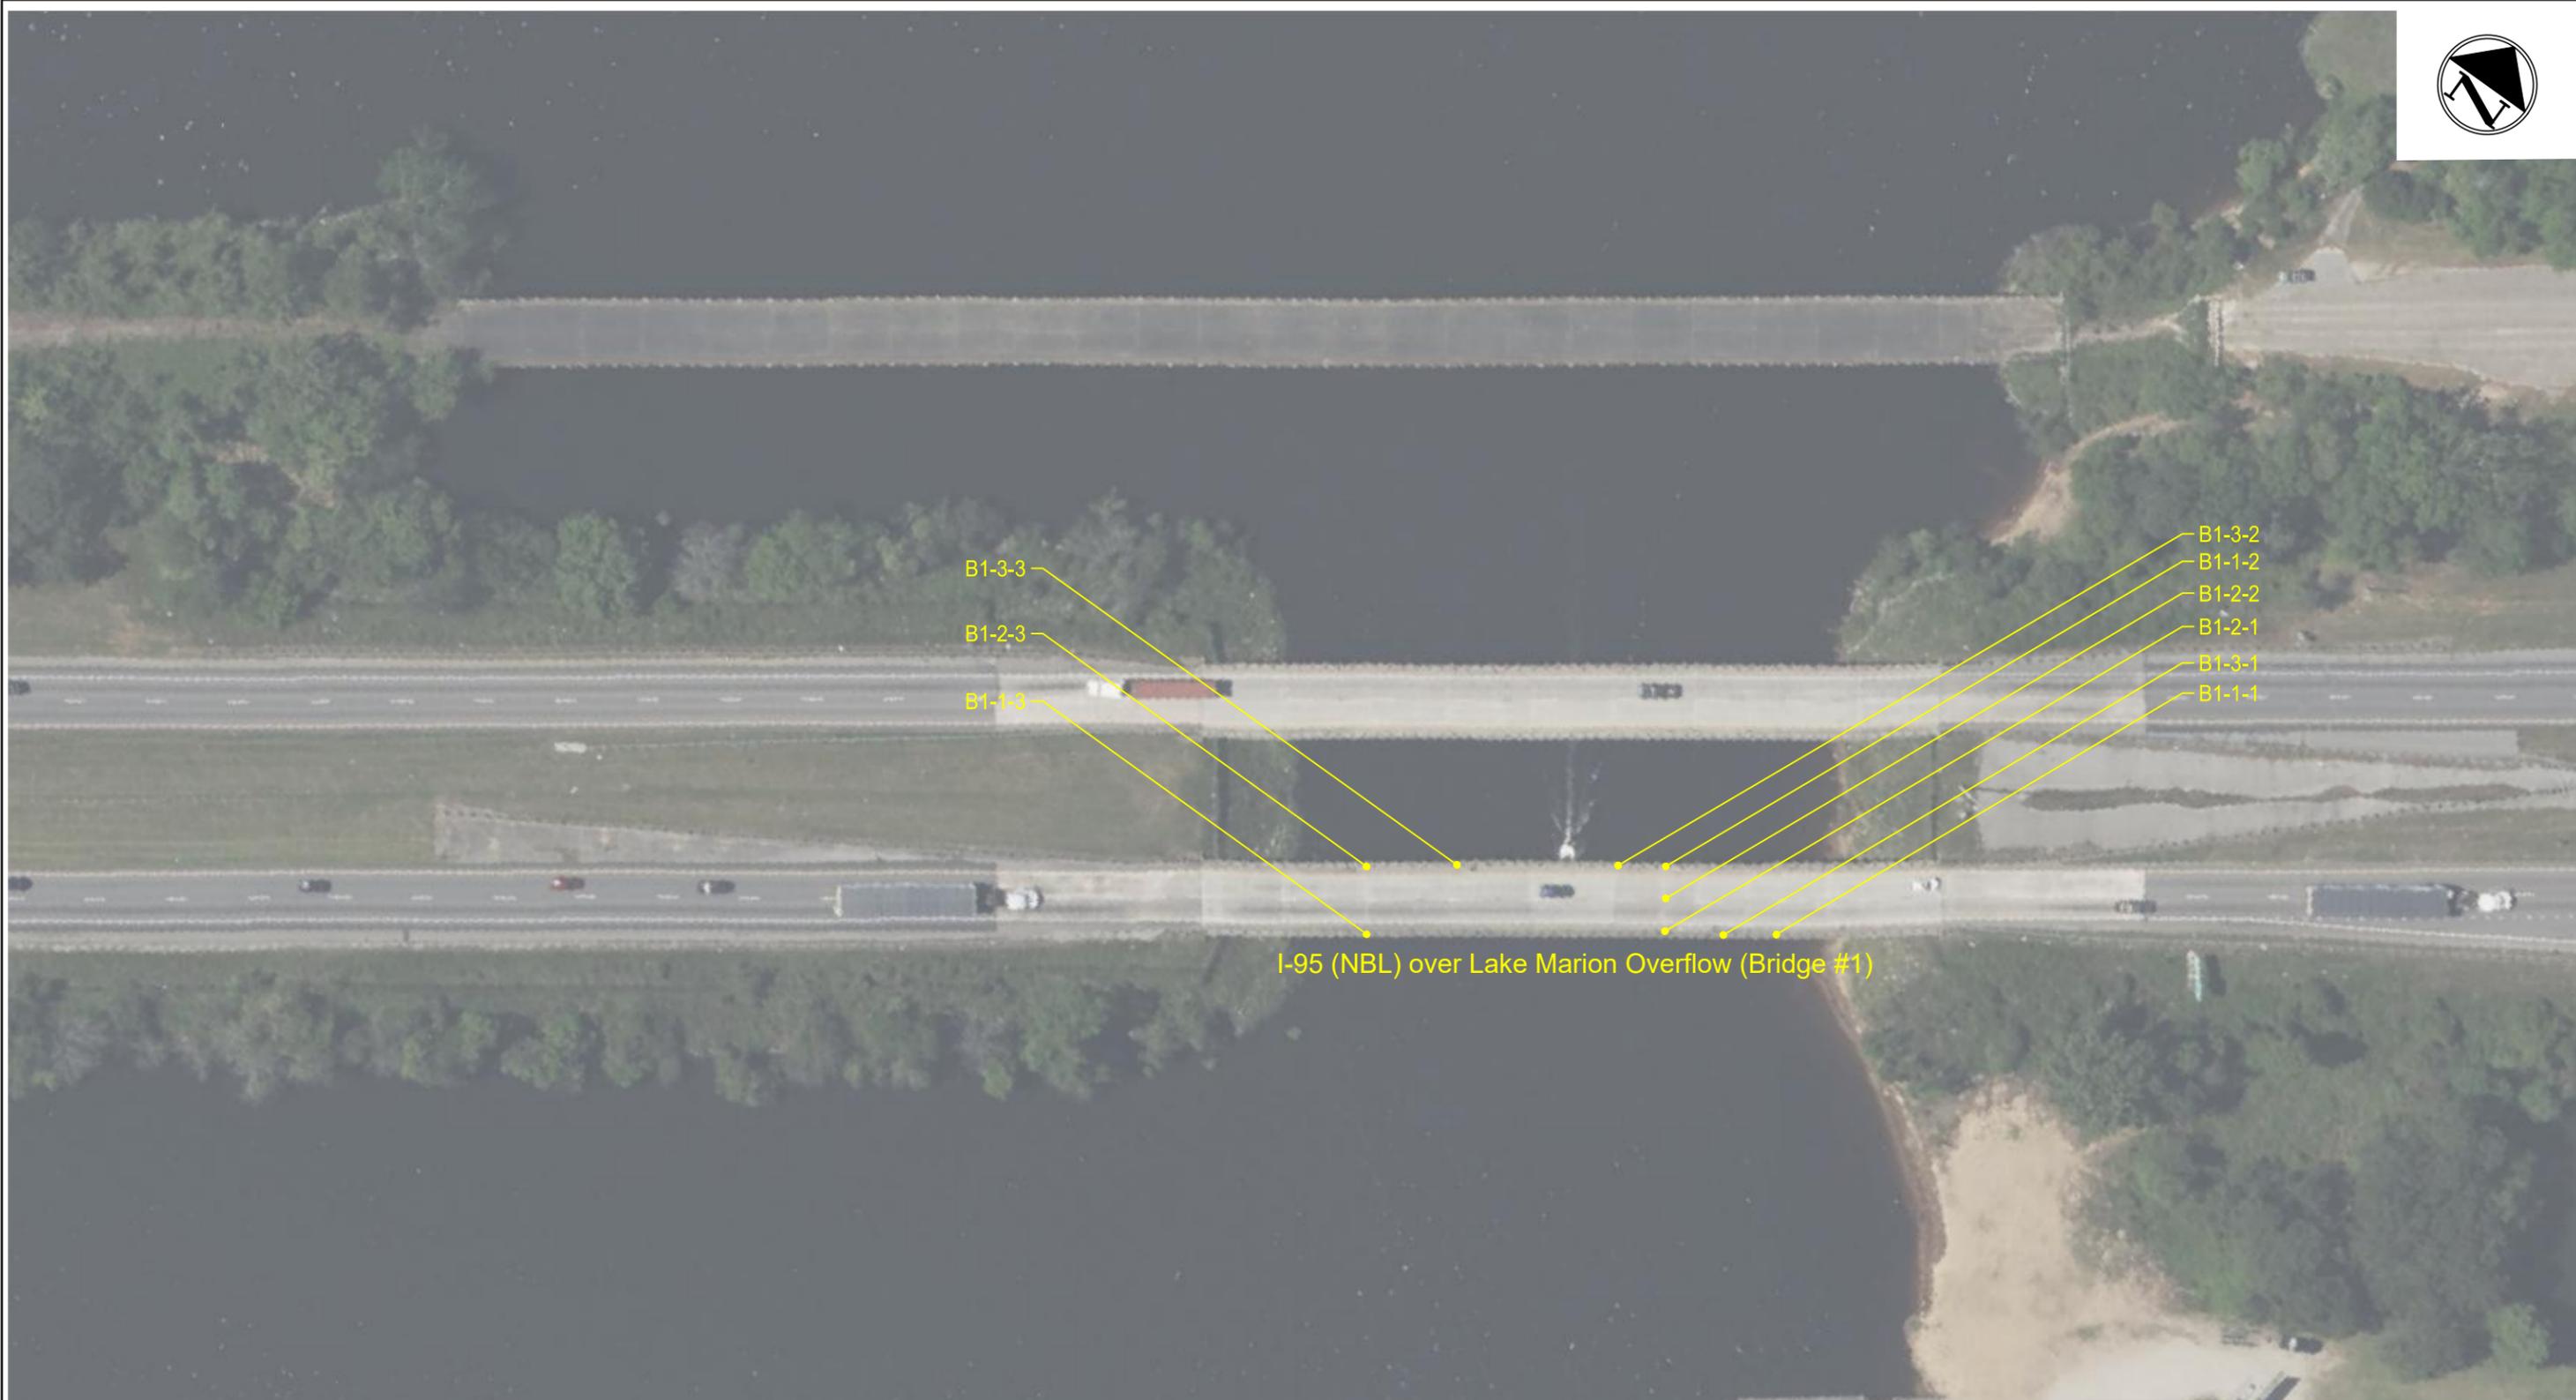
SAMPLE LOCATION PLAN

Sample ID	Description
<b>Bridge #1 (I-95 NBL Overflow Bridge over Lake Marion)</b>	
B1-1-1	Black Expansion Joint Material
B1-1-2	Black Expansion Joint Material
B1-1-3	Black Expansion Joint Material
B1-2-1	Bond Break Bearing Pad
B1-2-2	Bond Break Bearing Pad
B1-2-3	Bond Break Bearing Pad
B1-3-1	Expansion Joint Sealer
B1-3-2	Expansion Joint Sealer
B1-3-3	Expansion Joint Sealer

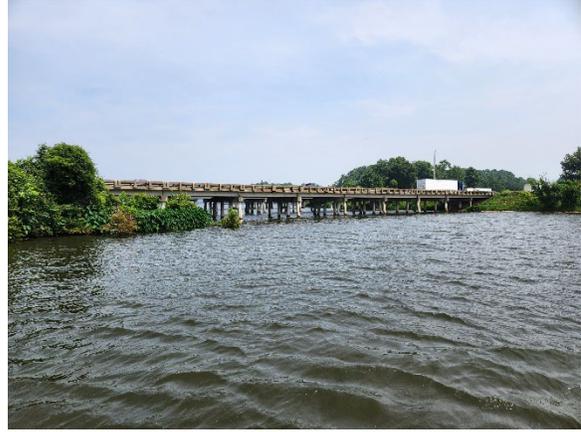
**Photo 2.** Southeast View of NB I-95 Overflow Bridge #1.

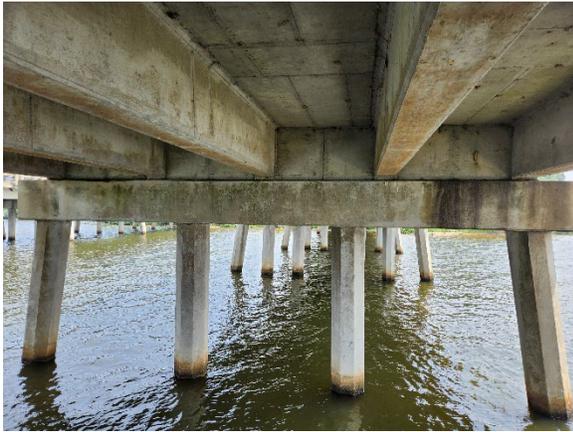
**Photo 3.** Underside View of NB I-95 NBL Overflow Bridge #1.

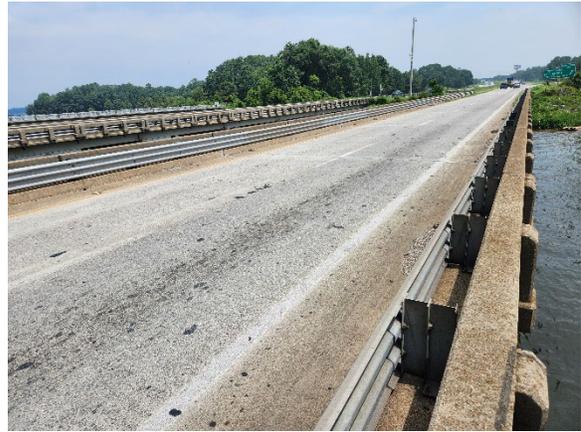
**Photo 4.** Top View of Bridge Deck.

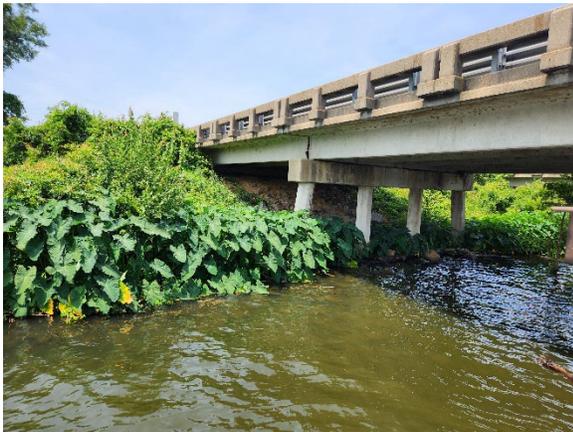
**Photo 5.** Northeast View of South End Bent.

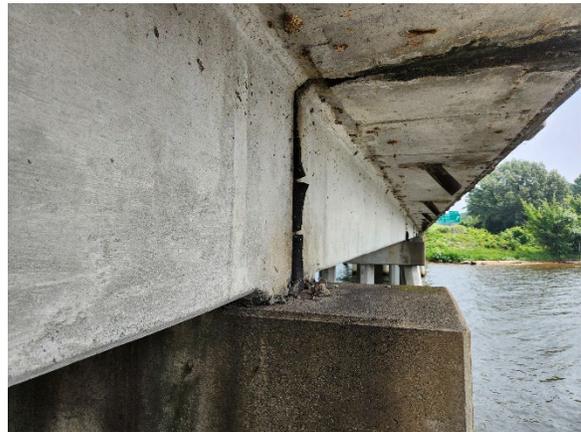
**Photo 6.** Non-ACM Expansion Joint Material.
