ASBESTOS CONTAINING MATERIAL INVESTIGATION REPORT

US 301/15 TRAIL BRIDGE OVER LAKE MARION
CLARENDON & ORANGEBURG COUNTIES, SOUTH CAROLINA

August 18, 2023

F&ME Project No.: G6744.000

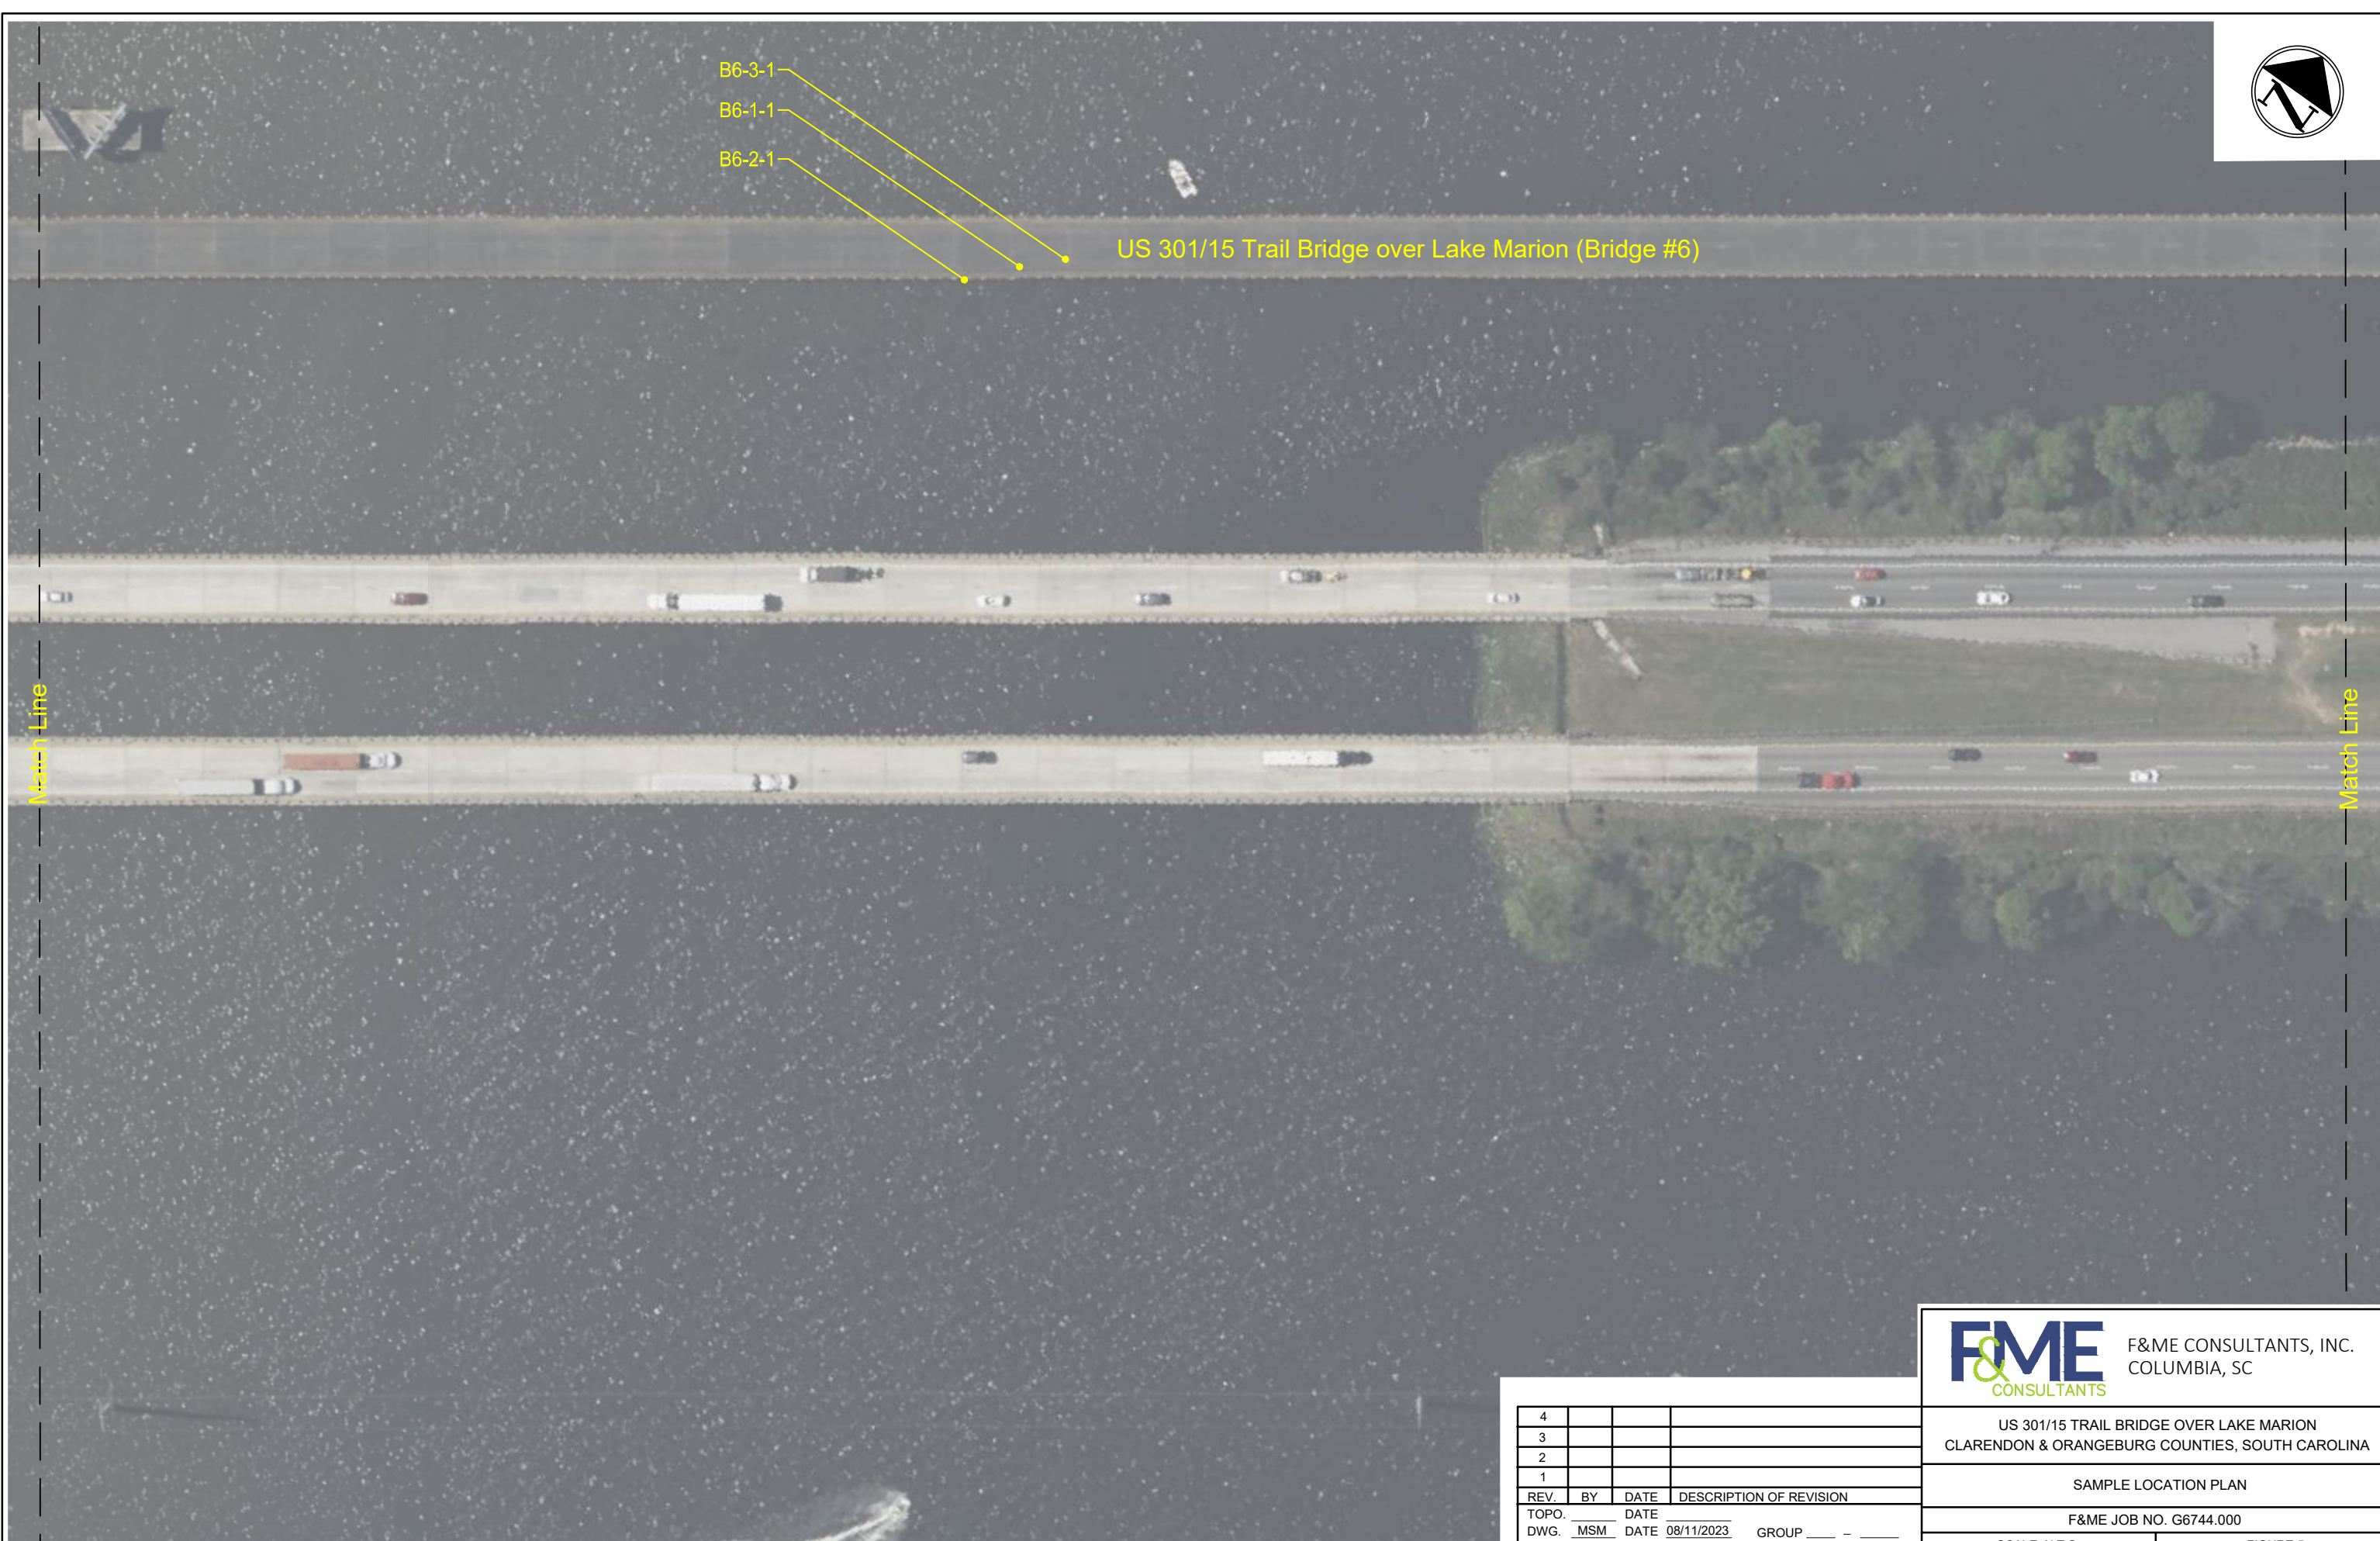
SCALE: N.T.S. FIGURE 4

B6-3-1
B6-1-1
B6-2-1

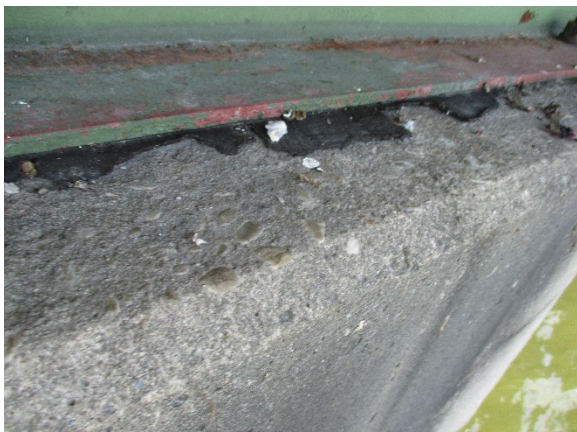
Photo 5. Non-ACM Repair Bond Break Bearing Pad.

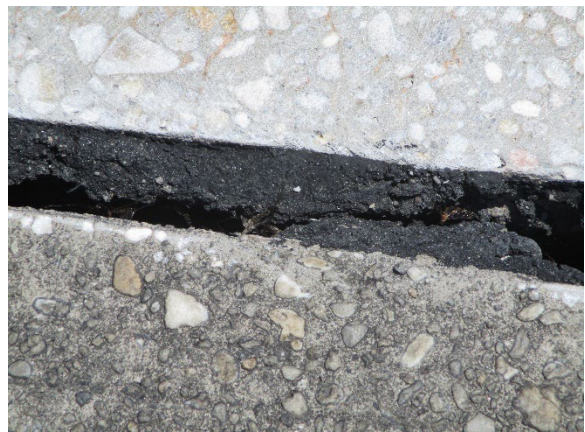
Photo 6. Non-ACM Expansion Joint Material.
