Pavement Design

DATE: March 12, 2025

RE: I-95 Over Lake Marion Supplementary Pavement Investigation

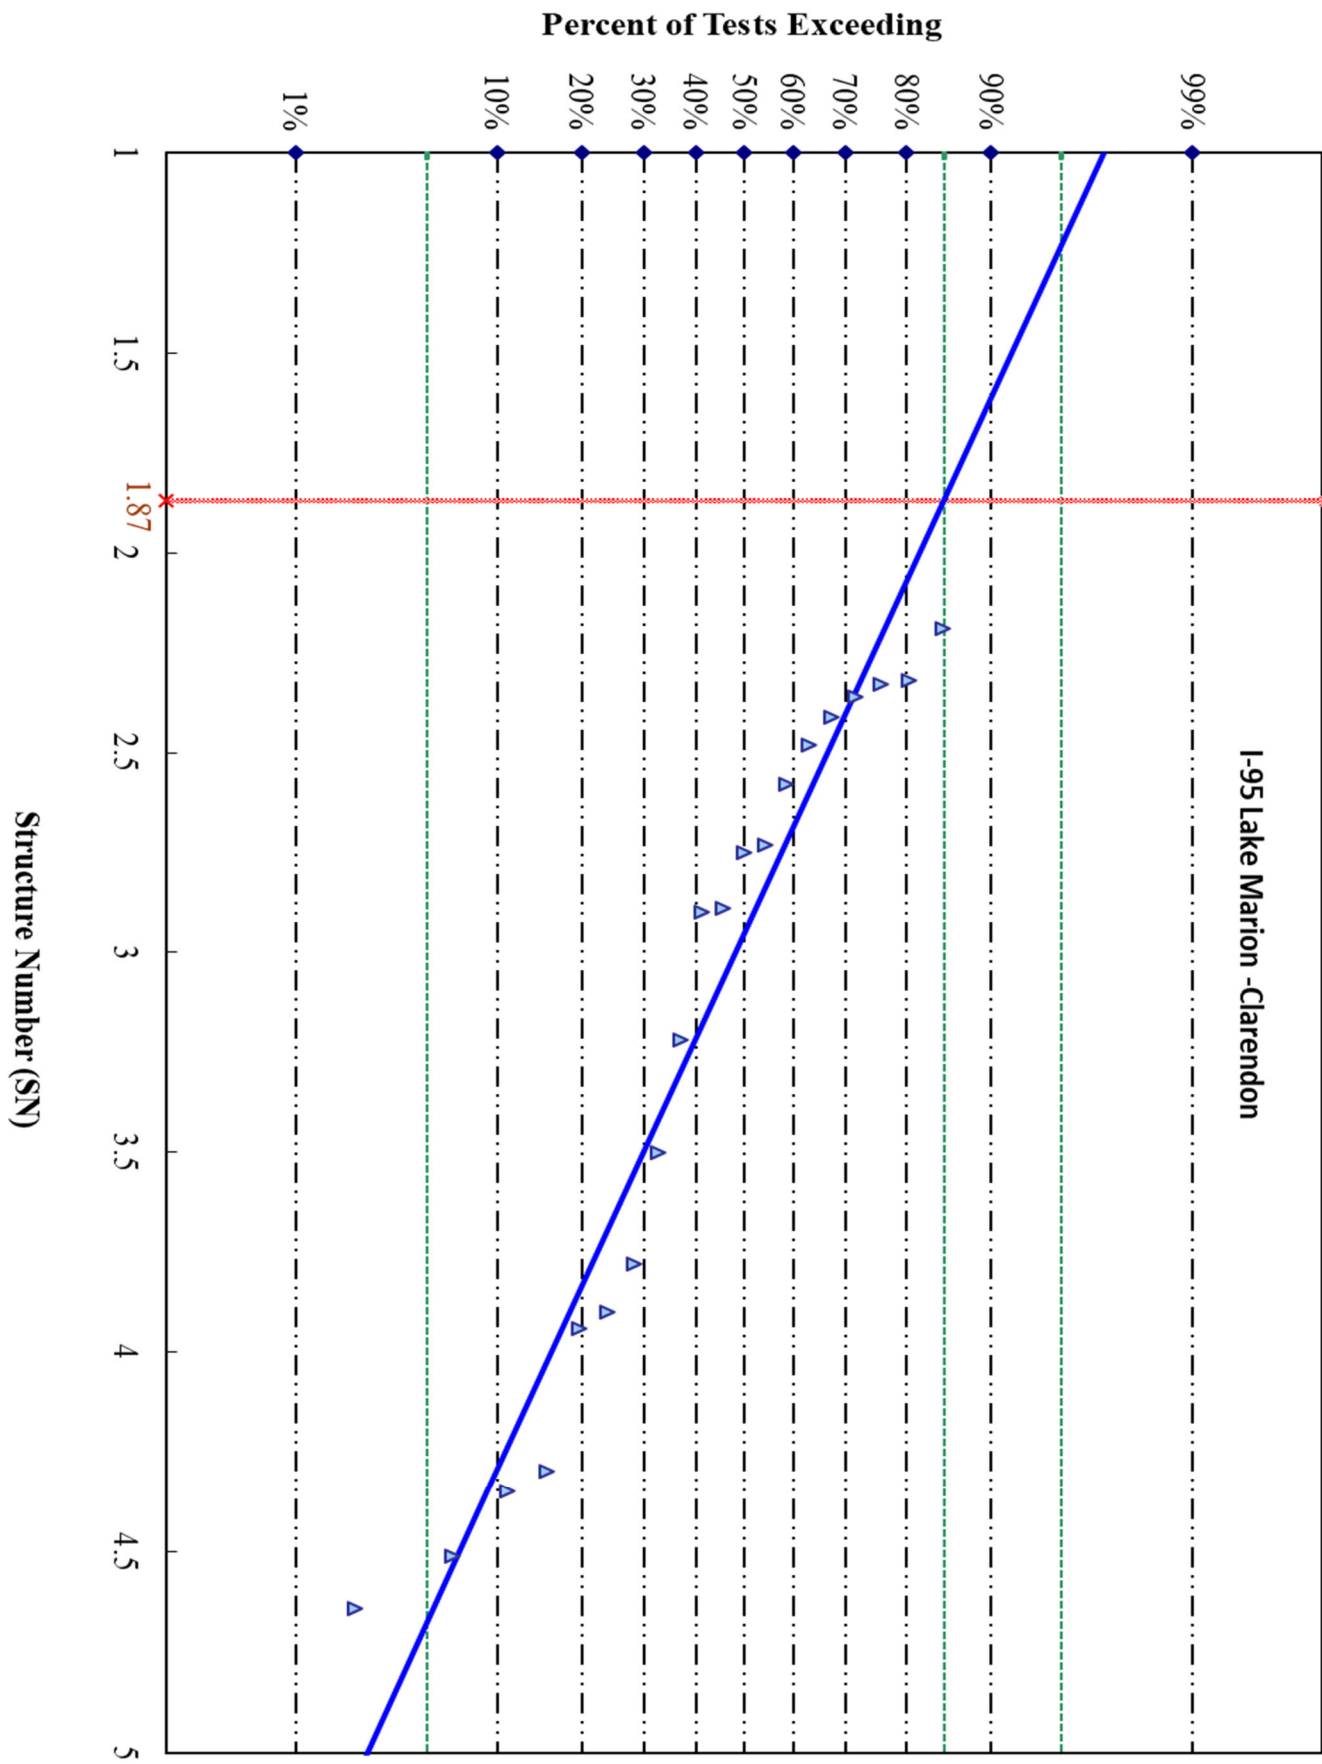
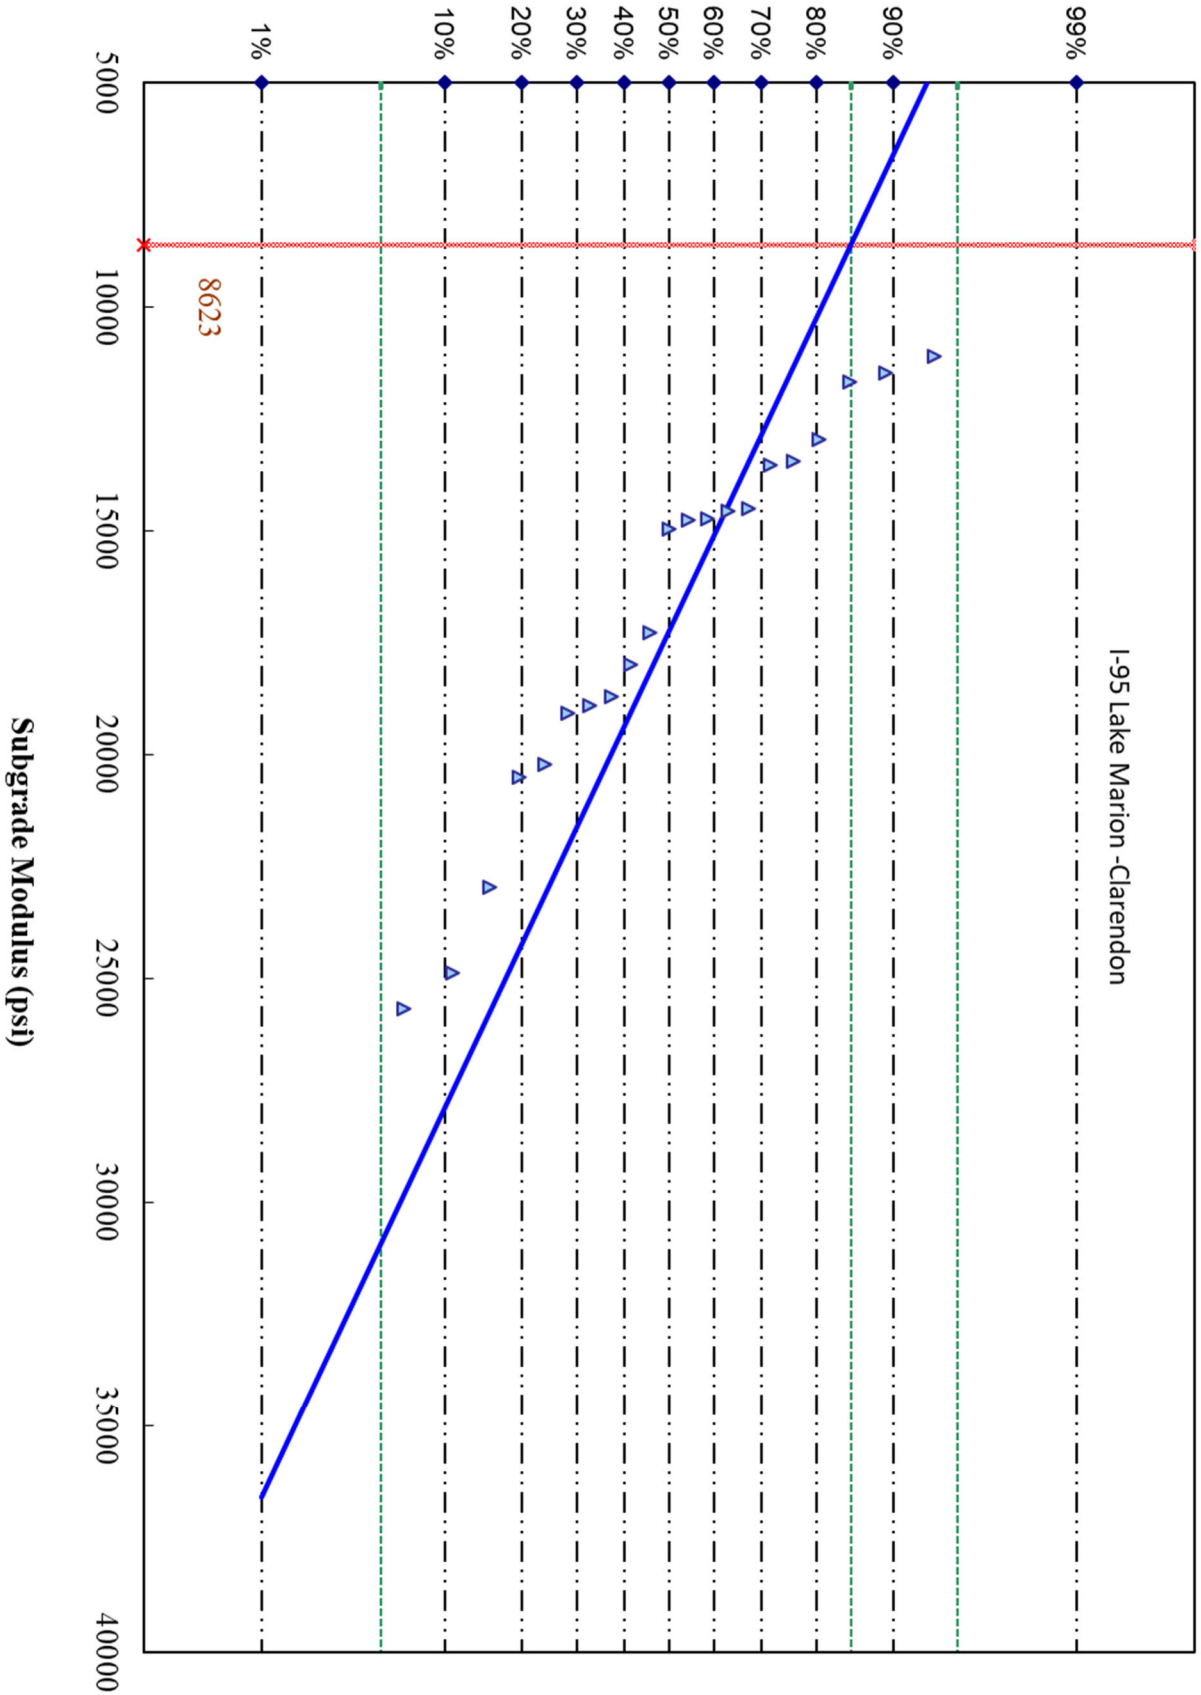
FWD Data – Outside Shoulder

FWD testing results show that the outside shoulder pavement structure is highly variable with structural number values ranging from 2.19 – 4.64. An existing structural number of 1.87 was determined based on the statistical analysis of the results. This is a value lower than any tests due to the variability of the test results and the probability of missing the lowest values during field testing. Additionally, a subgrade modulus value of 8623 psi also indicates that the soils may be worse than historical references and mechanistically would be more indicative of something in the 1-2 range. Significant repairs would be required to bring the pavement to a desired SN that could comfortably carry temporary traffic. Alternatively, a mechanistic analysis was performed using

the 1100 psy of asphalt over a poor subgrade, which indicates a 3 plus year design. This design has been included in the RFP for temporary designs.
